**DALTON LAKE DAM
STE. GENEVIEVE COUNTY, MISSOURI
MO 31038**

PHASE 1 INSPECTION REPORT NATIONAL DAM SAFETY PROGRAM

Name of Dam: Dalton Lake Dam
State Located: Missouri
County Located: Ste. Genevieve
Stream: Tributary Coldwater Creek
Date of Inspection: 9 August 1978

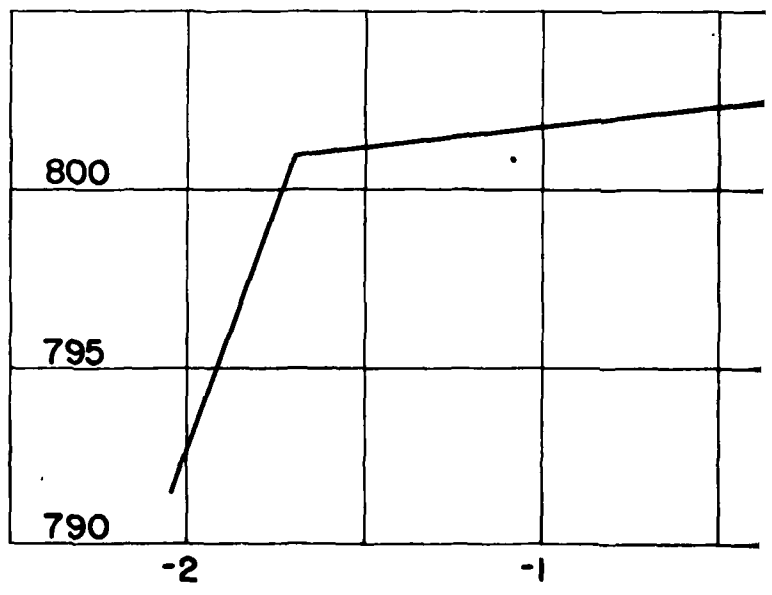
PROFILE SPILLWAY
 SCALES: 1" = 5' V., 1" = 50' H.

The crest of the dam was found to be approximately 2 feet lower near the left abutment than in the area adjacent to the spillway. (The low point of the dam is approximately 2 feet higher than the spillway crest.) As a result, the capacity of the spillway to discharge lake outflow without overtopping the dam is reduced.

d. Earth Spillway. The spillway section is an excavated earth section that contains a considerable quantity of gravel which appears to exist naturally in the soil. The entire spillway channel is unprotected (see Photo 5) and some erosion of the bottom was noticed. A profile of the spillway channel through the control section is shown on Plate 2.
