**LAKE FOREST DAM,  
STE. GENEVIEVE COUNTY, MISSOURI,  
MO 30087**

**PHASE I INSPECTION REPORT  
NATIONAL DAM SAFETY PROGRAM**

**PREPARED BY: U. S. ARMY ENGINEER DISTRICT, ST. LOUIS**

**DECEMBER 1978**

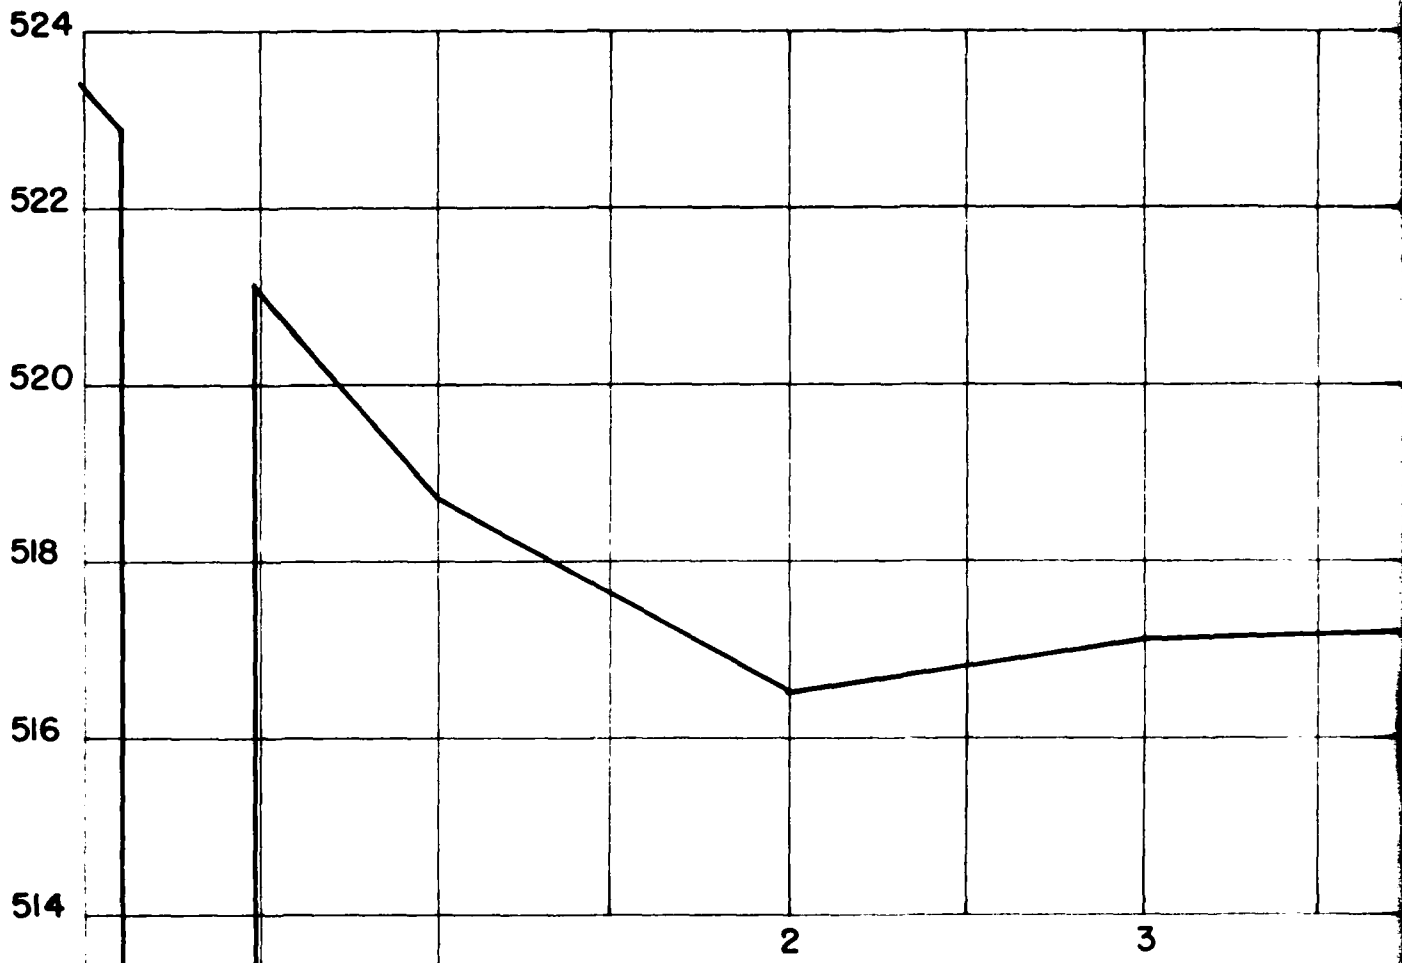
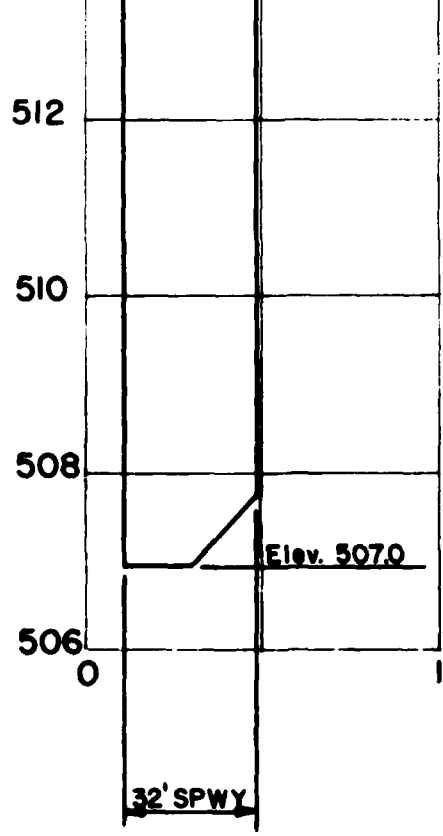
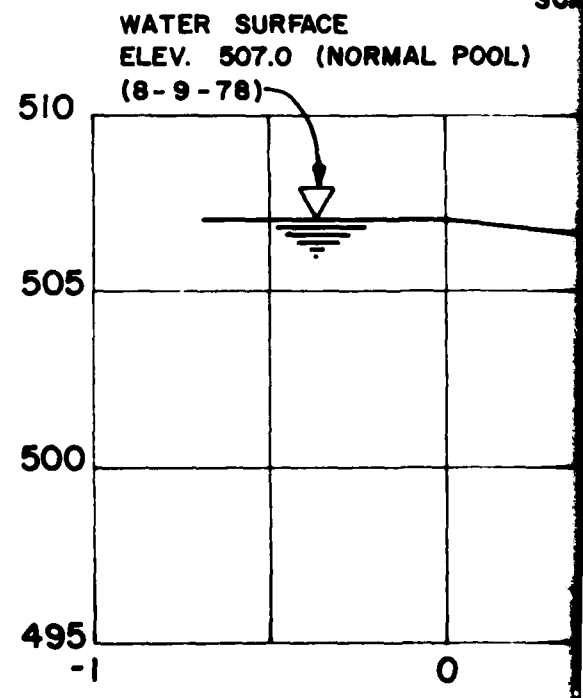
**PROFILE DAM CREST**  
 SCALES: 1" = 2' V., 1" = 50' H.

The crest of the dam was found to be approximately 5 feet lower at a point near the center of the dam than in the area adjacent to the spillway. (The low point of the dam is approximately 9 feet higher than the spillway crest.) As a result, the capacity of the spillway to discharge lake outflow without overtopping the dam is reduced. According to the criteria set forth in the recommended guidelines (see text) the minimum spillway design flood for this dam, which is classified as intermediate in size and of high hazard potential, is specified to be the Probable Maximum Flood (PMF). PMF is the flood that may be expected from the most severe combination of critical meteorologic and hydrologic conditions that are reasonably possible in the region. Results of a hydrologic/hydraulic analysis indicated that the existing spillway is inadequate to pass the lake outflow resulting from a storm of PMF magnitude. It is capable of passing the lake outflow resulting from the 1 percent chance (100-year frequency) flood. The spillway is capable of passing lake outflow corresponding to approximately 22 percent of the PMF without overtopping the dam. The length of the downstream damage zone, should failure of the dam occur, is estimated to be ten miles. There are at least two houses and one bridge crossing within the first two miles downstream of the dam.
