**WEBER HILL TERRACE LAKE DAM
JEFFERSON COUNTY, MISSOURI
MO 30449**

**PHASE I INSPECTION REPORT
NATIONAL DAM SAFETY PROGRAM**

Weber Hill Terrace Lake Dam (~~Inventory~~
~~Number~~ MO-30449), Mississippi-Kaskaskia-St
Louis Basin, Jefferson County, Missouri.
Phase I Inspection Report.

Name of Dam: Weber Hill Terrace Lake Dam
State Located: Missouri
County Located: Jefferson
Stream: Bear Creek
Date of Inspection: 19 July 1978

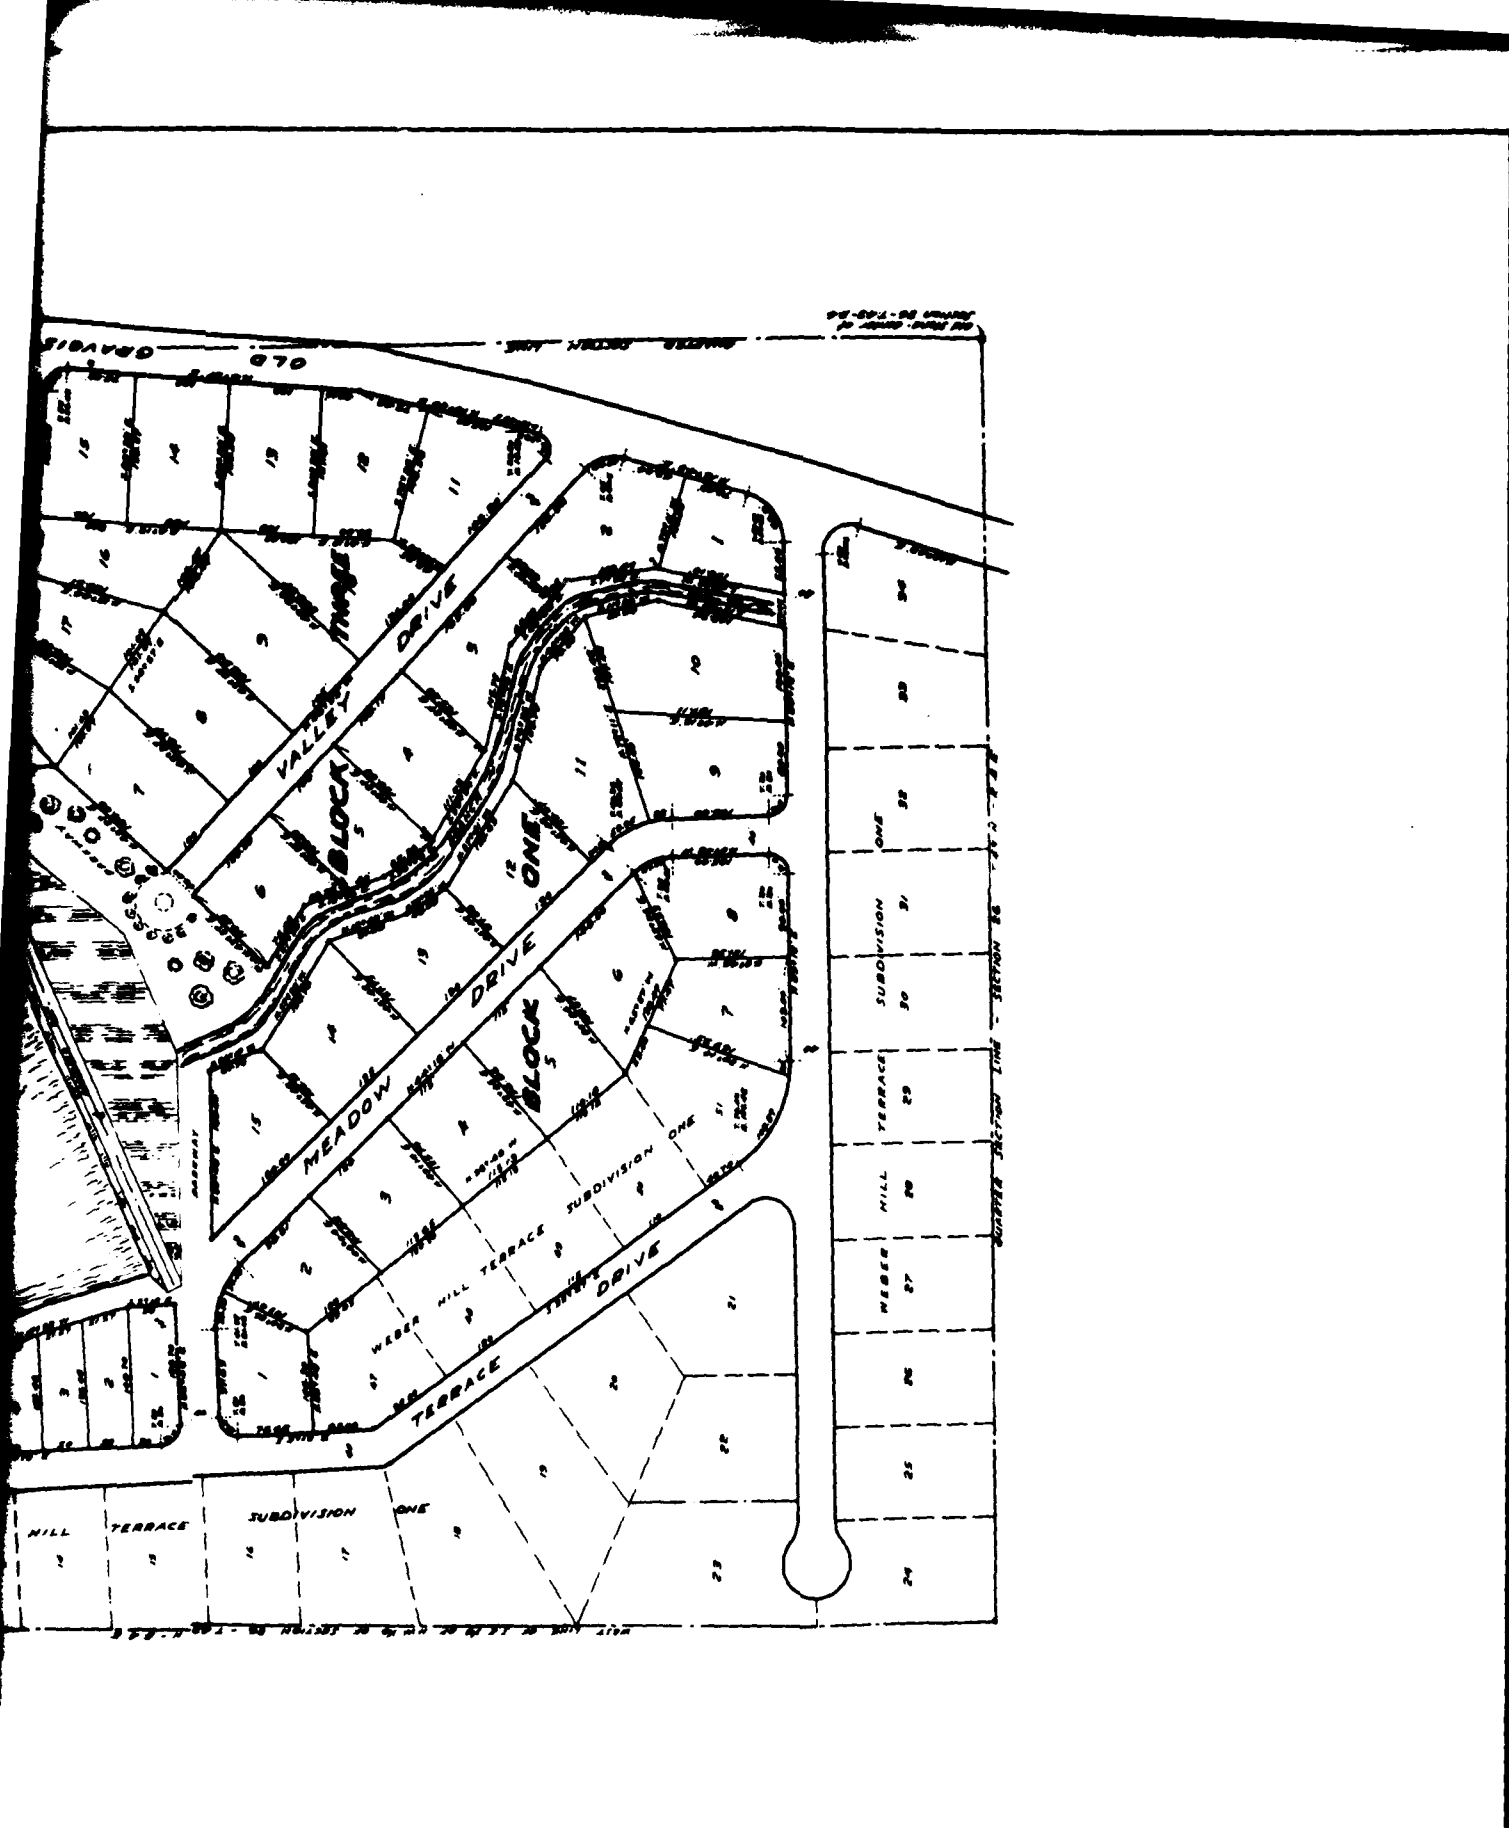
PLATE 2

joins the original stream, Bear Creek. At normal pool elevation the lake occupies approximately 11 acres. There are no drawdown facilities for dewatering the lake. A plan of the Weber Hill Terrace Subdivision showing the lake, dam, and spillway is shown on Plate 2.

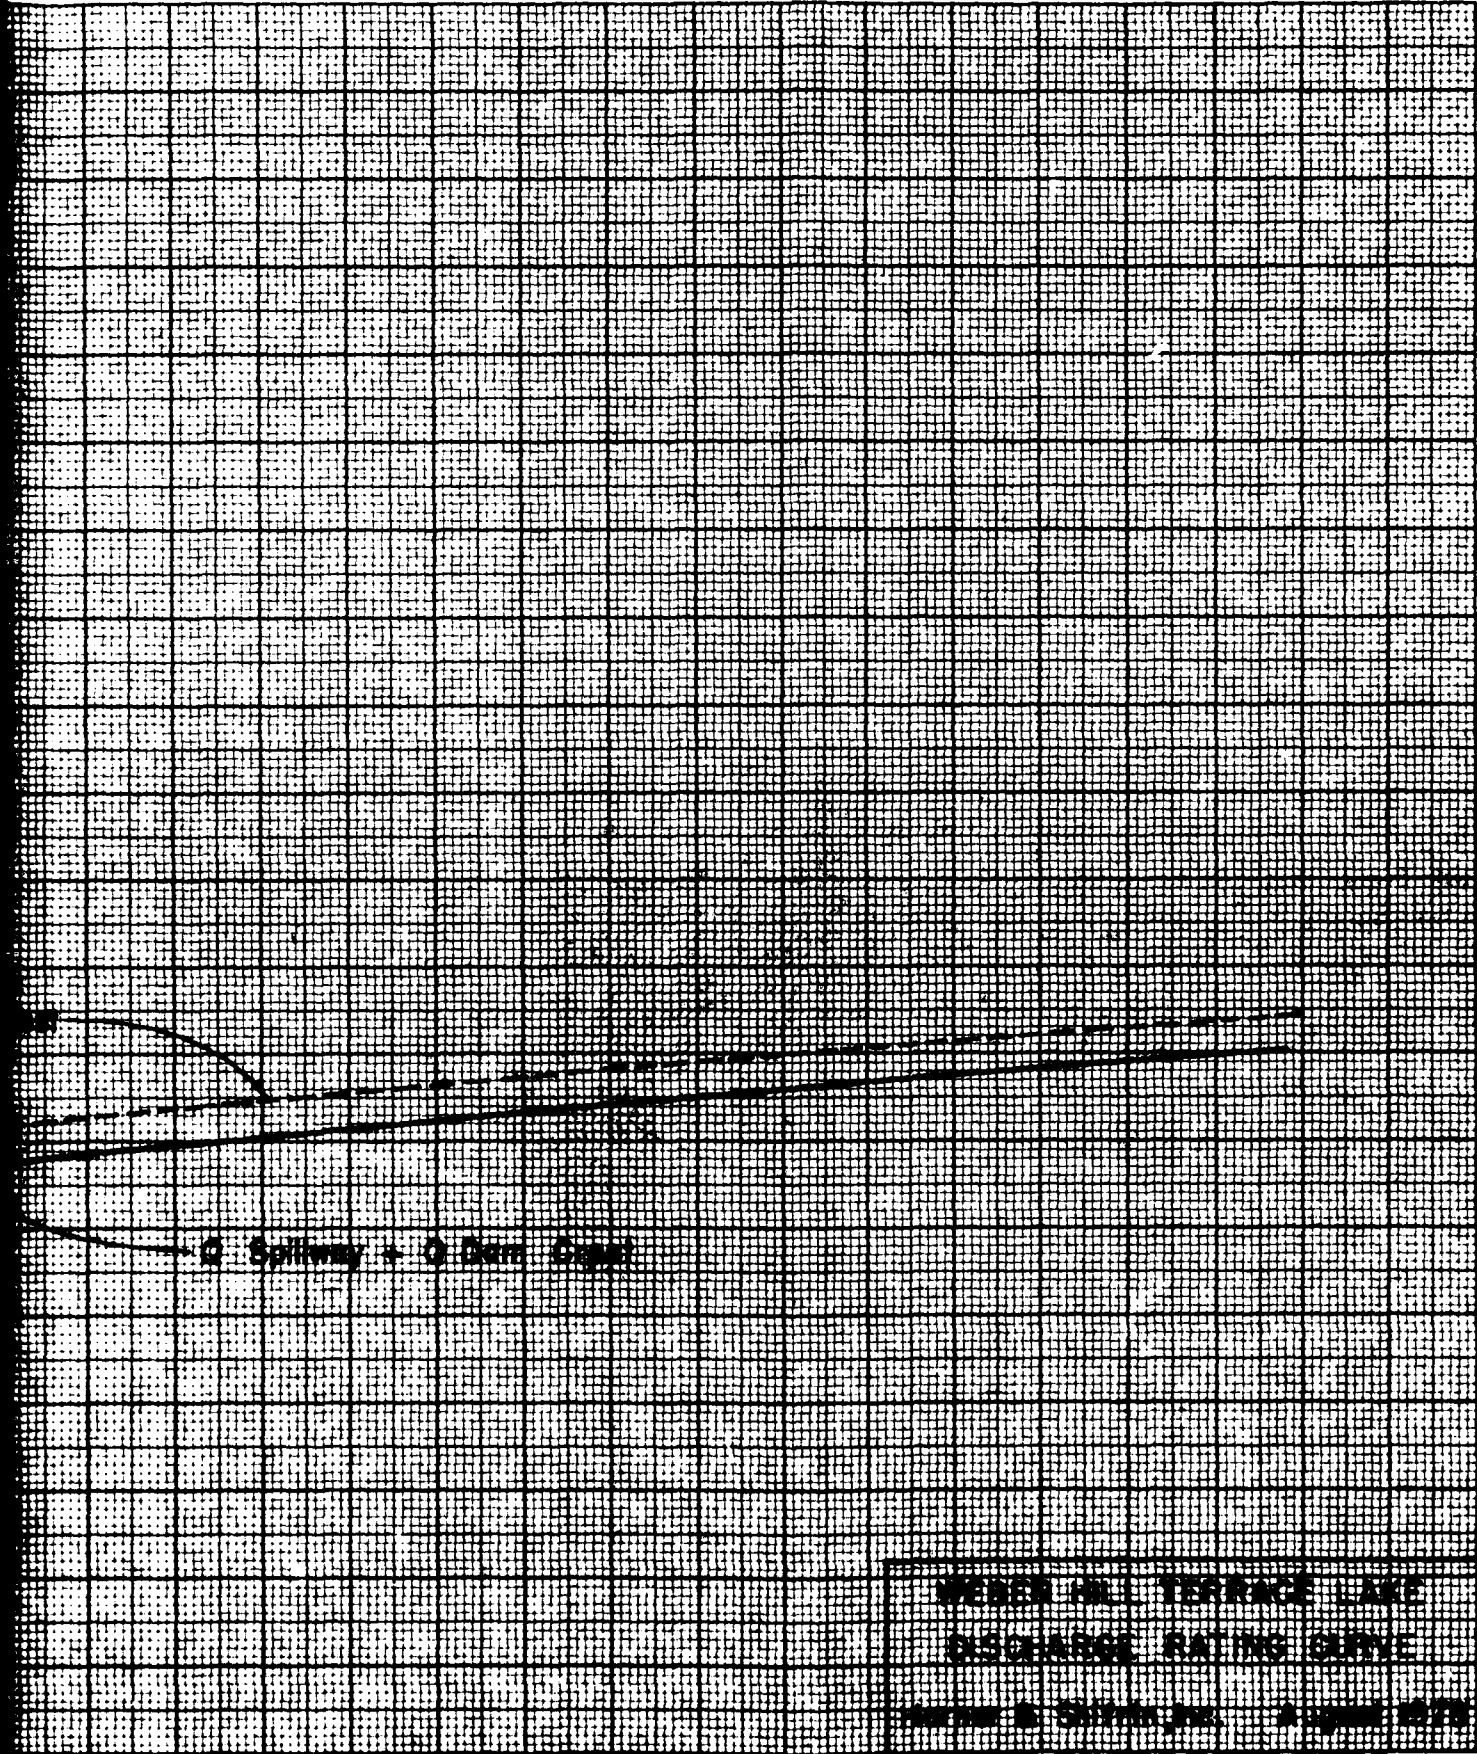
PLATE 4

3. The profile of the dam crest is irregular and flow over the dam crest cannot be determined by conventional weir formulas. Flow quantities overtopping the dam crest were computed as described in the preceding paragraph and corresponding flow over the dam and spillway for given elevations were added to obtain the combined outflow rating curve for the dam and spillway. This rating curve is shown on Plate 4. The inflow and outflow hydrographs for the PMF are shown on Plate 5.
