HORNER AND SHIFRIN INC ST LOUIS MO  
NATIONAL DAM SAFETY PROGRAM. UPPER LAKE MINNIE HA-HA DAM (MO-30--ETC(U)  
DEC 79

- UPPER LAKE MINNIE HA-HA DAM, MO 30643
- LOWER LAKE MINNIE HA-HA DAM, MO 30644
- LAKE MINNIE HA-HA DEVELOPMENT,
- STE. GENEVIEVE COUNTY, MISSOURI .

5 PHASE 1 INSPECTION REPORT.  
1 NATIONAL DAM SAFETY PROGRAM.

DECEMBER 1979

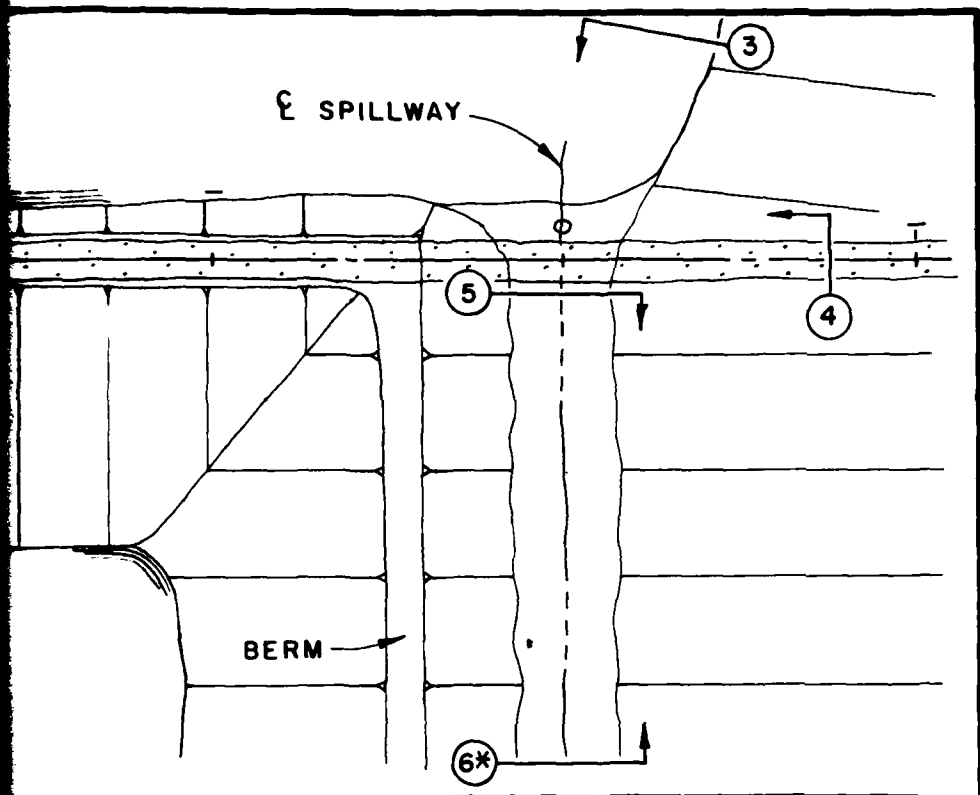
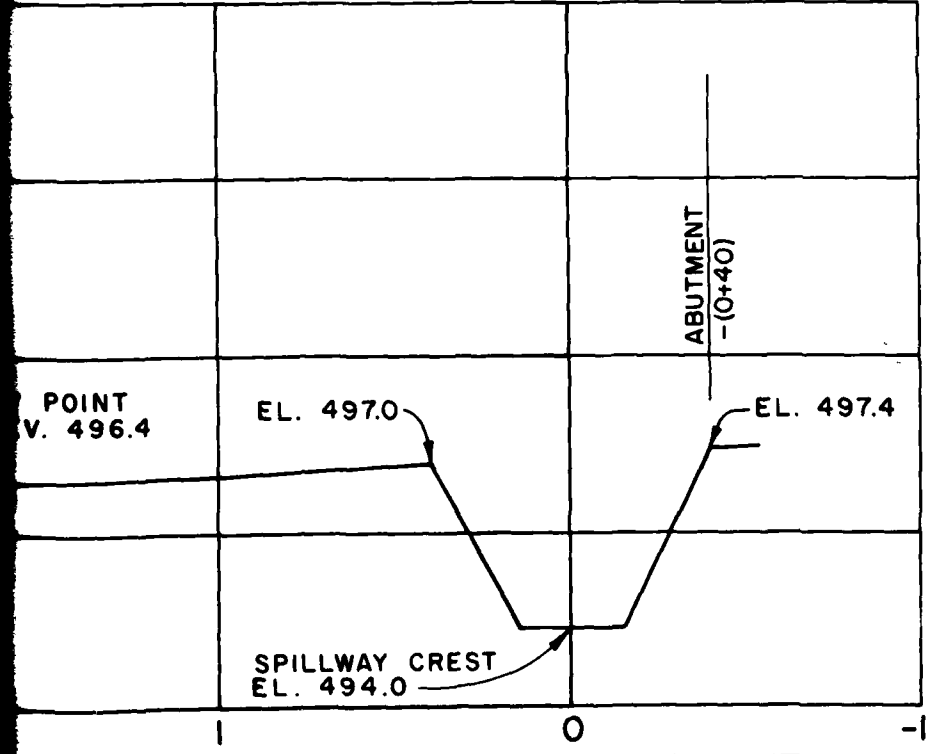
UPPER LAKE MINNIE HA-HA  
DAM PLAN & PROFILE  
Horner & Shifrin, Inc. Oct. 1979

(1) Upper Lake Minnie Ha-Ha Dam. The visible portions of the upstream and downstream faces of the dam (See Photos 1 and 2) appeared generally to be in sound condition. A hole, believed to be an animal burrow (see Photo 8) was noticed at the downstream toe of slope about 120 feet from the right abutment, with consequent erosion (about 0.8 foot deep) above the hole. An erosion ditch approximately 3 feet deep has developed in the hillside about 15 feet downstream of the right abutment. Stone riprap, average 18-inch dimension, with some larger, is provided along the waterline at the upstream face. Above the riprap on the upstream face there are several areas of dense brush and grass, about 2 feet high.

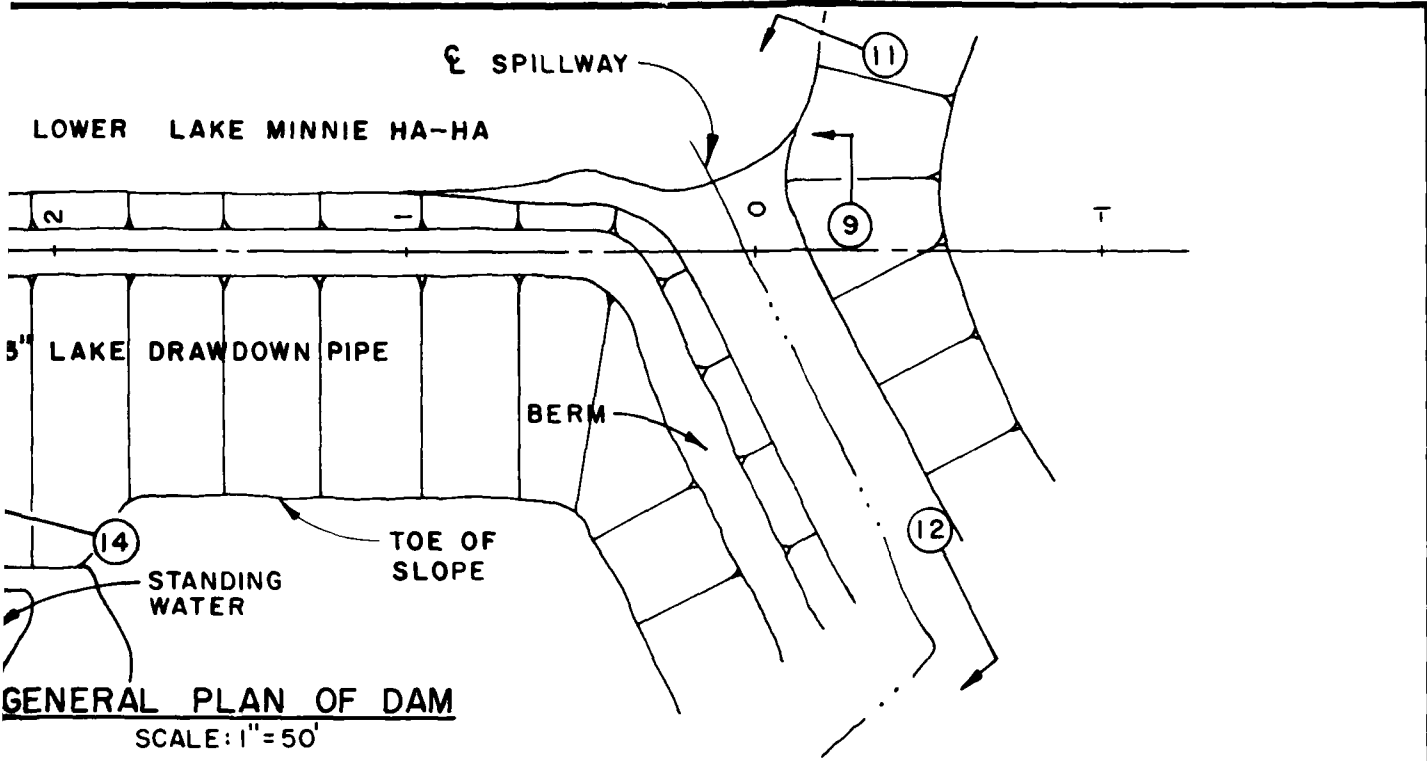
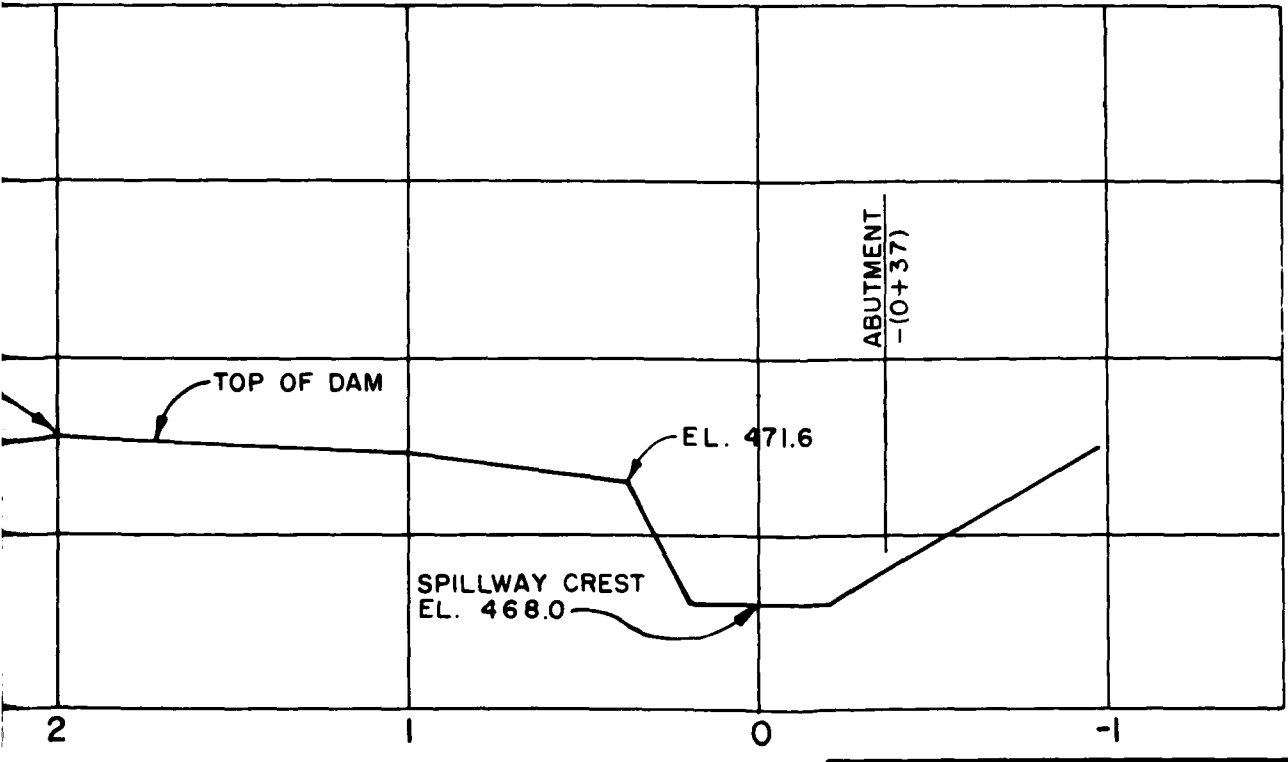
LOWER LAKE MINNIE HA-HA  
 DAM PLAN & PROFILE

(2) Lower Lake Minnie Ha-Ha Dam. The visible portions of the upstream and downstream faces of the dam (see Photos 9 and 10) appeared to be in satisfactory condition although the plant cover on the crest and the downstream face of the dam was in an unkept condition with high, about 3 feet, grass, dense brush and numerous small trees. Minor erosion at the waterline of the unprotected upstream face that appeared to be due to wave action was noticed. Above the eroded area the grass on the upstream face was about 2.5 feet high. No cracking or misalignment of the dam crest was evident.
