DUCK CREEK
 STATE WILDLIFE REFUGE - POND 1
 BOLLINGER AND STODDARD COUNTIES, MISSOURI
 MISSOURI INVENTORY NO. 40063

⑥ PHASE I INSPECTION REPORT ...
 NATIONAL DAM SAFETY PROGRAM,

PHASE I REPORT

Name of Dam	Duck Creek State Wildlife Refuge - Pond 1
State Located	Missouri
County Location	Bollinger and Stoddard Counties
Stream	Castor River
Date of Inspection	22 May 1979

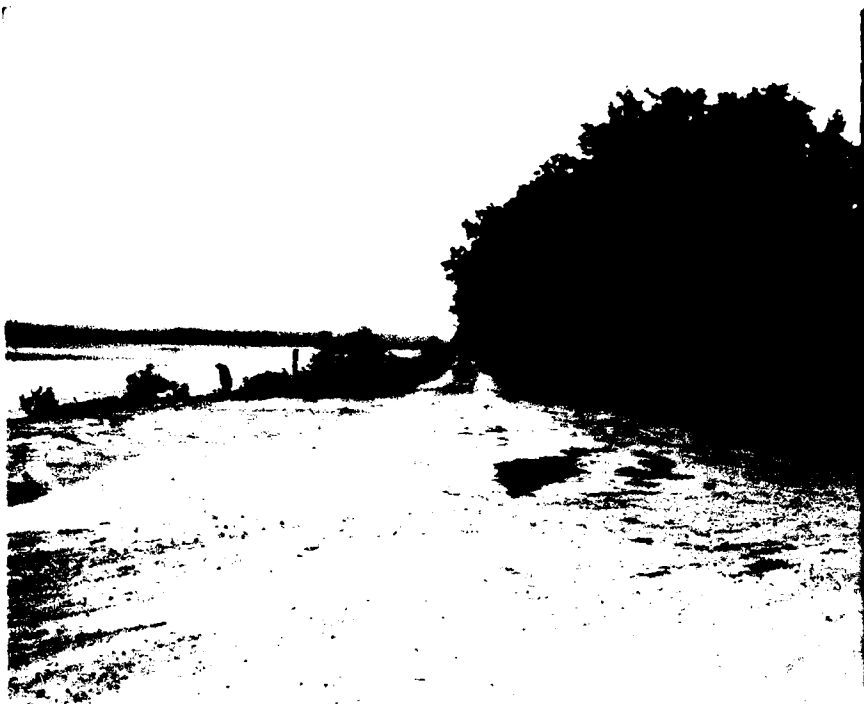
Photo 1: Eastern Levee - Looking North from Section "Q"

The maintenance of the levee crown and slopes was satisfactory. In many areas trees and small brush covered the landside slope. Only the southern boundary was free from significant brush and tree growth. All evidence of wash has been repaired with riprap. Riprap had also been placed to control animal burrows on the lakeside slope (see Photos 3, 4, and 5). The riprap protection was approximately 2 feet thick all around the lake except on the northern edge. No significant sloughing, caving or seepage was noticed. The normal pool elevation is 345.5 N.G.V.D.; however, the day of the inspection it was at an elevation of 345.6 N.G.V.D. The eastern and western boundaries were bordered by two ditches to carry the surface drainage from the areas north and east of the reservoir (see Photo 8). Also Ditch 1 on the western boundary serves as the influent to Pond 1 during filling periods as discussed in Section 4.

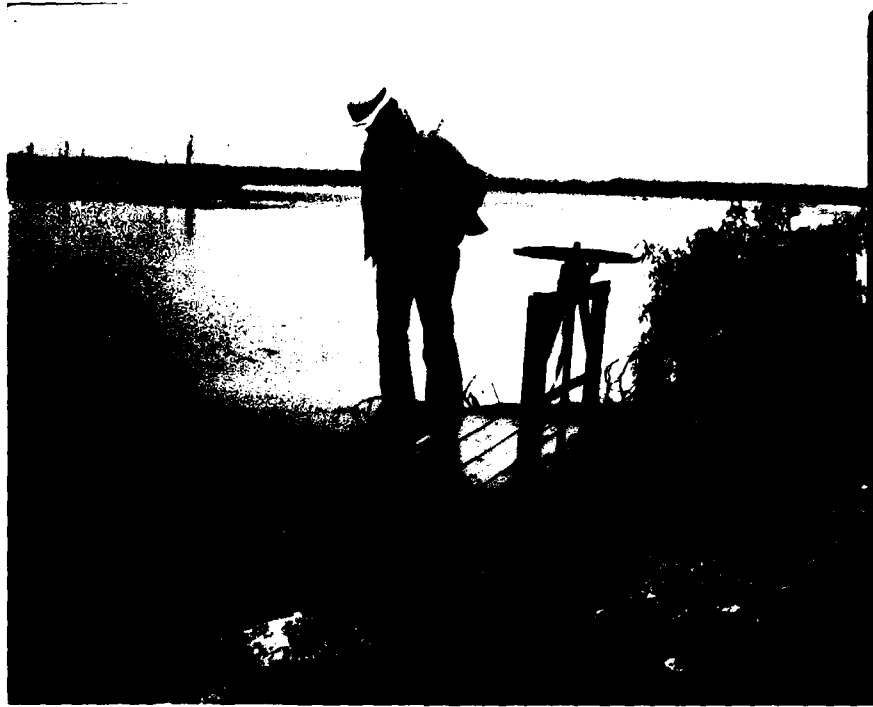
Photo 9: Culvert Control Structure at Section "Q"

d. Appurtenant Structures. Three culverts, a sluice gate, and an emergency spillway provide the means of inflow and outflow for the pond. All discharge structures were satisfactorily maintained and appeared to be in good working condition. Photos 9 and 10 show the gated - control structure and outlet respectively for the 36-inch CMP culvert located at Station 350+77. This culvert is used to fill Pond 2 prior to the duck season. Photos 11 and 12 show the gated -control structure and outlet respectively for the 36-inch CMP culvert located at Station 18+04. This culvert is used to fill Pond 3 prior to the duck season. Photos 13 and 14 show the gated - control structure and outlet respectively for the 42-inch CMP culvert located at Station 65+43. This culvert is the primary culvert used to control the water level surface if necessary. Photos 15 and 16 show the sluice gate structure located at station 134+63. Photos 17, 18, and 19 show the radial arm structure on Ditch 1 immediately west of the sluice gate.
