MADDOX LAKE DAM
 WAYNE COUNTY, MISSOURI
 MISSOURI INVENTORY NO. 30024

⑥ ~~PHASE I INSPECTION REPORT~~
 NATIONAL DAM SAFETY PROGRAM

Maddox Lake Dam (MO 30024), Lower
 Mississippi - St. Francis Basin, Wayne
 County, Missouri. Phase I Inspection Report.

11 AUG 1978

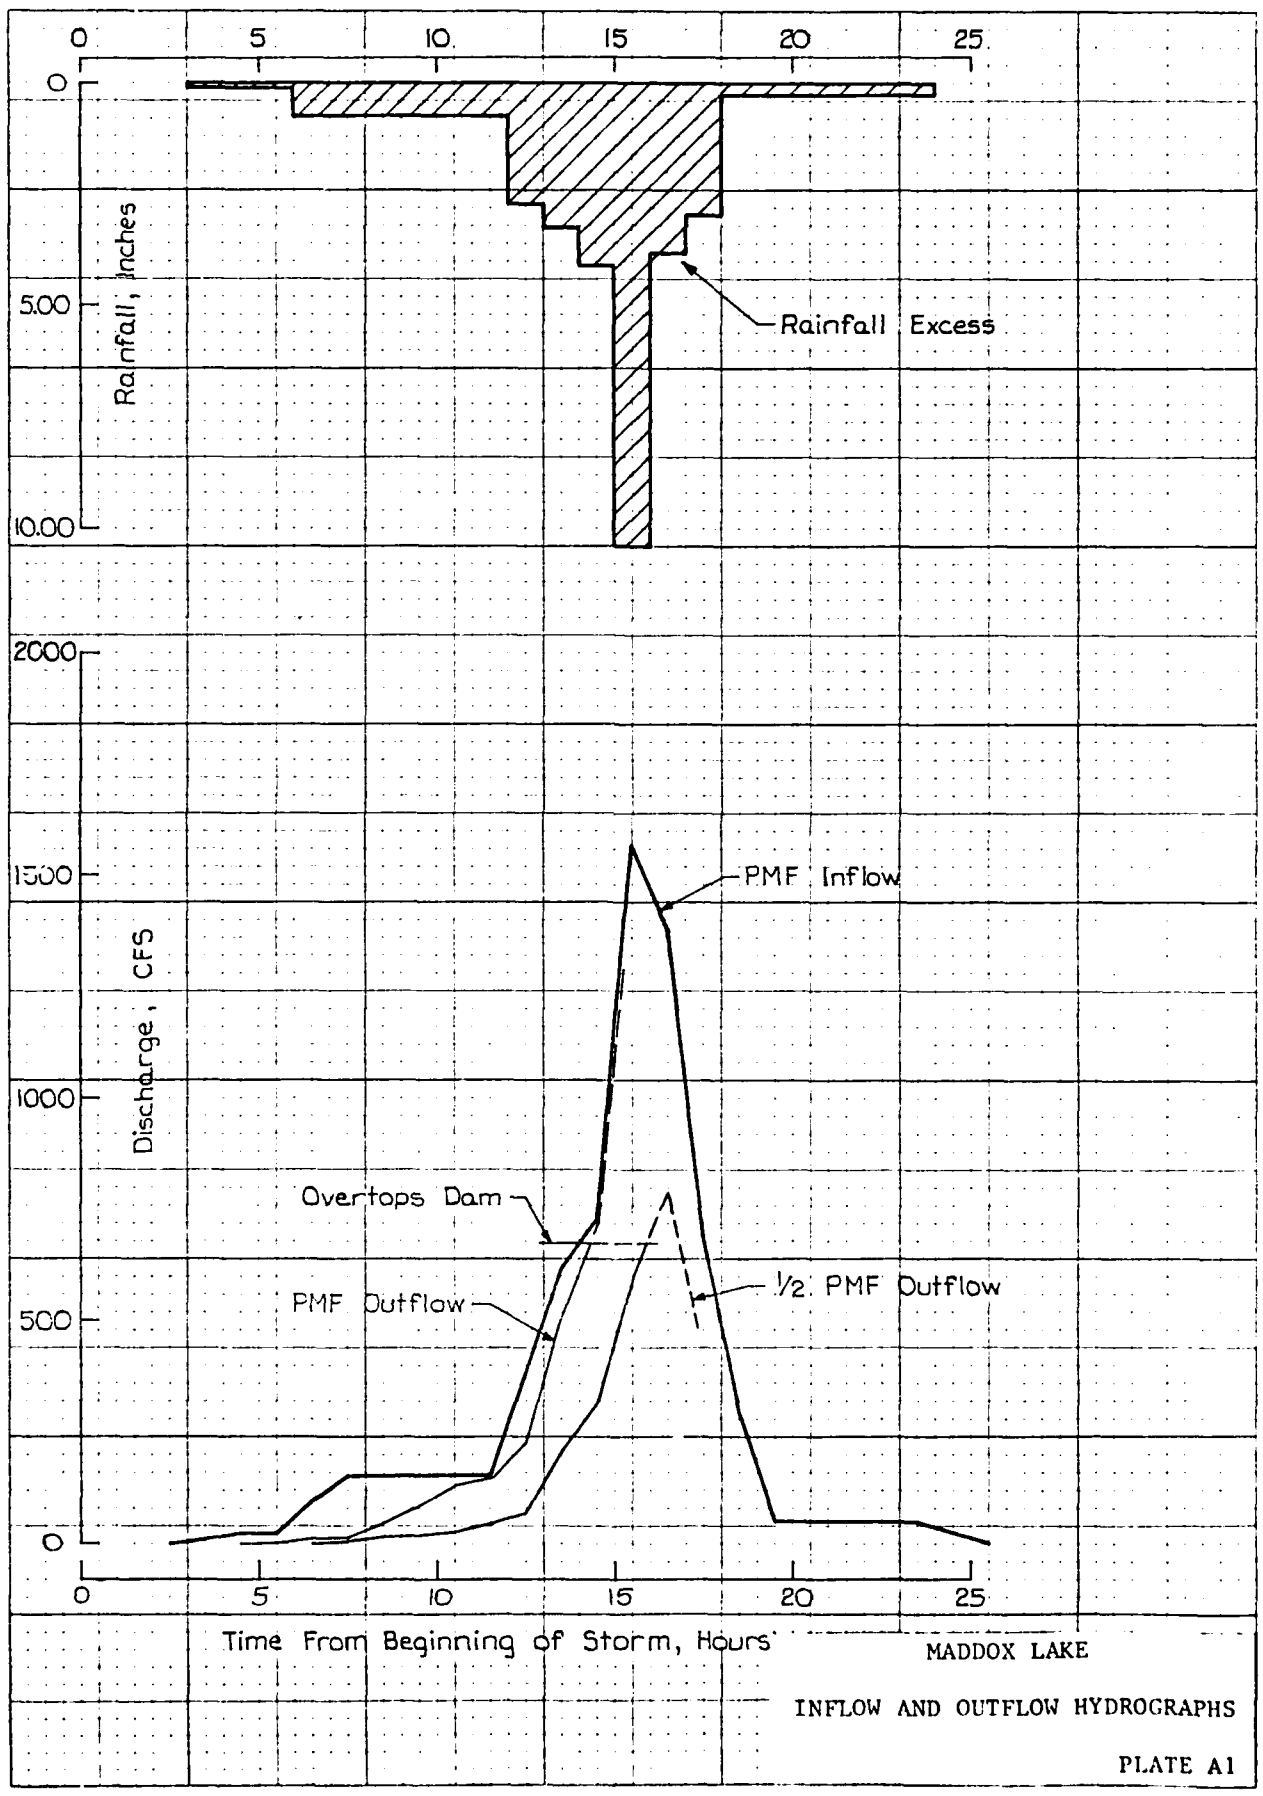
PLATE A1

4. PMF rainfall distribution, inflow hydrograph, and outflow hydrograph are shown on Plate A1.

INFLOW AND OUTFLOW HYDROGRAPHS

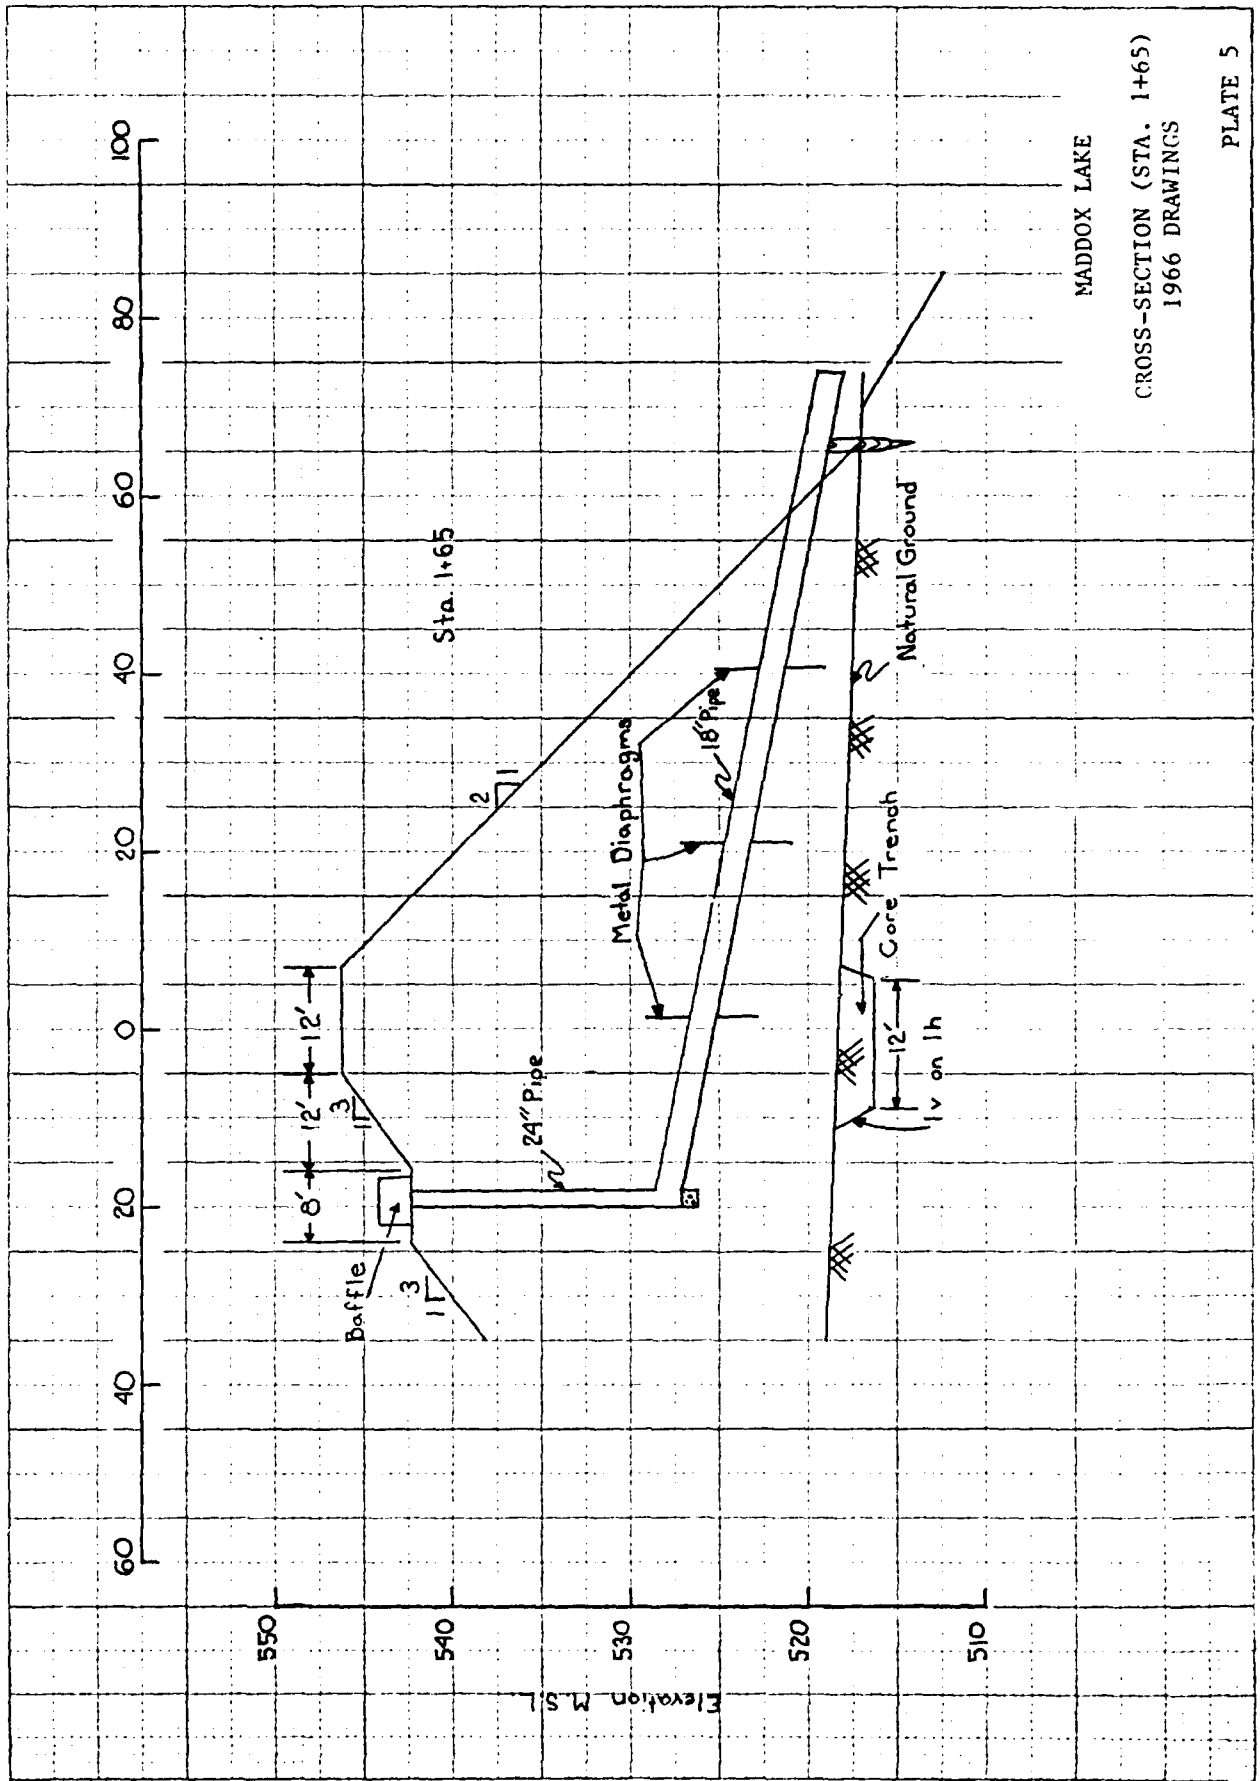
PLATE 5

c. Dam. No detrimental settlement, cracking, slides or animal burrows were observed in or near the earth embankment. Typical existing cross-sections of the embankment are shown on Plate 6. These sections are consistent with the cross-section presented in the Soil Conservation Service 1966 drawings (see Plate 5) except the existing downstream slope is a 1V on 2.4H instead of the specified 1V on 2H. The dam embankment appears to be well maintained except for several 3 to 4-foot high bushes and trees growing on the downstream slope (see Photo 4).

CROSS-SECTION (STA. 1+65)
1966 DRAWINGS
