MOUNTAIN LAKE DAM
WAYNE COUNTY, MISSOURI

MISSOURI INVENTORY NO. 30044

PHASE I INSPECTION REPORT
NATIONAL DAM SAFETY PROGRAM

AUGUST 1978

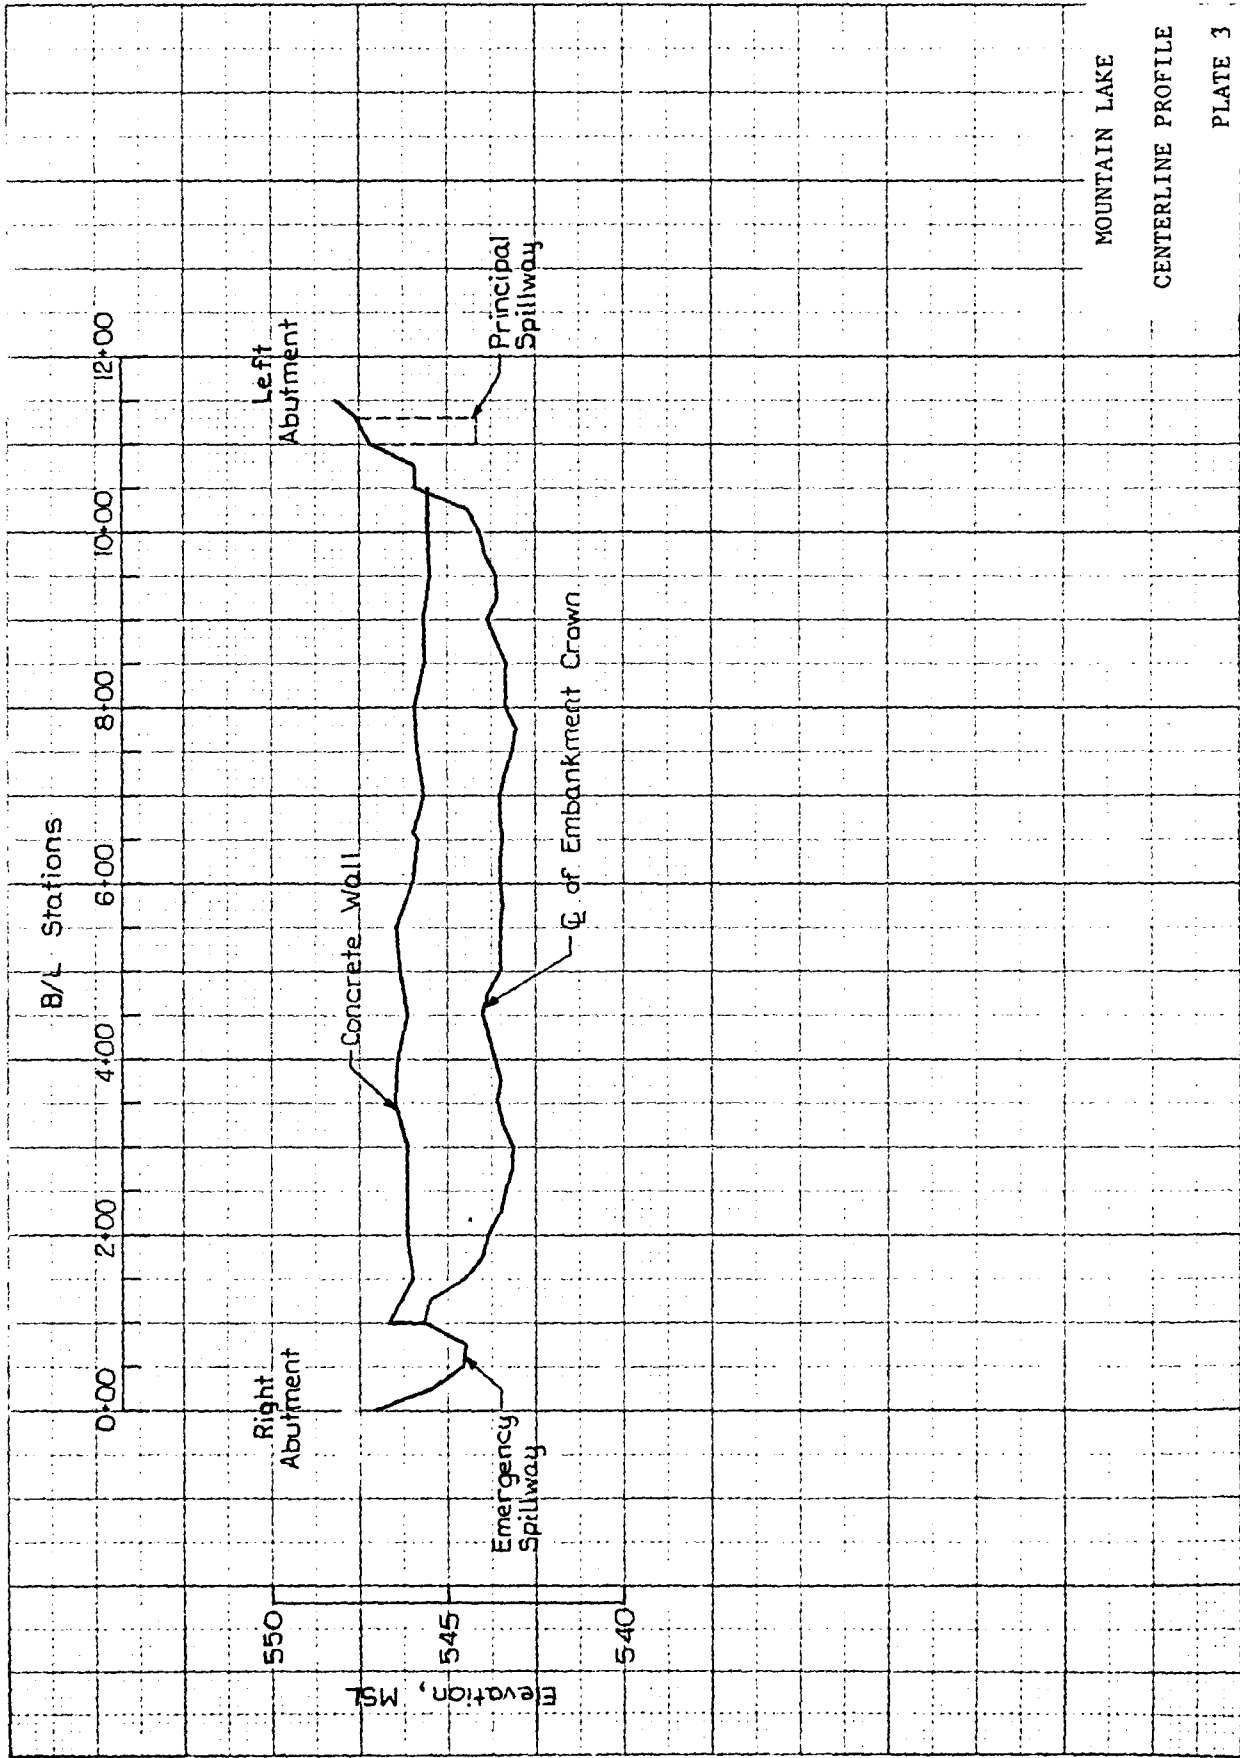
PLATE 3

- (1) Top of dam - 546.0 + (See Plate 3).
- (2) Crest of Principal Spillway - 544.3+.
- (3) Crest of Emergency Spillway - 544.6+.
- (4) Streambed at centerline of dam - 522+ (Extrapolation from survey).
- (5) Maximum tailwater - unknown.

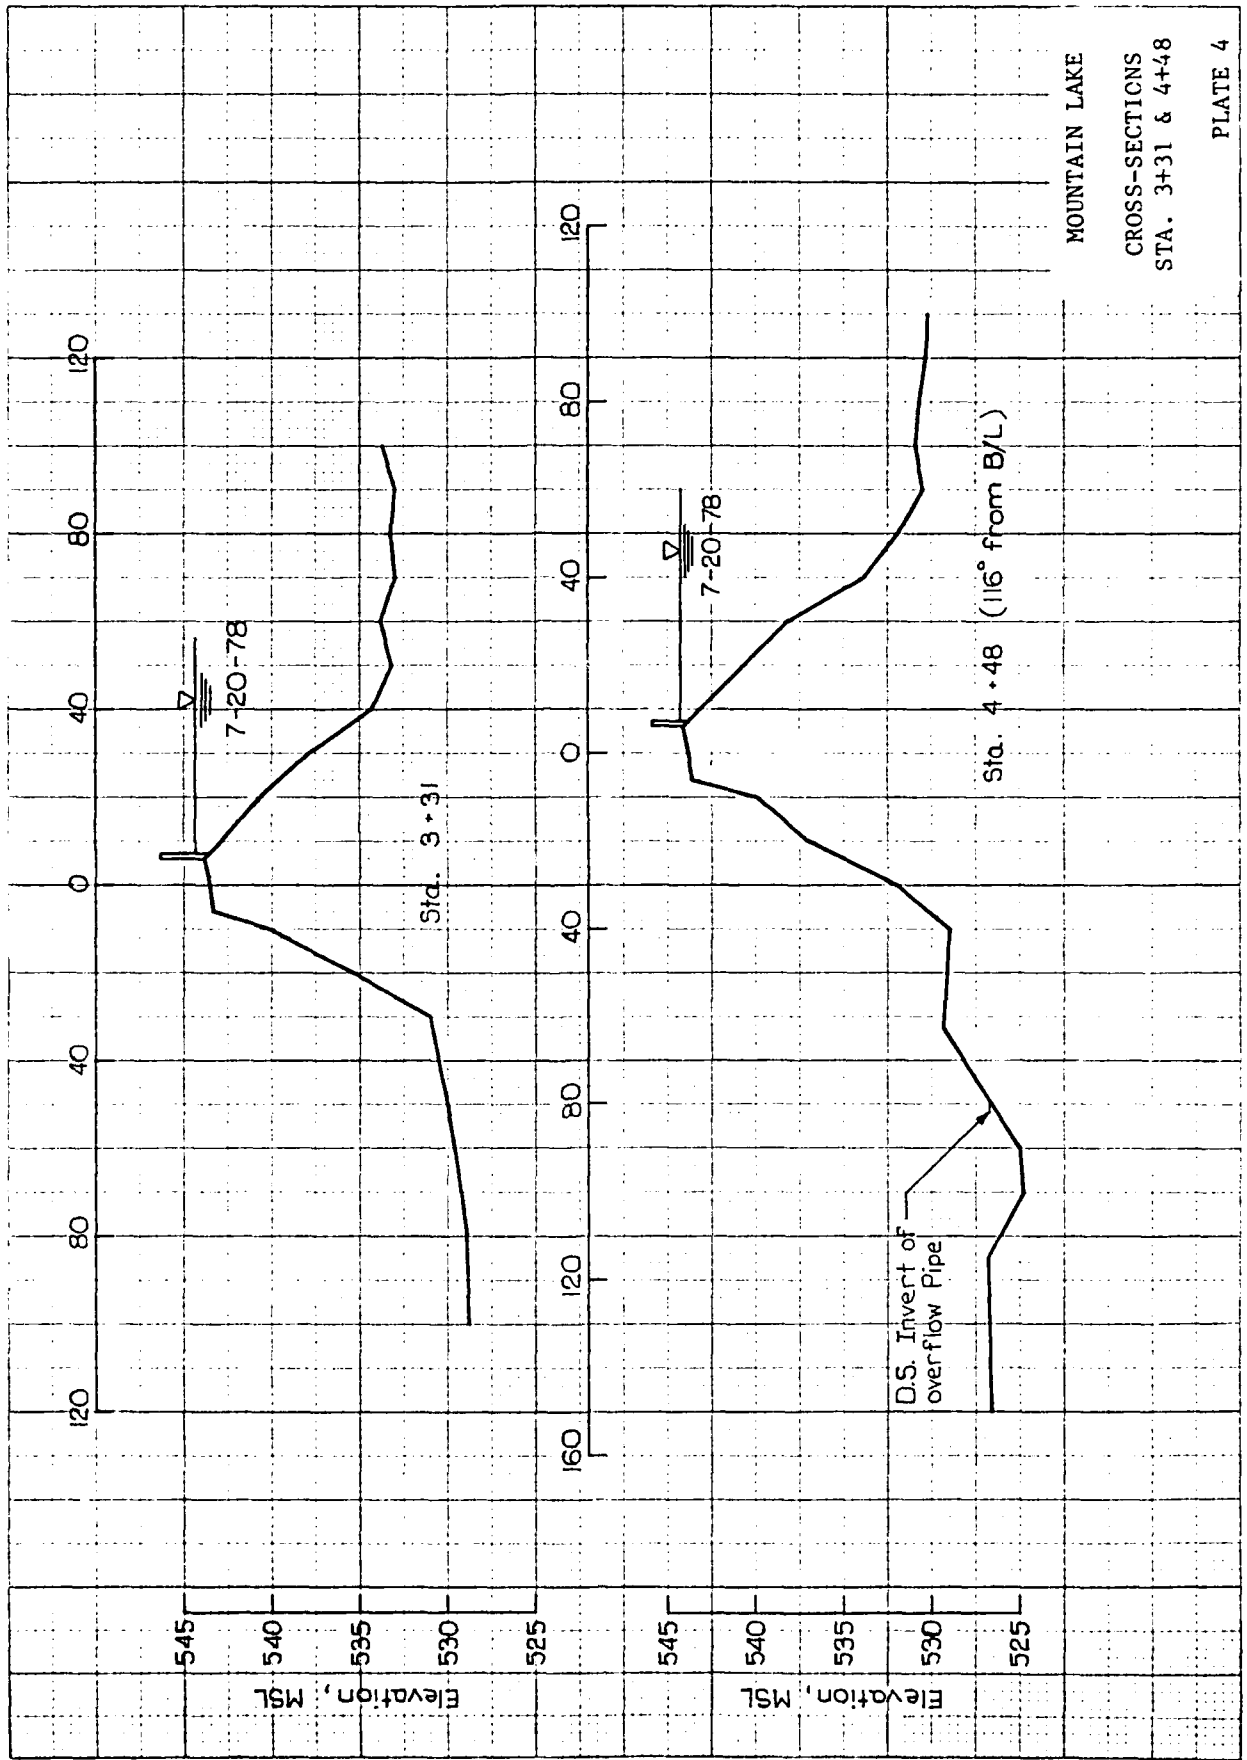
MOUNTAIN LAKE
 CROSS-SECTIONS
 STA. 3+31 & 4+48
 PLATE 4

Trees and bushes are growing on the lake side of the core wall (see Photo 5). The upstream embankment has an average slope of 1V on 3H based on the cross-section presented on Plates 4 and 5. The downstream embankment slope is very steep (1V on 1.7H average slope) and overgrown with trees (see Photos 7 and 9), and also the slope has numerous erosion gullies (see Photo 8) which were developed when the core wall was overtopped by the lake.

f. Downstream Channel. The downstream channel parallels the dam embankment for approximately 500 feet and then angles away from the dam. As shown on Plates 4 and 5, the channel is located approximately 60 feet from the embankment toe. The channel is in good condition and is not overgrown with vegetation (see Photo 14).

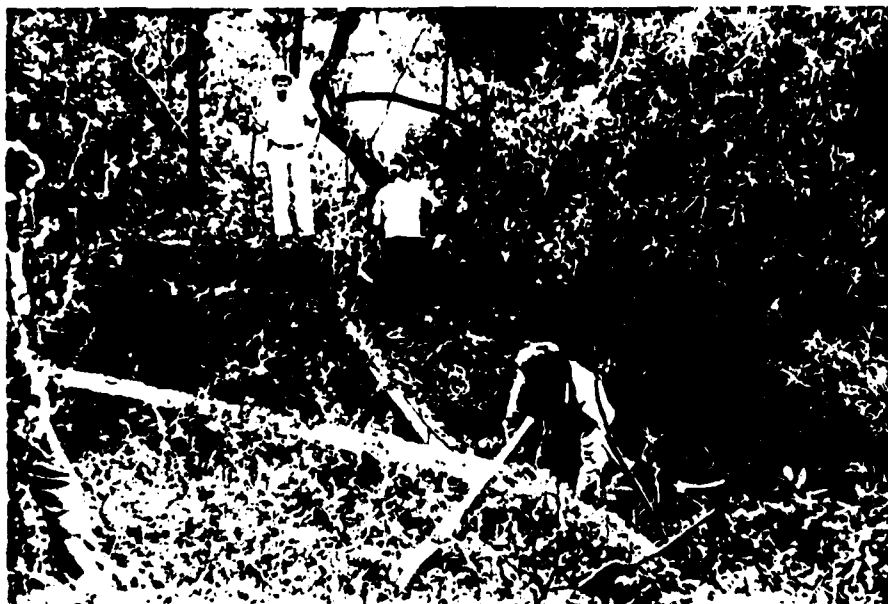
PHOTO 10: Spillway - Left to Right View

Light seepage was observed in three areas downstream of the embankment. Two of the areas were approximately 50 feet long and 10 feet wide located at baseline stations 6+00 + and 3+50 + about 10 feet from the downstream toe of the embankment. The other area of seepage is adjacent to the downstream embankment toe between baseline stations 2+00 and 3+00. Approximately 5 gpm was flowing from this area (see Photo 10).
