Lake Adelle Dam (MO 30411). Mississippi -
Kaskaskia - St. Louis River Basin.
Jefferson County, Missouri. Phase I
Inspection Report.

SUBJECT: Lake Adelle Dam Phase I Inspection Report
Jefferson County, Missouri
Missouri Inventory No. 30411

LAKE ADELLE DAM
JEFFERSON COUNTY, MISSOURI
MISSOURI INVENTORY NO. 30411

PHASE I INSPECTION REPORT
NATIONAL DAM SAFETY PROGRAM

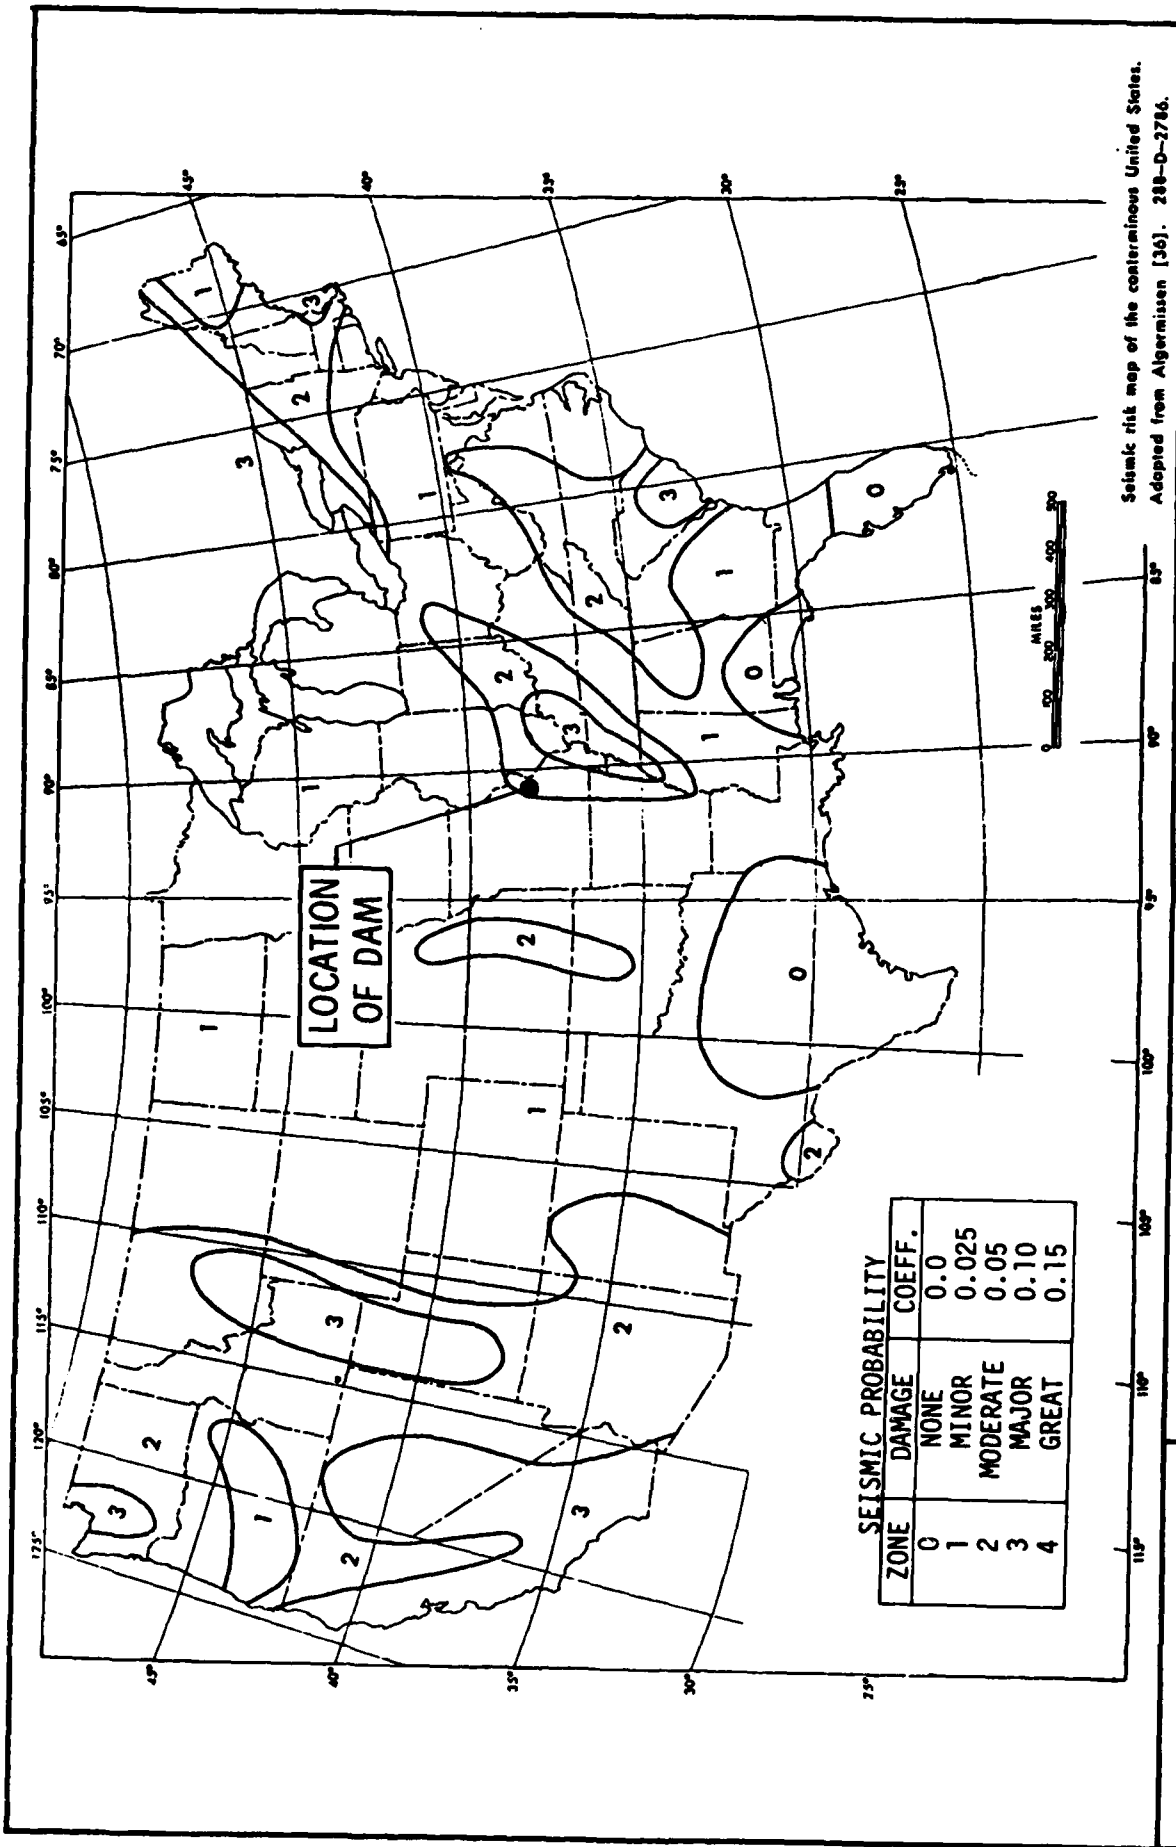
SEISMIC ZONE MAP OF CONTIGUOUS STATES
LAKE ADELLE DAM MO. 30411

The steep and irregular slopes of the downstream face present a condition that may contribute to instability. It should be noted that Lake Adelle Dam is located in Seismic Zone 2 as shown on Plate 3 of Appendix A. A Seismic Zone 2 delineates areas in which moderate damage would result from the expected seismic activity in the area. The lack of seepage and stability analyses is a deficiency which should be corrected. Seepage and stability analyses should include an allowance for seismic loadings.

This dam is located in Seismic Zone 2, as shown on Plate 3 of Appendix A. Zone 2 delineates areas in which moderate damage would result from the expected seismic activity in the area. In general, it is anticipated that an earthquake of this magnitude would not cause severe structural damage to a well constructed earth dam of this size. However, a slope stability analysis should be performed, as indicated in the inspection guidelines, to determine if static stability conditions are satisfactory and conventional safety margins do exist for this earth dam.
