LITTLE LAKE DAM
JEFFERSON COUNTY, MISSOURI
MO. 30456

**PHASE I INSPECTION REPORT
NATIONAL DAM SAFETY PROGRAM**

PHASE I INSPECTION REPORT
NATIONAL DAM SAFETY PROGRAM

LITTLE LAKE DAM, Missouri Inv. No. 30456

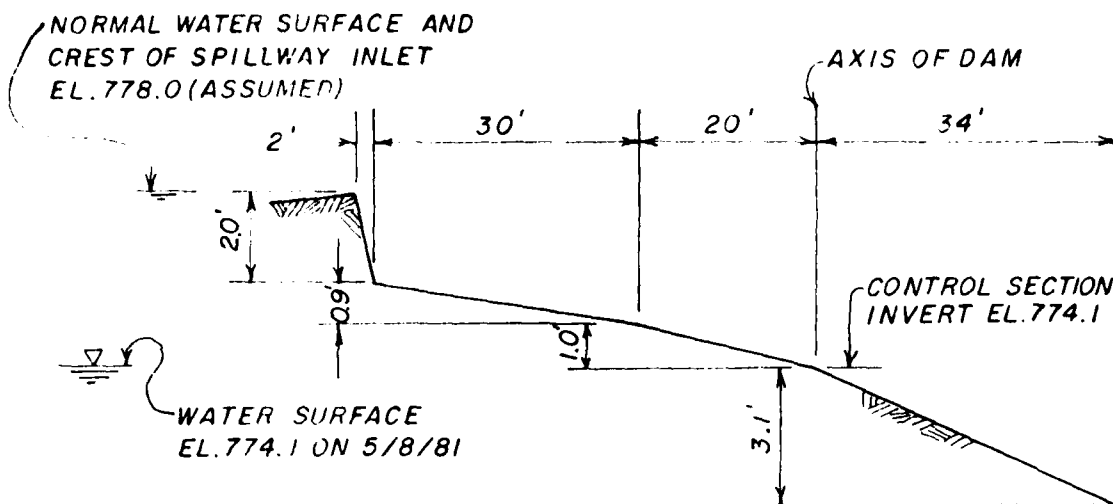
SECTION A-A
 (SPILLWAY PROFILE)

The overall condition of the dam appears to be poor due to the seepage at the damsite and the severe erosion in the spillway channel. Both of these conditions jeopardize the safety of the dam and will require prompt attention. Other deficiencies noted by the inspection team, which will require remedial measures, included: the trees and brush on the embankment; a need for periodical maintenance of the grass cover; and a lack of a maintenance schedule. There also exists a need for periodic inspection by a qualified engineer. The lack of seepage and stability analyses on record is also a deficiency that should be corrected.

It is recommended that the owner take action to correct or control the deficiencies described above. Replacement of the present spillway with a more stable and erosion-free spillway and further investigation of the seepage warrant prompt attention and should be pursued on a high priority basis. All other remedial measures should be undertaken within a reasonable period of time.
