CLEAR LAKE DAM
JEFFERSON COUNTY, MISSOURI
MO. 30437

**PHASE I INSPECTION REPORT
NATIONAL DAM SAFETY PROGRAM**

JULY 1981

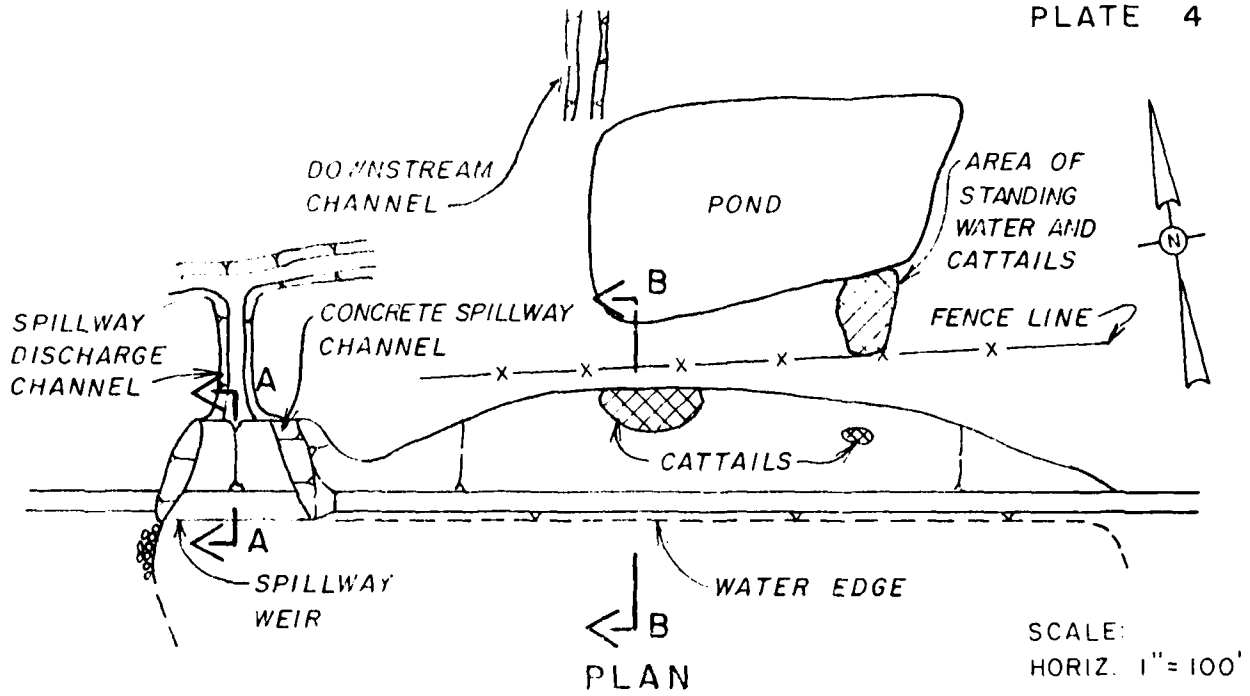
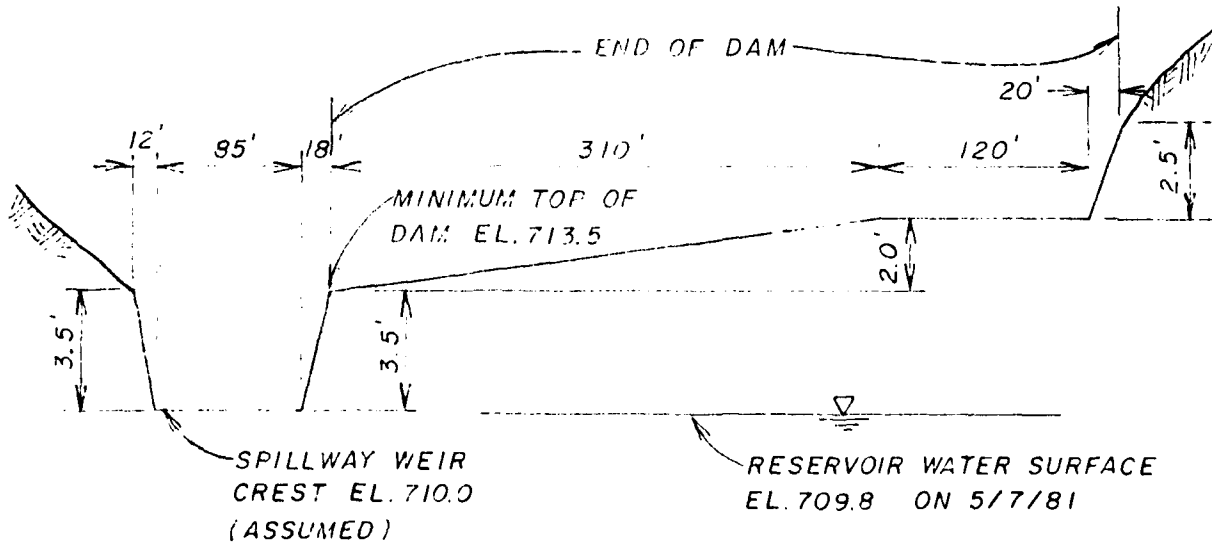
CLEAR LAKE DAM (MO. 30437)
PLAN AND ELEVATION
(SHEET 1 OF 2)

Photos 1 through 3 show views of the dam. The top of dam has a length of 450 feet between the right abutment and the spillway. The minimum elevation of the top of dam was found to be 713.5 feet above mean sea level (M.S.L.) at the spillway. From the spillway, the top of dam slopes upward to a point 140 feet from the right abutment with a rise in elevation of two feet. The top of dam was surveyed to be level for the next 120 feet. For the last 20 feet of the dam, the top of dam slopes upward with a rise in elevation of 2.5 feet. The embankment has a top width of 12 feet and a maximum structural height of 29.9 feet. The downstream slope was measured to be 1 vertical to 2 horizontal (1V to 2H). The upstream slope was measured to be 1V to 1.5H above the water surface on the day of the inspection.
