EHRlich LAKE DAM  
MONTGOMERY COUNTY, MISSOURI  
MO. 10993

**PHASE I INSPECTION REPORT**  
**NATIONAL DAM SAFETY PROGRAM**

PREPARED BY: U. S. ARMY ENGINEER DISTRICT, ST. LOUIS

DECEMBER 1980

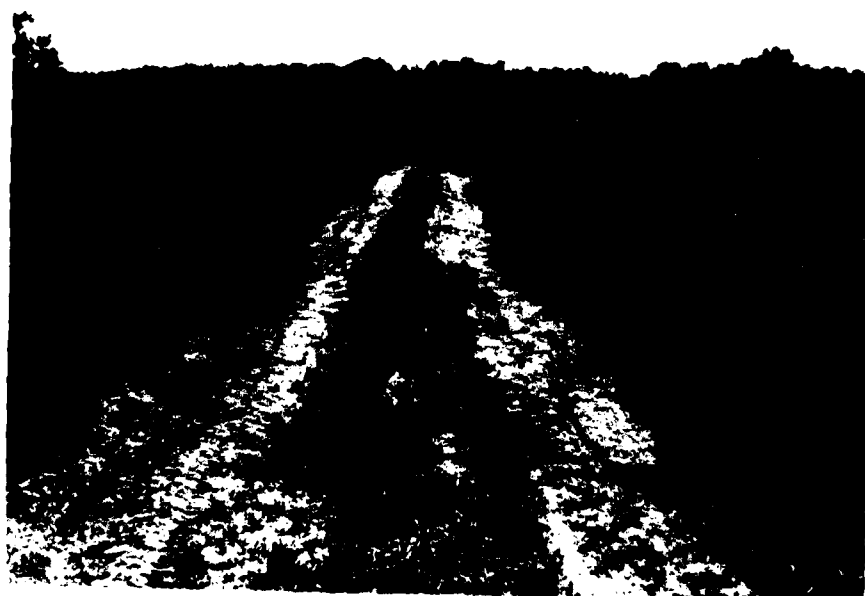
The top of the dam which serves as an access road for farm equipment does not have adequate erosion protection. Some minor damage due to the vehicular traffic was observed. A small depression was observed on the crest at the point where the principal spillway pipe passes through the embankment which appears to be due to settlement of backfill placed in the pipe excavation (see Photo 2). No other settlements of the crest or cracks were observed. No significant deviation in the vertical or horizontal alignment was apparent, other than the curved alignment as originally constructed. According to Mr. Ehrlich, the dam has never been overtopped and no evidence indicating the contrary was observed.

- Photo 1 - View of the upstream slope from the left side of the embankment showing the wave erosion and vegetative cover.
- Photo 2 - View of the top of dam showing the sparse vegetative cover and the settlement over the principal spillway outlet pipe.

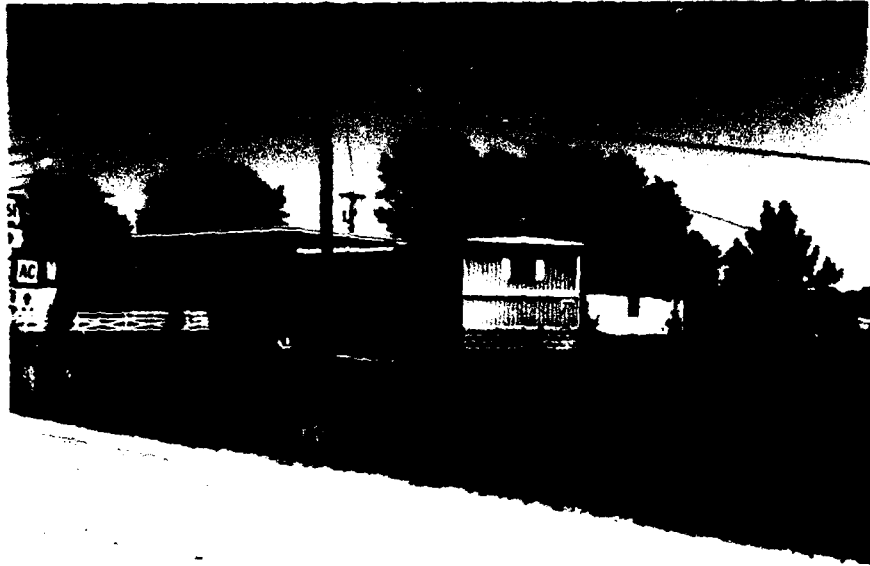
- Photo 10 - View of the left emergency spillway discharge channel with the dam embankment on the right side of the photo.
- Photo 11 - View of the portable centrifugal pump used at the dam site.
- Photo 12 - View of the reservoir and rim.
- Photo 13 - View of a dwelling downstream of the dam that appears to be in the downstream hazard zone.
- Photo 14 - View of a dwelling downstream of the dam that appears to be in the downstream hazard zone.
