KOHL IRRIGATION LAKE SOUTH DAM  
AUDRAIN COUNTY, MISSOURI  
MO. 11208

**PHASE I INSPECTION REPORT  
NATIONAL DAM SAFETY PROGRAM**

Name of Dam: Kohl Irrigation Lake South Dam,  
Missouri Inv. No. 11208  
State Located: Missouri  
County Located: Audrain  
Stream: An unnamed tributary of the Shady Creek  
Date of Inspection: July 9, 1980

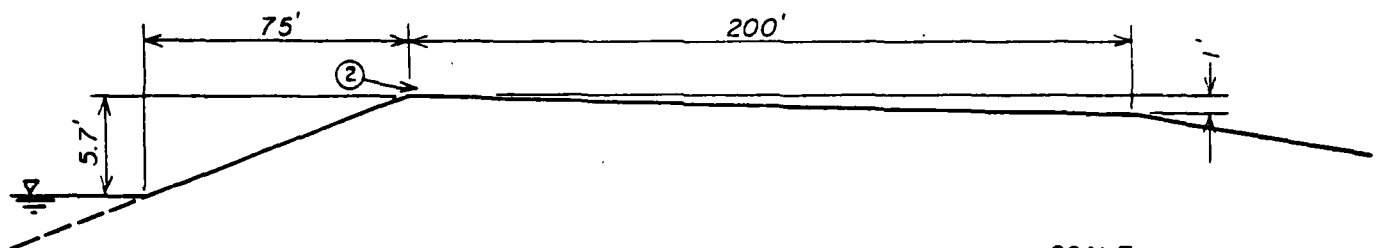
**SECTION C-C**  
EMERGENCY SPILLWAY PROFILE

The emergency spillway is a grass-lined, trapezoidal, open channel cut into the left abutment. The spillway has a bottom width of 23 feet, a top width of 50 feet with side slopes of about 1V to 4.5H, and is located about 115 feet upstream of the embankment (see Plate 2). The flows through the spillway are directed by a 115-foot long training berm back towards the embankment. The flows, once past the embankment, will flow through a natural channel created by the dam and highway embankments and in the direction of the box culvert under the highway. The crest elevation of the spillway is 760 feet above M.S.L., assuming the crest of the principal spillway is at 759 feet above M.S.L. The spillway channel has a slope of about a half of a percent for a distance of about 200 feet at which point the channel steepens.
