## MISSOURI - KANSAS CITY RIVER BASIN

HAUCK LAKE DAM  
CALLAWAY COUNTY, MISSOURI  
MO. 10989

## PHASE I INSPECTION REPORT NATIONAL DAM SAFETY PROGRAM

SEPTEMBER, 1980

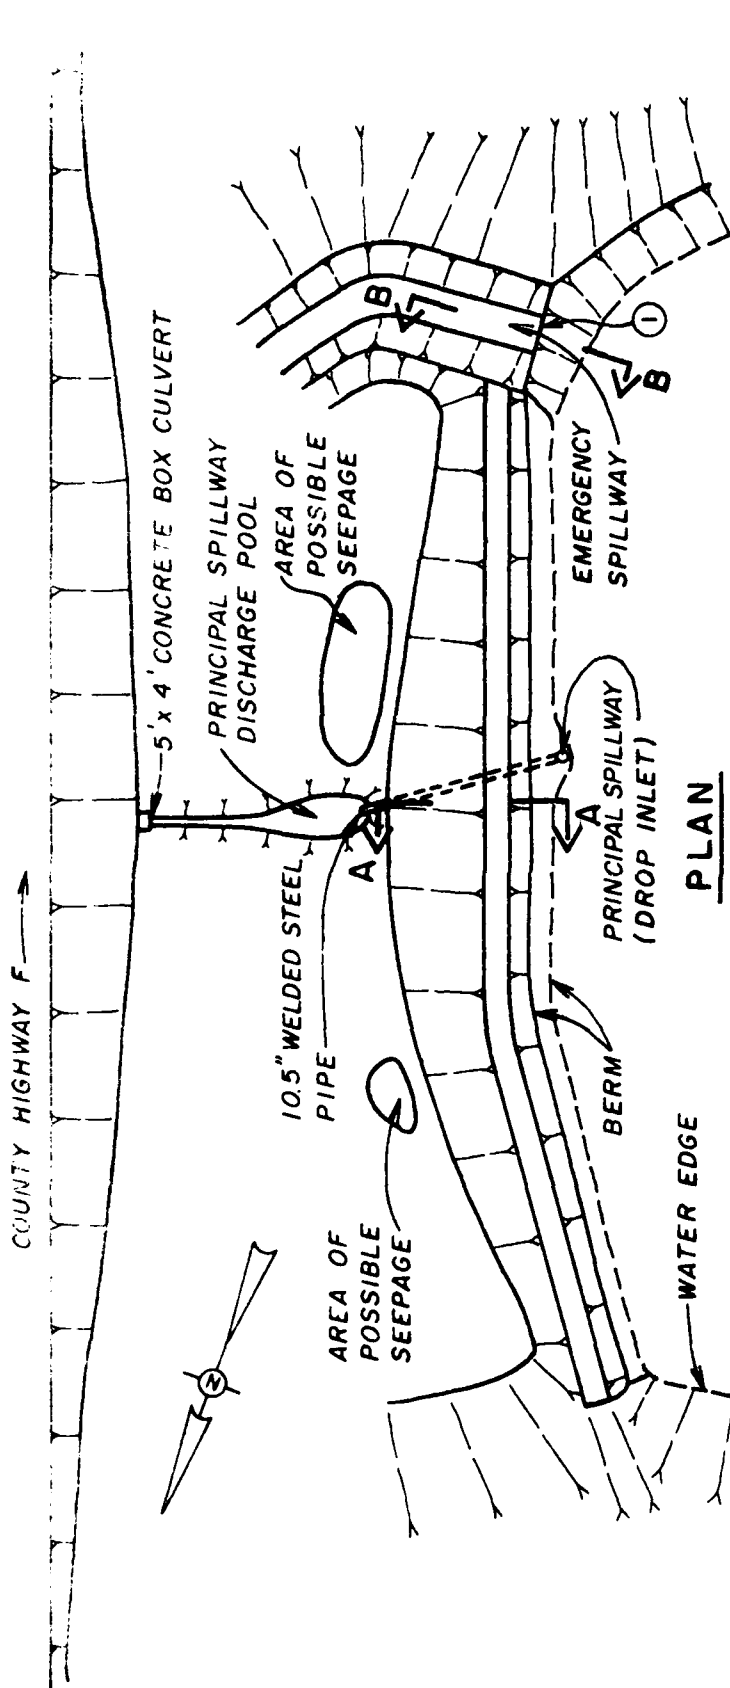
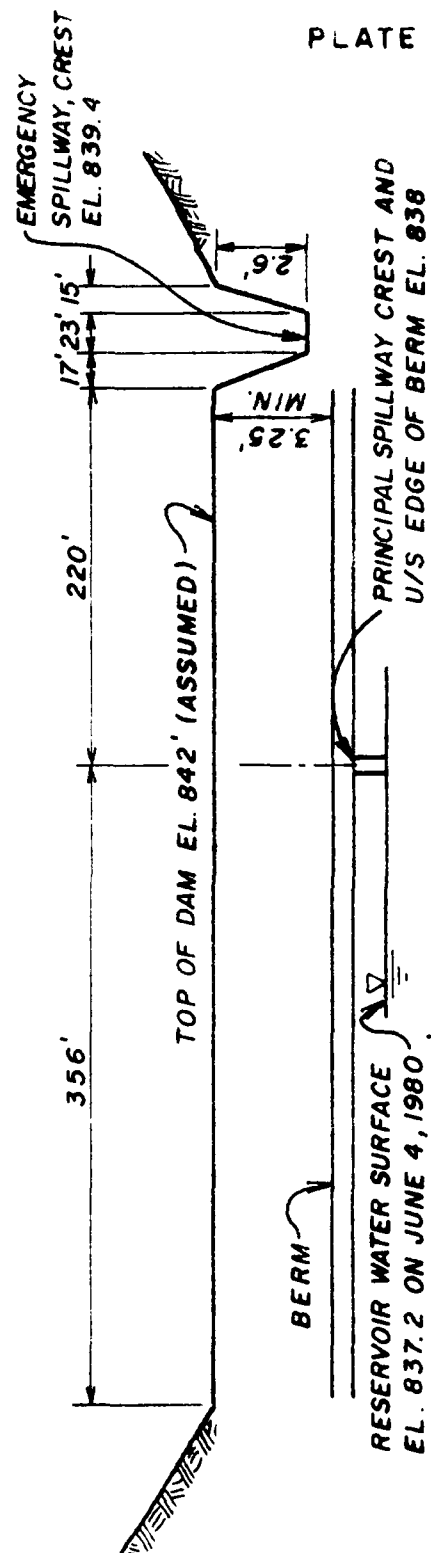
HAUCK LAKE DAM (MO. 10989)  
PLAN AND ELEVATION  
(SHEET 1 OF 2)

The dam is an earthfill structure between earth abutments. A plan and elevation of the dam is shown on Plate 2, and Photos 1 through 3 show views of the dam. The dam consists of two straight segments of embankment angled at approximately 15 degrees to each other and connected by a smooth curve. The major portion of the embankment has a bearing of approximately N 10° W and an axis length of 358 feet between the emergency spillway and the point of intersection of the two segments. The other portion has a bearing of approximately N 25° W and an axis length of 218 feet between the point of intersection of the two segments and the left abutment. The top of dam has a width of 12 feet and a total length of 576 feet between the emergency spillway and the left abutment. The top of dam was measured as level and has the assumed elevation of 842 feet above mean sea level (M.S.L.) The maximum structural height of the dam was measured to be 23 feet. A berm, varying in width from 5 to 10 feet, was constructed on the upstream slope 3.25 feet below the top of dam. The berm sloped down towards the reservoir on an average of 7.5 percent. The upstream slope was measured as 1 vertical to 2.5 horizontal (1V to 2.5H) from the top of dam to the berm and nearly vertical from the berm to the water surface. The downstream slope was measured to be 1V to 2H.
