MOORES LAKE DAM  
BOONE COUNTY, MISSOURI  
MO. 11173

**PHASE I INSPECTION REPORT**

**6 NATIONAL DAM SAFETY PROGRAM.**

Moore Lake Dam (MO 11173),  
Missouri - Kansas City River Basin,  
Boone County, Missouri. Phase I Inspection  
Report.

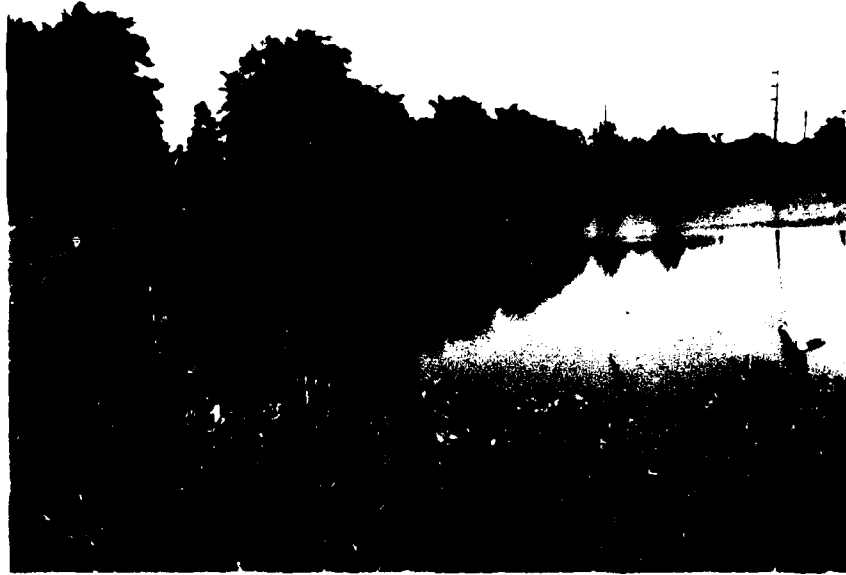
- Photo 1 - View of the upstream slope from the left abutment showing the dense vegetation.
- Photo 2 - View of a portion of the top of dam from the left abutment. Note the disturbed area of soil in the foreground due to the recently constructed 10-inch spillway pipe.
