**LITTLE PRAIRIE DAM  
PHELPS COUNTY, MISSOURI  
MO 30090**

# **PHASE I INSPECTION REPORT NATIONAL DAM SAFETY PROGRAM**

Name of Dam: Little Prairie Dam  
State Located: Missouri  
County Located: Phelps County  
Stream: Unnamed Tributary to Bourbeuse River  
Date of Inspection: 24 August 1978

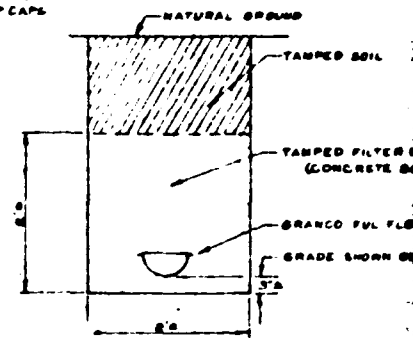
TYPICAL SECTION-TRENCH DRAIN

No foundation or embankment design reports were available from the Missouri Department of Conservation. Sheet 3 of Appendix A (from Plans for Construction) shows a plan view of a foundation trench drain. A typical section of this trench drain is shown on Sheet 8 of Appendix A. This foundation drainage system is shown located from about Station 7+00 to Station 11+50 at a distance of 60 ft downstream of the centerline of the dam. The bottom elevation of the trench drain ranges from 997 at Station 11+50 to 995 at its point of exit (Station 7+50). A shallow core trench apparently was constructed at the base of the dam from Station 4+00 to Station 17+00.
