BROWN LAKE DAM

CAPE GIRARDEAU COUNTY, MISSOURI

MO 31223

## PHASE 1 INSPECTION REPORT

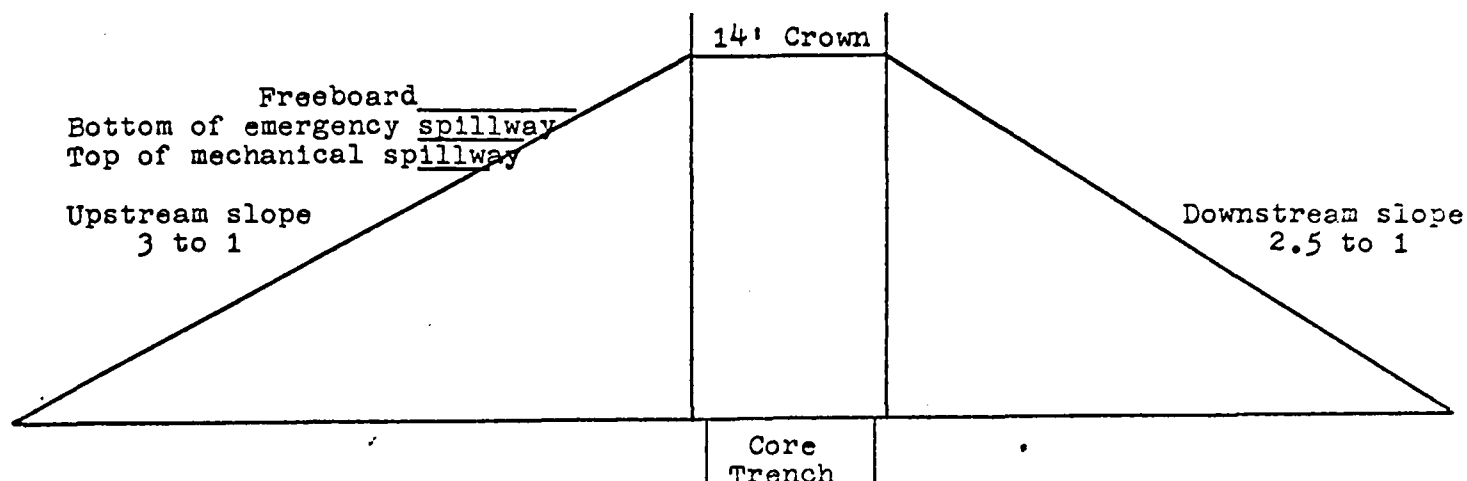
### CROSS SECTION THRU THE LAKE DAM

1. All dams over 20' high should have a wider crown, therefore, I'm recommending a 14' crown. This will also make a better road since the crown is to be used for this purpose.

2. The freeboard should be 3 feet, this means the bottom of the emergency spillway should be 3 feet below the top of the dam.
3. The top of the mechanical spillway should be one (1) foot below the bottom of the emergency spillway or four (4) feet below the top of the dam. This would give      acre feet of storage.
