# MISSISSIPPI-KASKASKIA-ST. LOUIS BASIN

GOOSE CREEK LAKE DAM  
ST. FRANCOIS COUNTY, MISSOURI  
MO 30297

## PHASE 1 INSPECTION REPORT NATIONAL DAM SAFETY INSPECTION

JUNE 1981

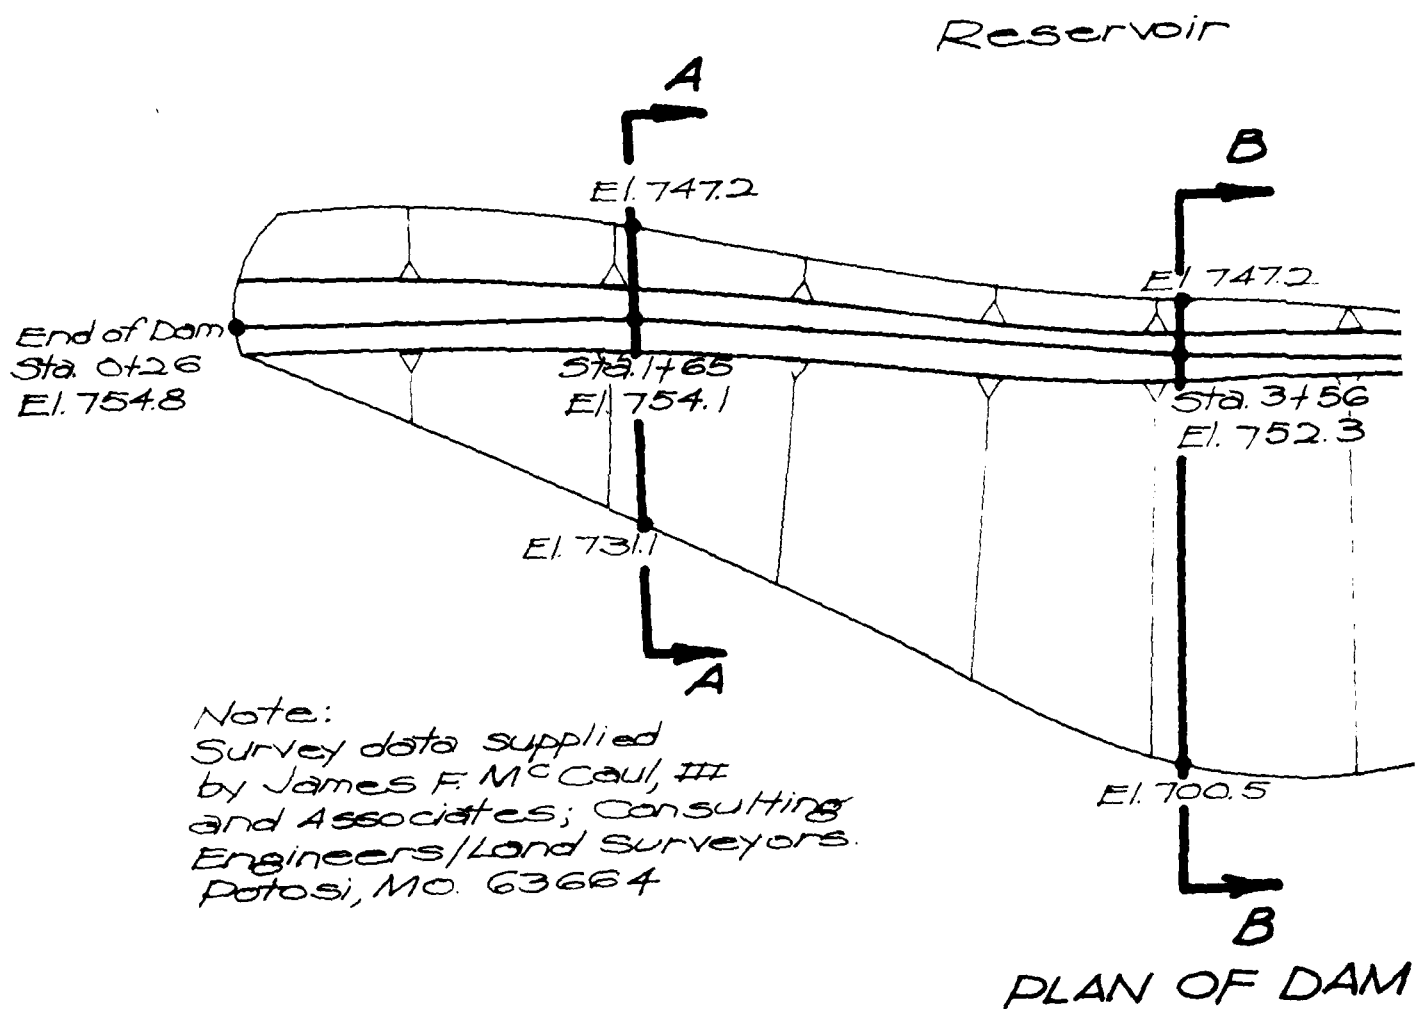
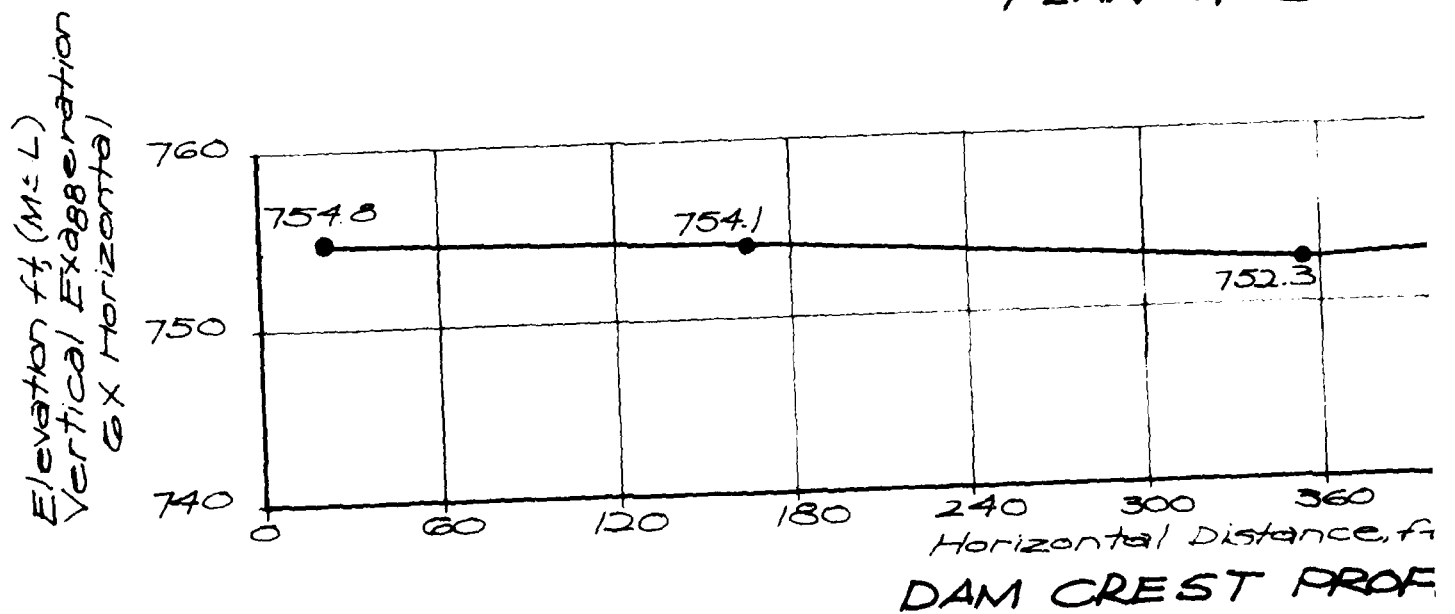
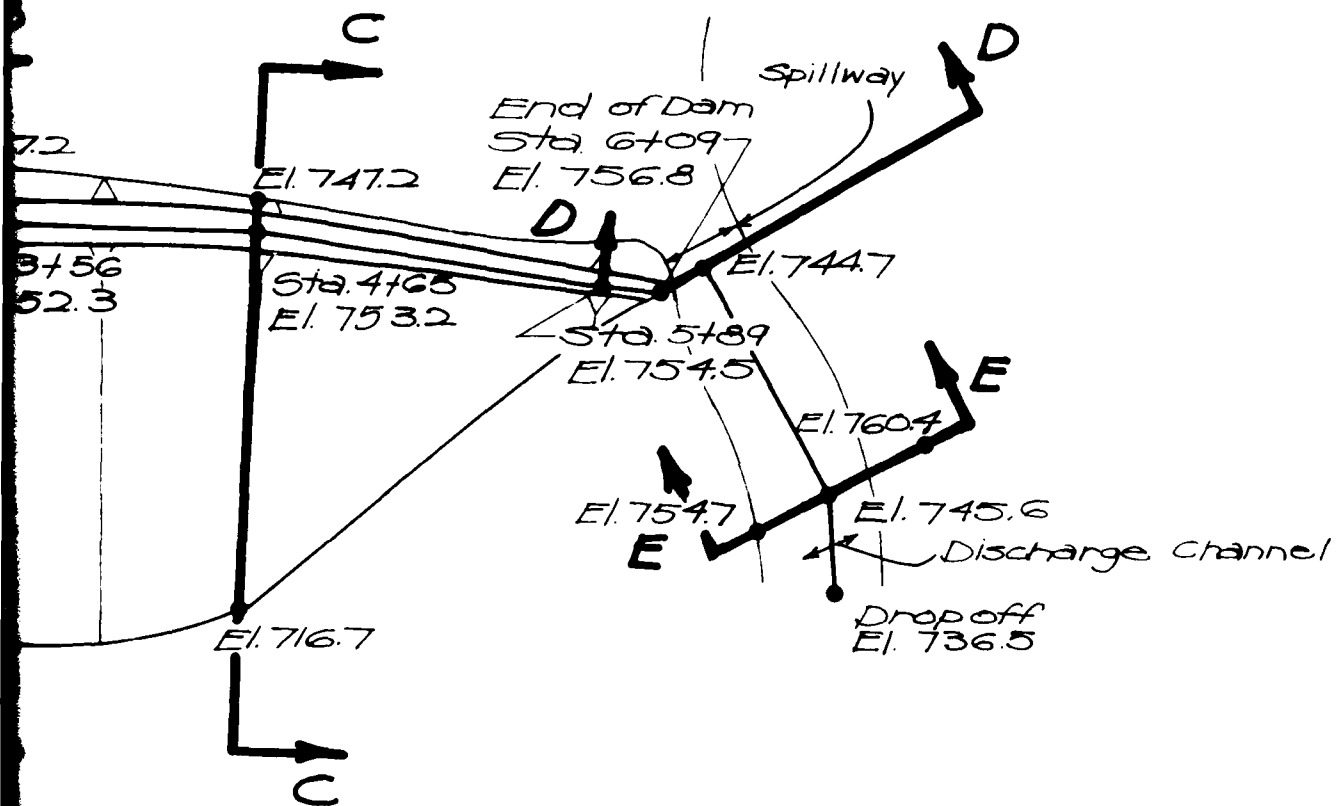
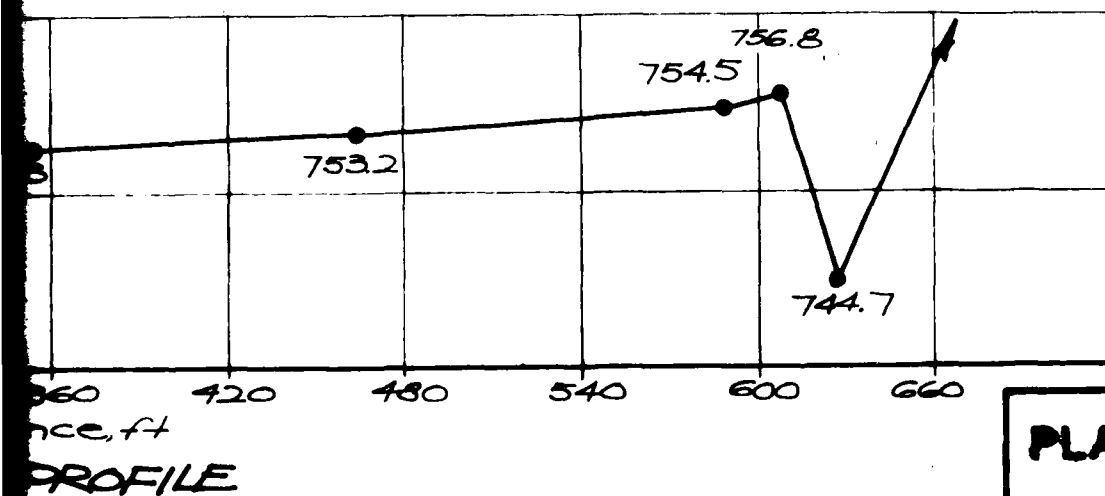
Fig. 3-A

No disruption was noted in the horizontal alignment of the dam crest. However, some settlement was reported by the dam owner's representative, Mr Stu McCaleb, and the crest of the dam appears lowest near the maximum section. Mr McCaleb reported 18 to 24 in. of fill was added to the dam crest approximately 2 years ago, but the field survey conducted for this report indicated the center of the dam is still approximately 18 to 24 in. lower than the ends of the dam (Fig. 3A). During the visual inspection an area of rocky fill was noted from about the middle of the dam crest to the left (spillway) end of the dam, specifically on the upstream slope (Photo 5). This appears to be the area where new fill has been added to the crest of the dam.

Mr McCaleb reported the crest of the dam had settled and the field survey (Fig 3-A) indicates the crest near the center of the dam is 18 to 24 in. lower than at the ends. The horizontal alignment of the dam crest appears undeformed.
