**RUSSELL ELSEY DAM
WASHINGTON COUNTY, MISSOURI
MO 30102**

**PHASE 1 INSPECTION REPORT
NATIONAL DAM SAFETY INSPECTION**

SEPTEMBER 1980

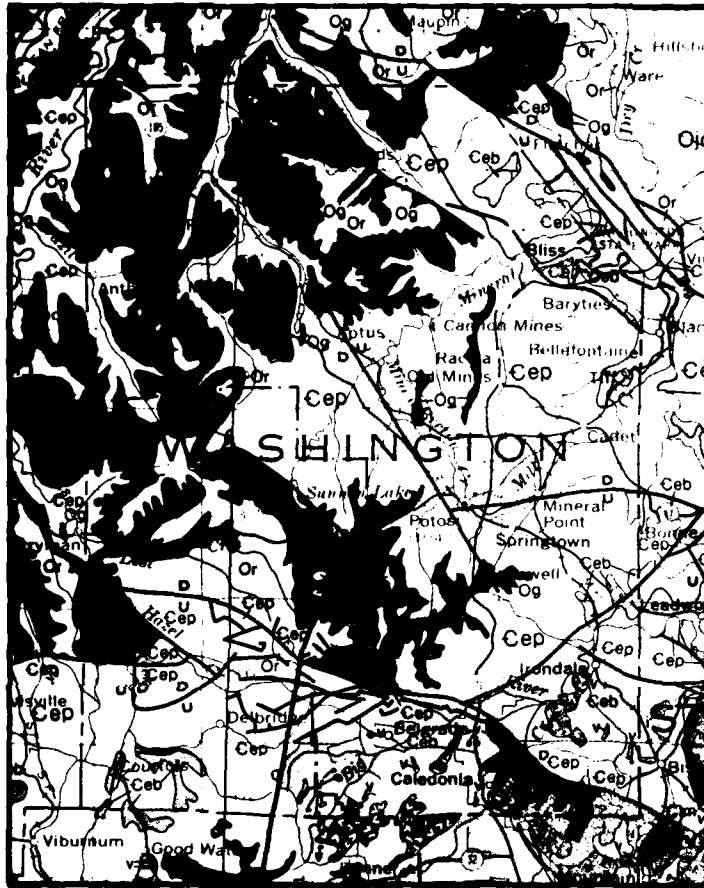
REGIONAL GEOLOGIC MAP	
RUSSELL ELSEY DAM	
MO 30102	Fig. 4

The dam site is located on the northern flank of the Ozark structural dome. The bedrock in the area is mapped as Ordovician age Gasconade Formation on the geologic Map of Missouri (Fig 4). The Gasconade Formation is predominantly a cherty dolomite which varies from coarsely crystalline and very cherty at the top to finely crystalline with relatively small amounts of chert near the bottom of the formation. Caves and springs are common in this formation in the central Ozarks, but the field inspection did not identify any evidence of solution activity in the vicinity of the dam.

Three faults or fault zones are mapped within 5 mi of the dam (Fig 4). The Shirley Fault Zone is mapped as approximately 8 mi in length, terminating 2 mi north-northwest of the dam. This fault is mapped as northeast side up. The Palmer Fault Zone, a complex network of short and long faults approximately 34 mi long is located approximately 4 mi south of the dam. The fault is mapped as north side down. The Aptus Fault is located approximately 4-1/2 mi northeast of the dam. This fault has a mapped length of approximately 15 mi and is mapped as northeast side up.
