**MISSISSIPPI - ST. FRANCIS BASIN**

SLIME POND DAM  
MADISON COUNTY, MISSOURI  
MO 30611

**PHASE 1 INSPECTION REPORT  
NATIONAL DAM SAFETY INSPECTION**

APRIL 1981

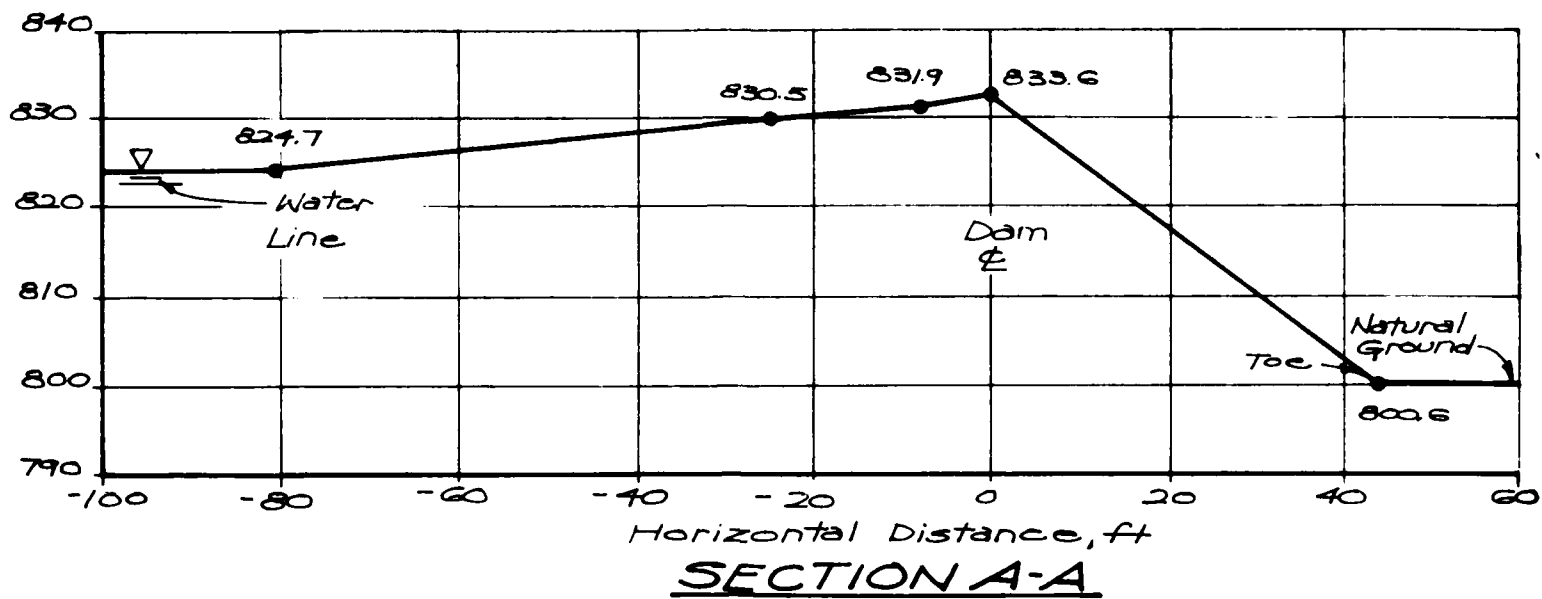
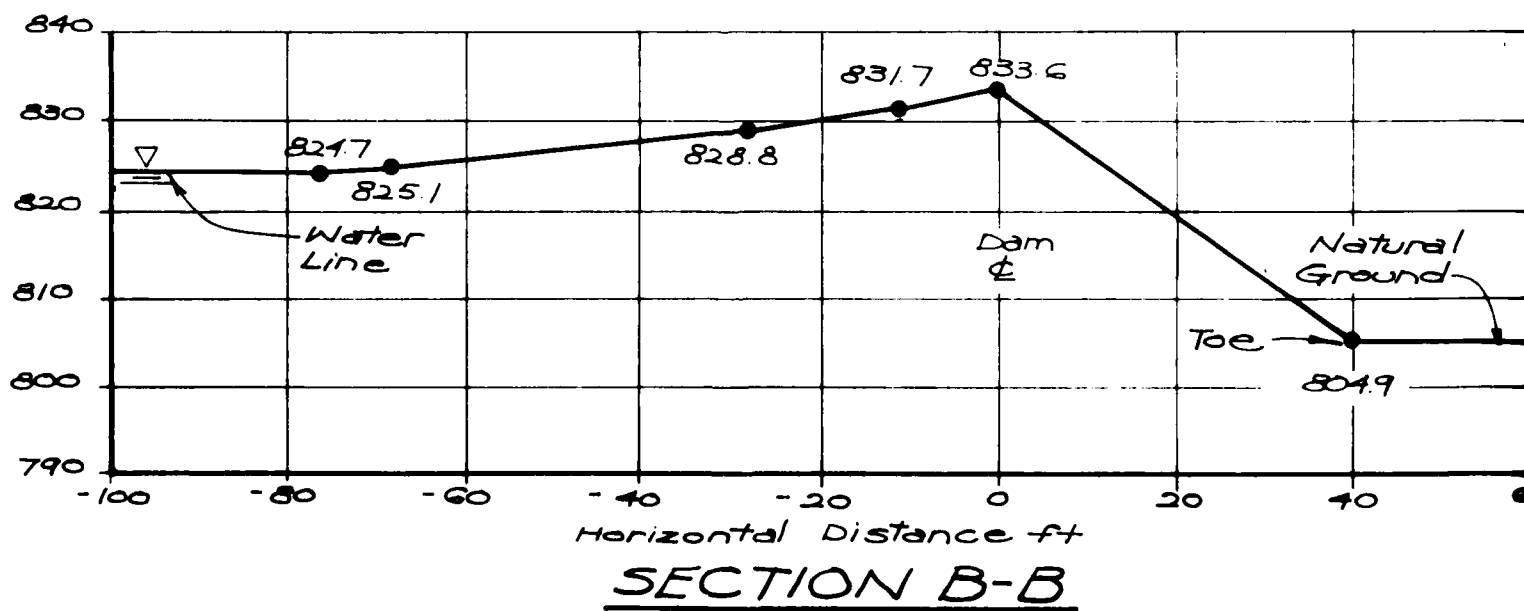
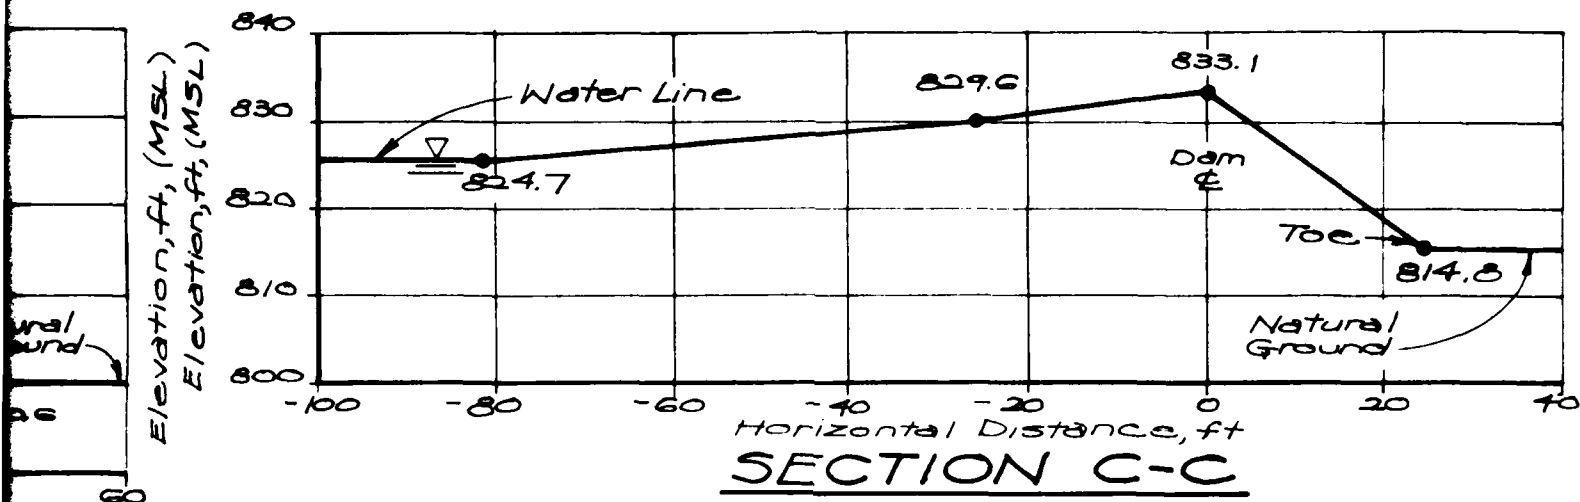
## CROSS SECTIONS OF DAM

The downstream slope of the dam is quite steep, on the order of 1.4(H) to 1(V) and locally steeper (Photo 2). The slope has a moderately dense cover of brush and trees up to 12 in. in diameter. Grading on the dam crest and flat upstream slope has pushed some soil and tailings over the crest onto the downstream slope (Photo 3).
