**SMITTY'S CATFISH POND DAM
MADISON COUNTY, MISSOURI
MO 30613**

**PHASE 1 INSPECTION REPORT
NATIONAL DAM SAFETY INSPECTION**

APRIL 1981

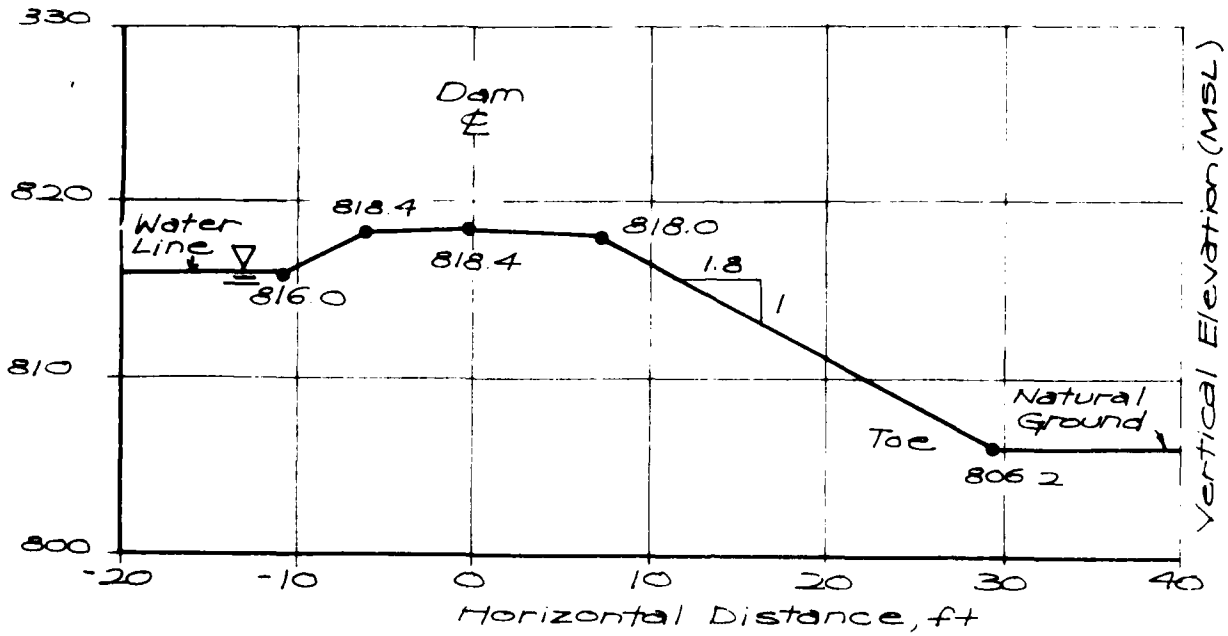
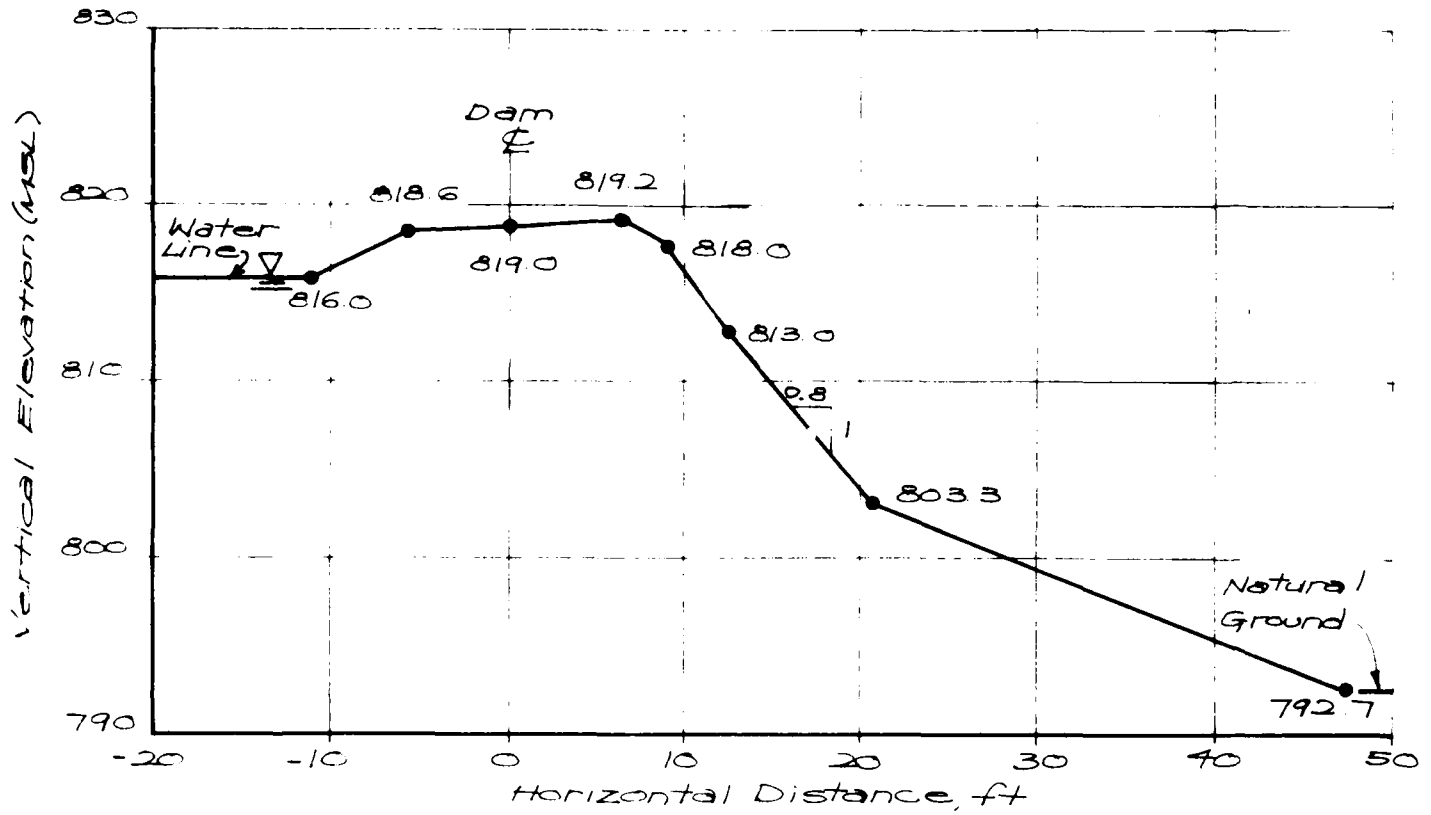
DAM SECTIONS	
SMITTY'S CATFISH POND DAM	
MO 30613	Fig. 3-B

The downstream slope is steep (Fig. 3B), typically 1.8(H) to 1(V), but locally the slopes are steeper than 1(H) to 1(V). As a result of the steep slopes and the embankment materials, the dam is judged to be moderately to highly erodible in the event of overtopping.
