UPPER VALLE MINES DAM
Jefferson County, Missouri
Missouri Inventory No. 30370

Phase I Inspection Report
National Dam Safety Program

Woodward-Clyde Consultants
Chicago, Illinois

for
Governor of Missouri
December 1980

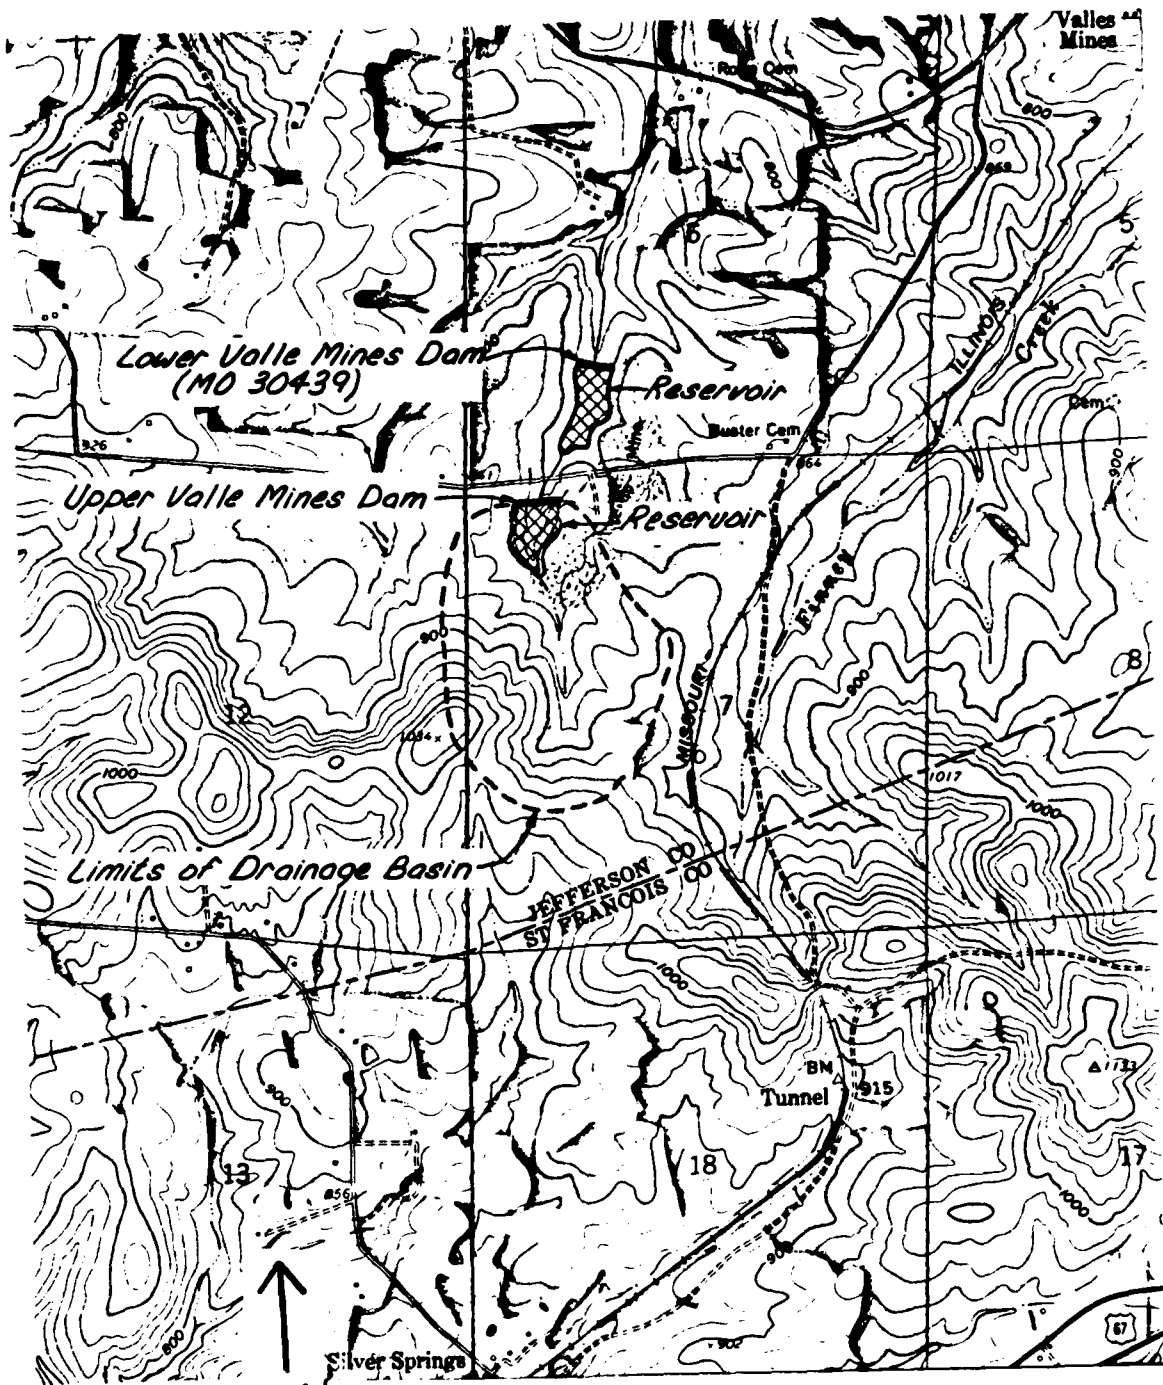
DRAINAGE BASIN AND SITE TOPOGRAPHY	
UPPER VALLE MINES DAM	
MO 30370	Fig. 2

- a. Drainage area. approximately 0.24 mi² (Fig 2)
- b. Discharge at damsite.

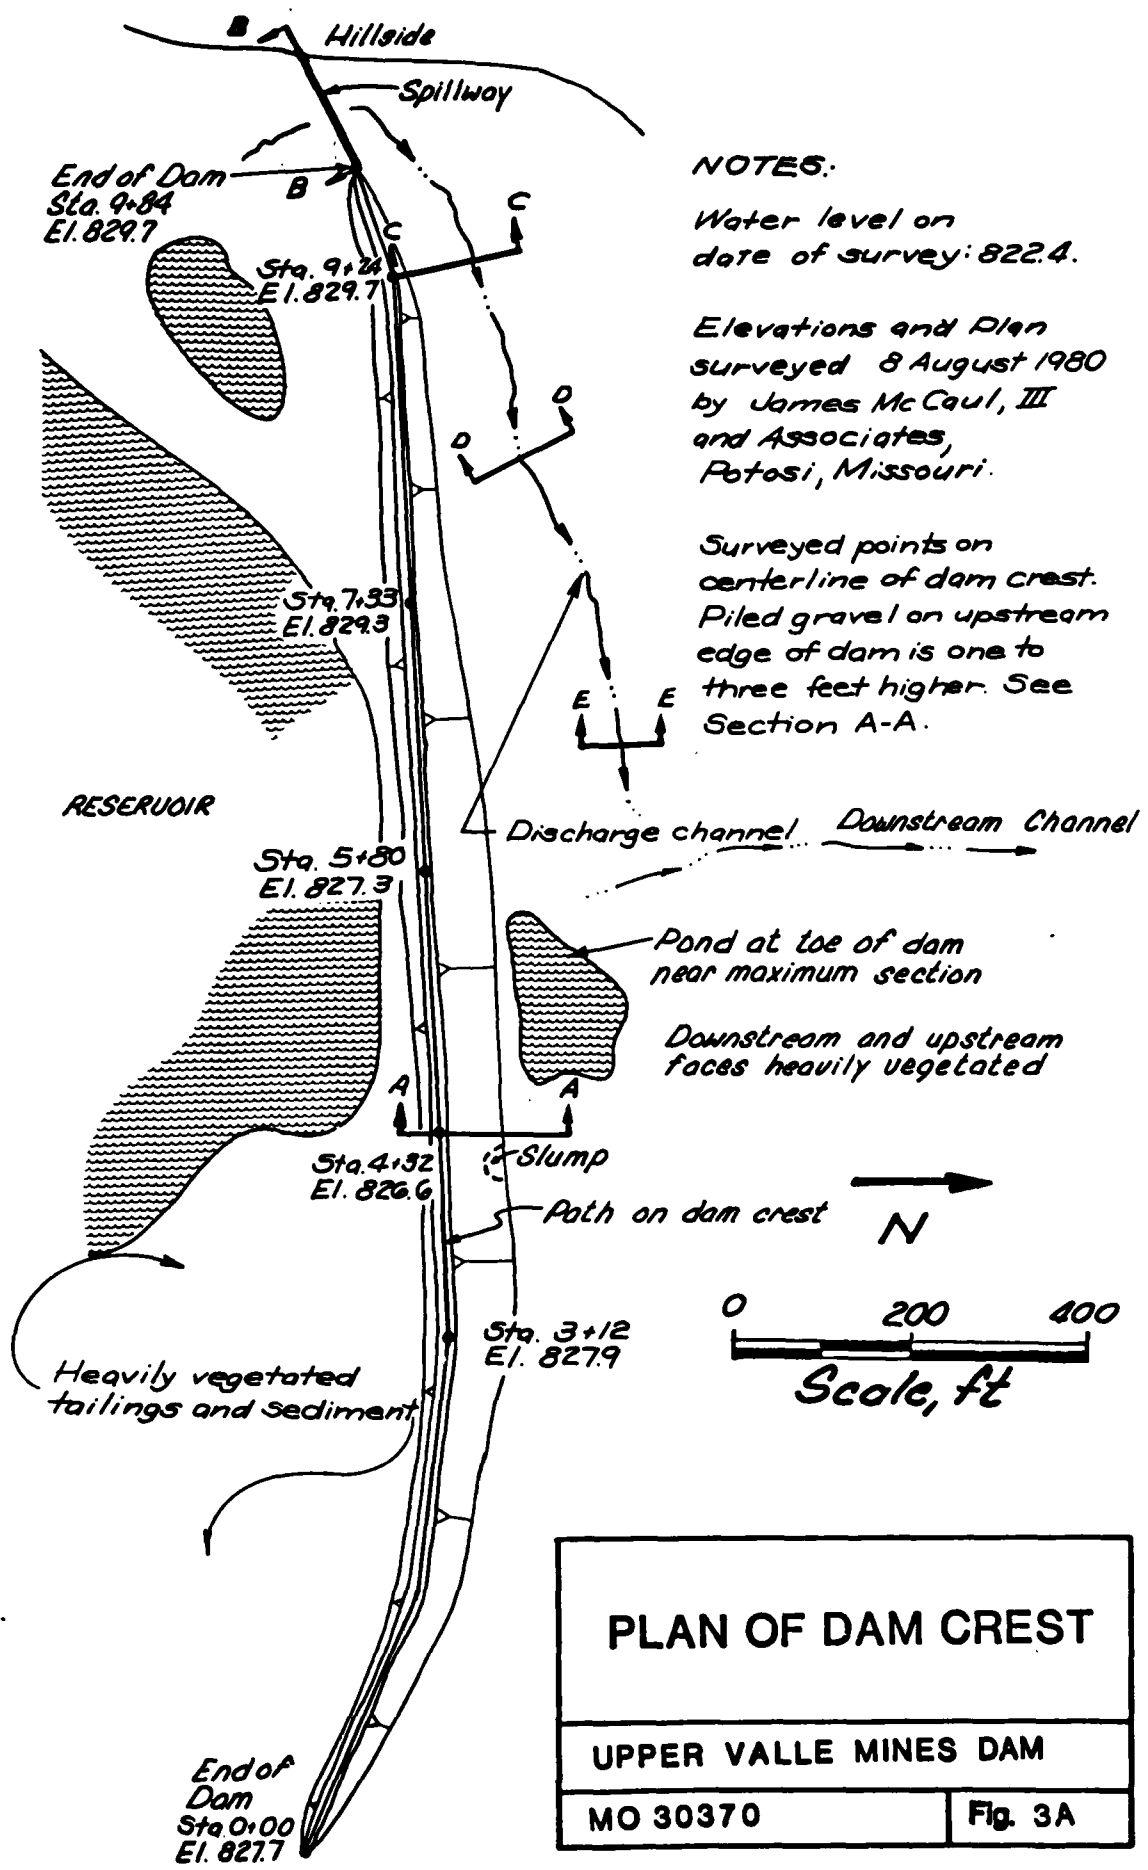
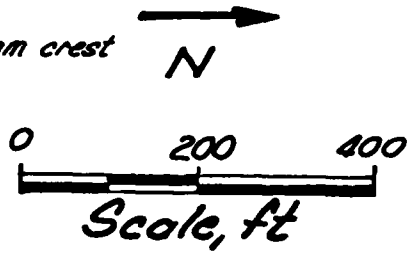
PLAN OF DAM CREST	
UPPER VALLE MINES DAM	
MO 30370	Fig. 3A

Top of dam (as measured along centerline)*	826.6 to 829.8 (Fig 3A)
Maximum pool-design surcharge	N/A
Full flood control pool	N/A
Recreation pool	N/A
Spillway crest (gated)	N/A
Upstream portal invert diversion tunnel	N/A
Downstream portal invert diversion tunnel	N/A
Streambed at centerline of dam	Unknown
Toe of dam at maximum section	788.6
Maximum tailwater	N/A

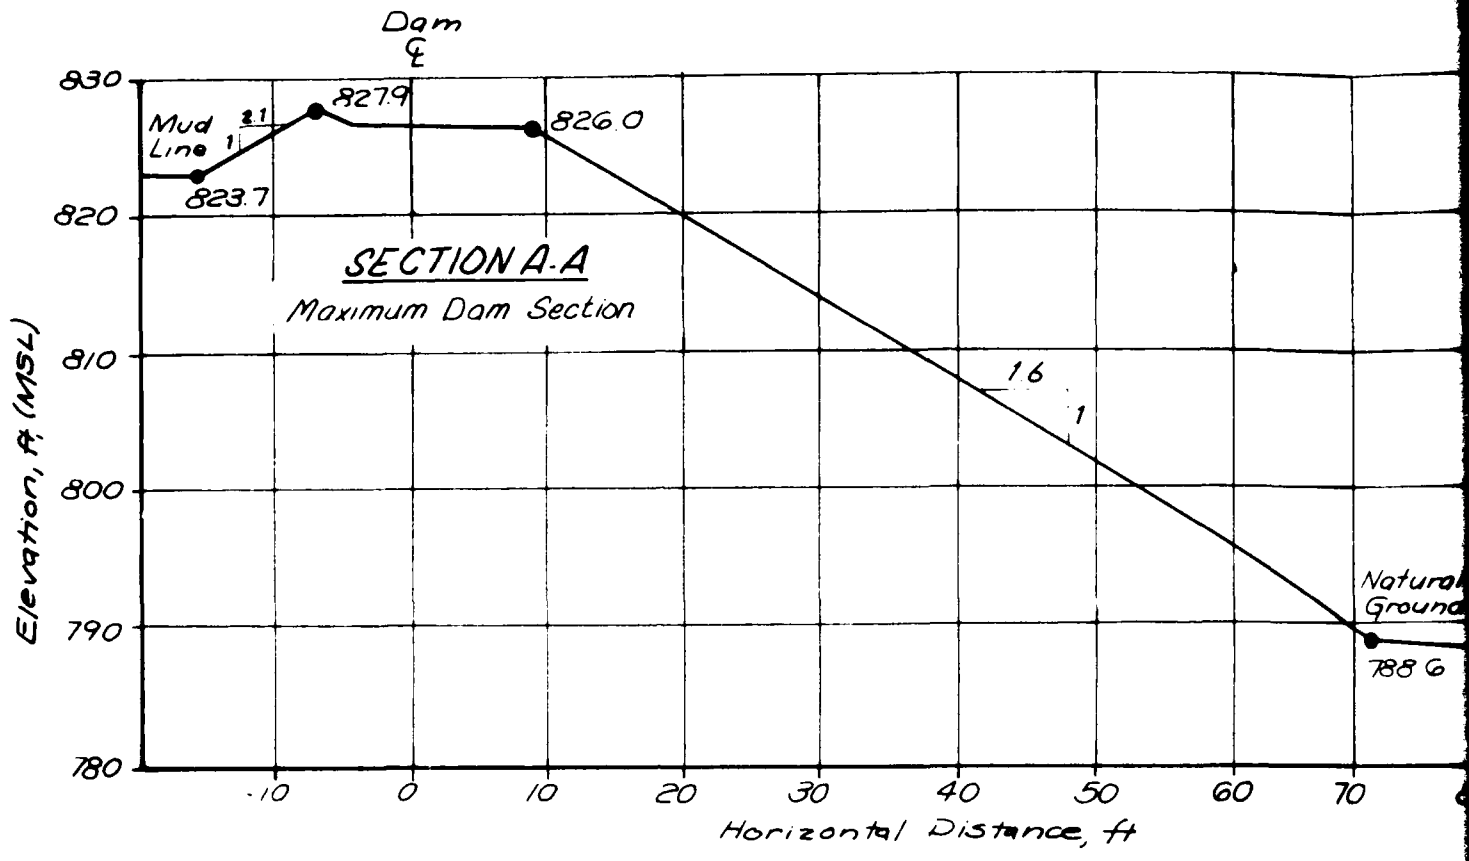
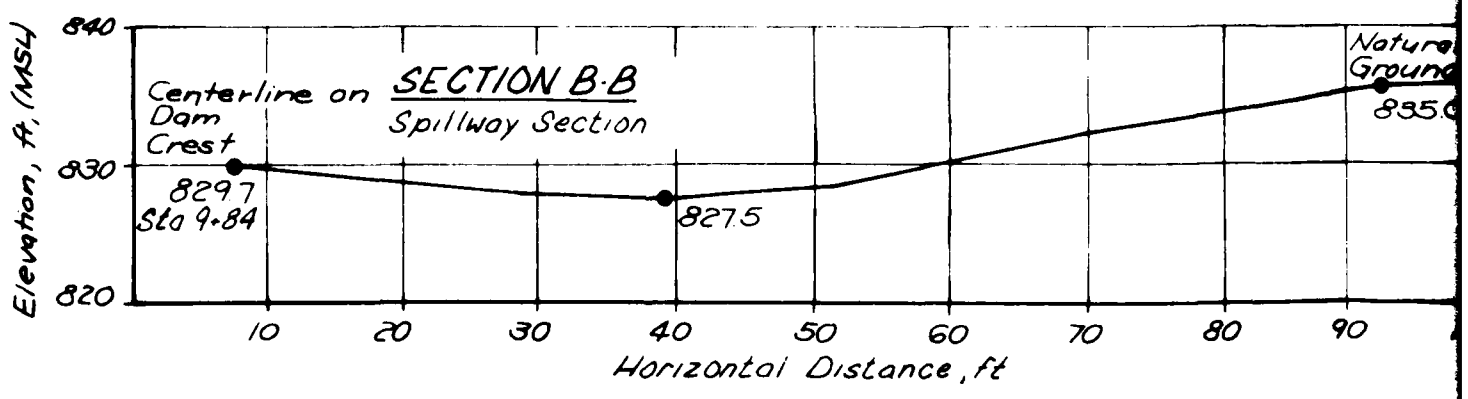
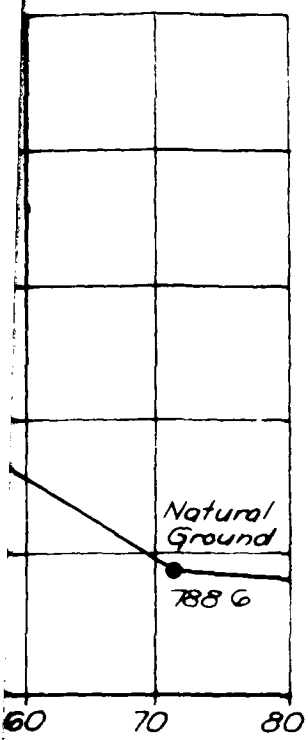
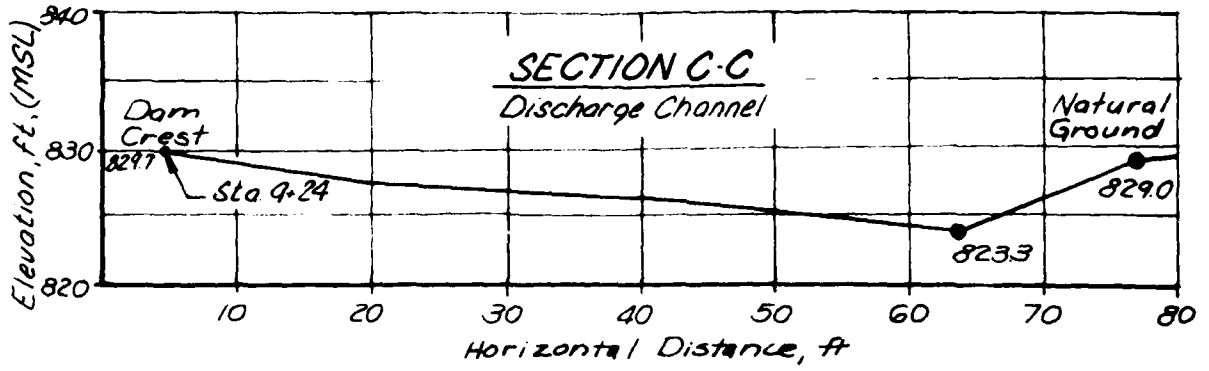
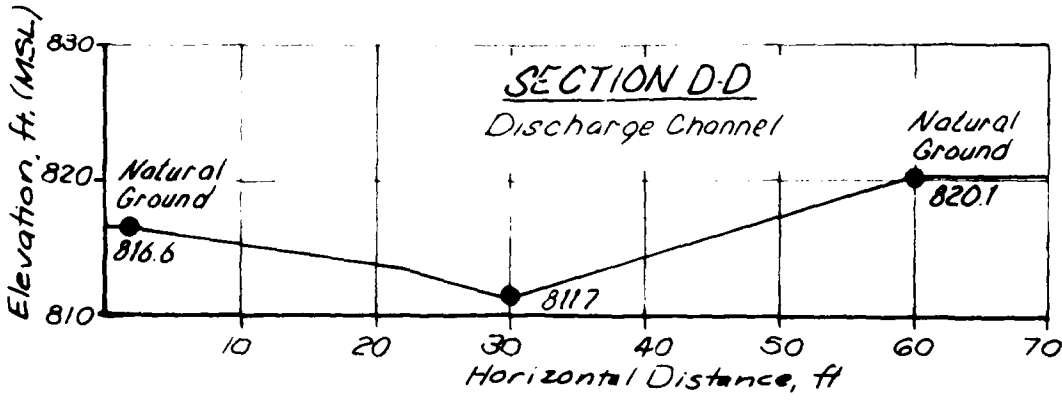
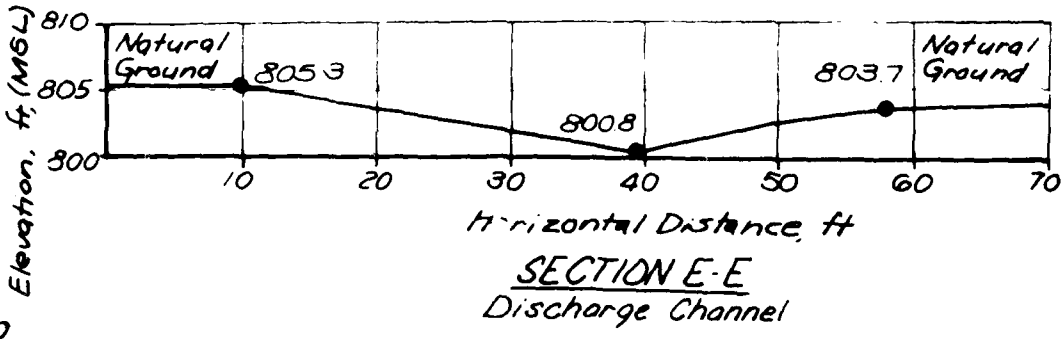
Fig. 3-B

*Chat piled along upstream edge of dam is typically 1 to 3 ft higher than centerline of dam (see Fig 3B, Maximum Section). For overtopping analyses the low point along the crest was taken at elevation 827.7.

The downstream face of the dam is quite steep, averaging approximately 1.6(H) to 1(V), (Fig 3B). Portions of the slope with a mantle of bullrock cobbles and boulders, are as steep as 1(H) to 1(V), (Photo 3). The exposed portion of the upstream slope is slightly flatter at about 2.1(H) to 1(V). Erosion protection is provided for by the vegetation present on the dam. The potential for erosion is low on the upstream face due to the presence of the vegetation and the short fetch of the reservoir.

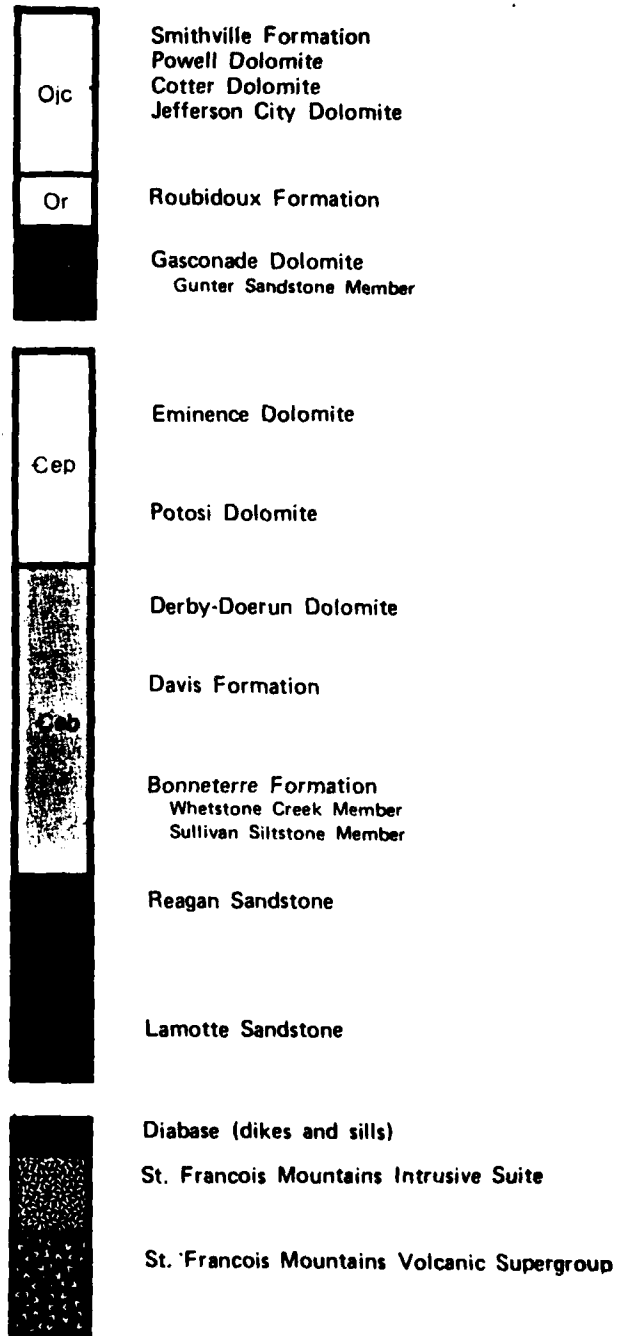
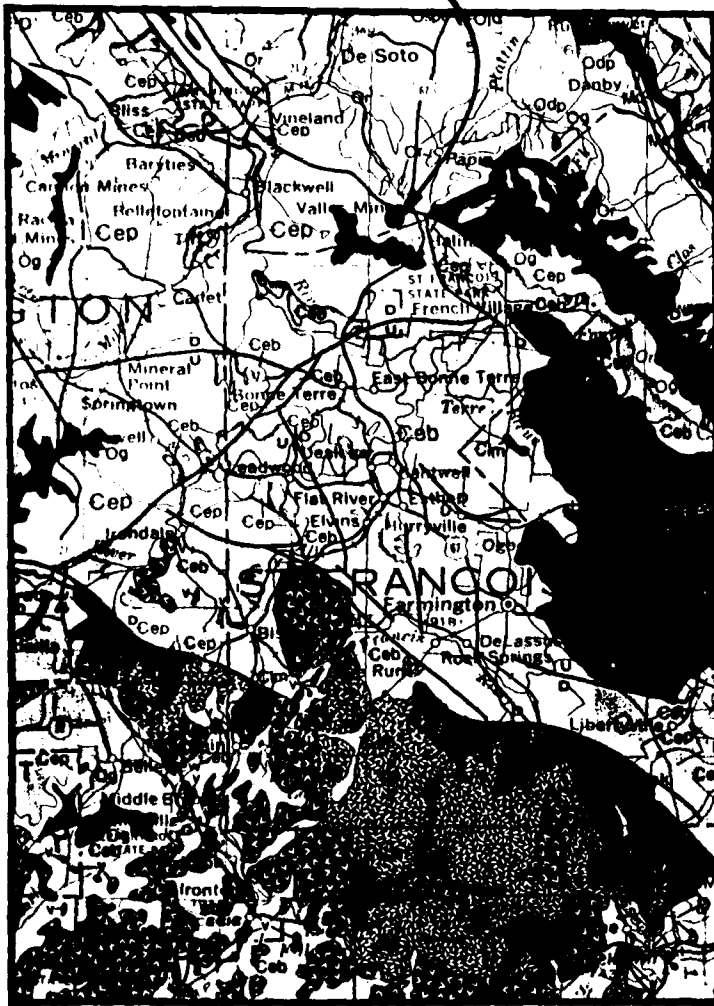
Fig. 4

The dam site is located on the northern flank of the Ozark structural dome. The regional dip is to the north. Bedrock in the area is mapped on the Geologic Map of Missouri (1979) as Cambrian age Potosi and Eminence dolomite formations (Fig 4). The Potosi Formation is a medium- to fine-grained, light gray dolomite and typically contains an abundance of quartz druse characteristic of chert bearing formations. The Eminence Formation conformably overlies the Potosi Formation, is similar in appearance but contains less chert and quartz. Large caves and springs are found in the Eminence Formation in parts of Missouri. The owner's representative described several large springs downstream from this dam. However, no evidence of solution activity or springs was noted during the visual inspection.
