RISS LAKE DAM

MO 20128

PHASE 1 INSPECTION REPORT  
NATIONAL DAM SAFETY PROGRAM

SEPTEMBER, 1978

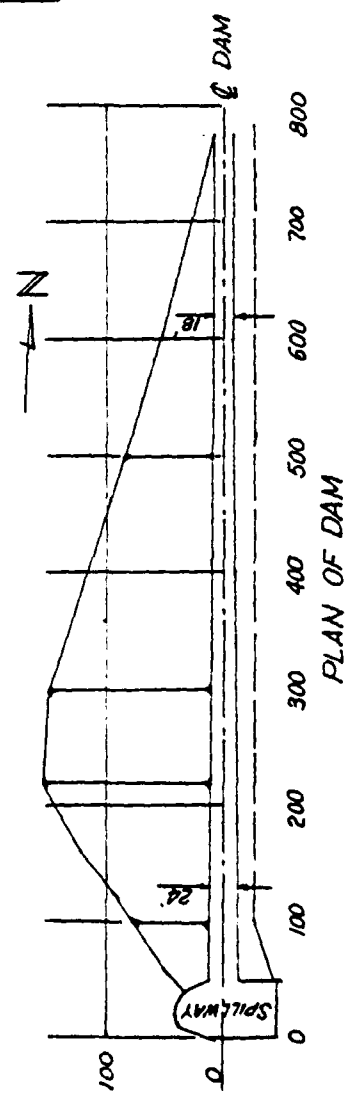
PLAN OF DAM

- d. Post-Construction Changes. The drawdown siphon has been constructed recently. It penetrates the dam just below the normal pool elevation at center line station 2+80. No seepage was noted where the siphon emerges onto the downstream slope. The siphon should pose no hazard to the stability of the dam. The deteriorated condition of the spillway and the repairs that have been performed constitute a hazard to the integrity of the embankment.
