NO NAME-448

ST. CHARLES COUNTY, MISSOURI

PHASE 1 INSPECTION REPORT NATIONAL DAM SAFETY PROGRAM

SEPTEMBER 1978

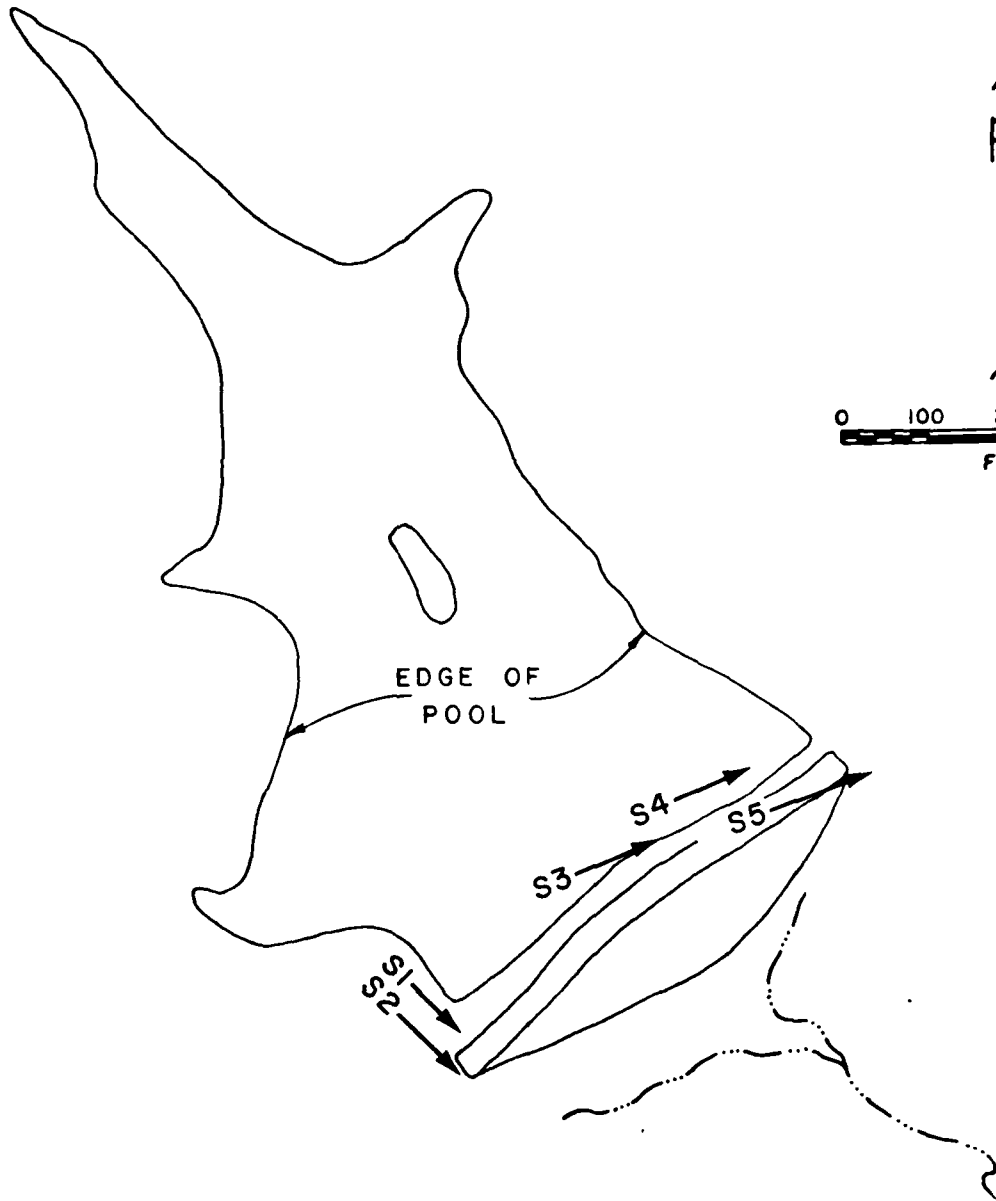
PHOTO INDEX 3
FOR
ABUTMENTS
NO NAME-448
ST. CHARLES COUNTY, MO.
SEPTEMBER 1978

The steep slope on the reservoir side at the east end of the dam (S-4, D-5) suggests a localized slough at some previous time. However, considering the reported source of material for the dam, i.e. waste from highway cut, it is possible that the original placement of fill was made on this slope. No cracks in or displacement of the dam were noted.

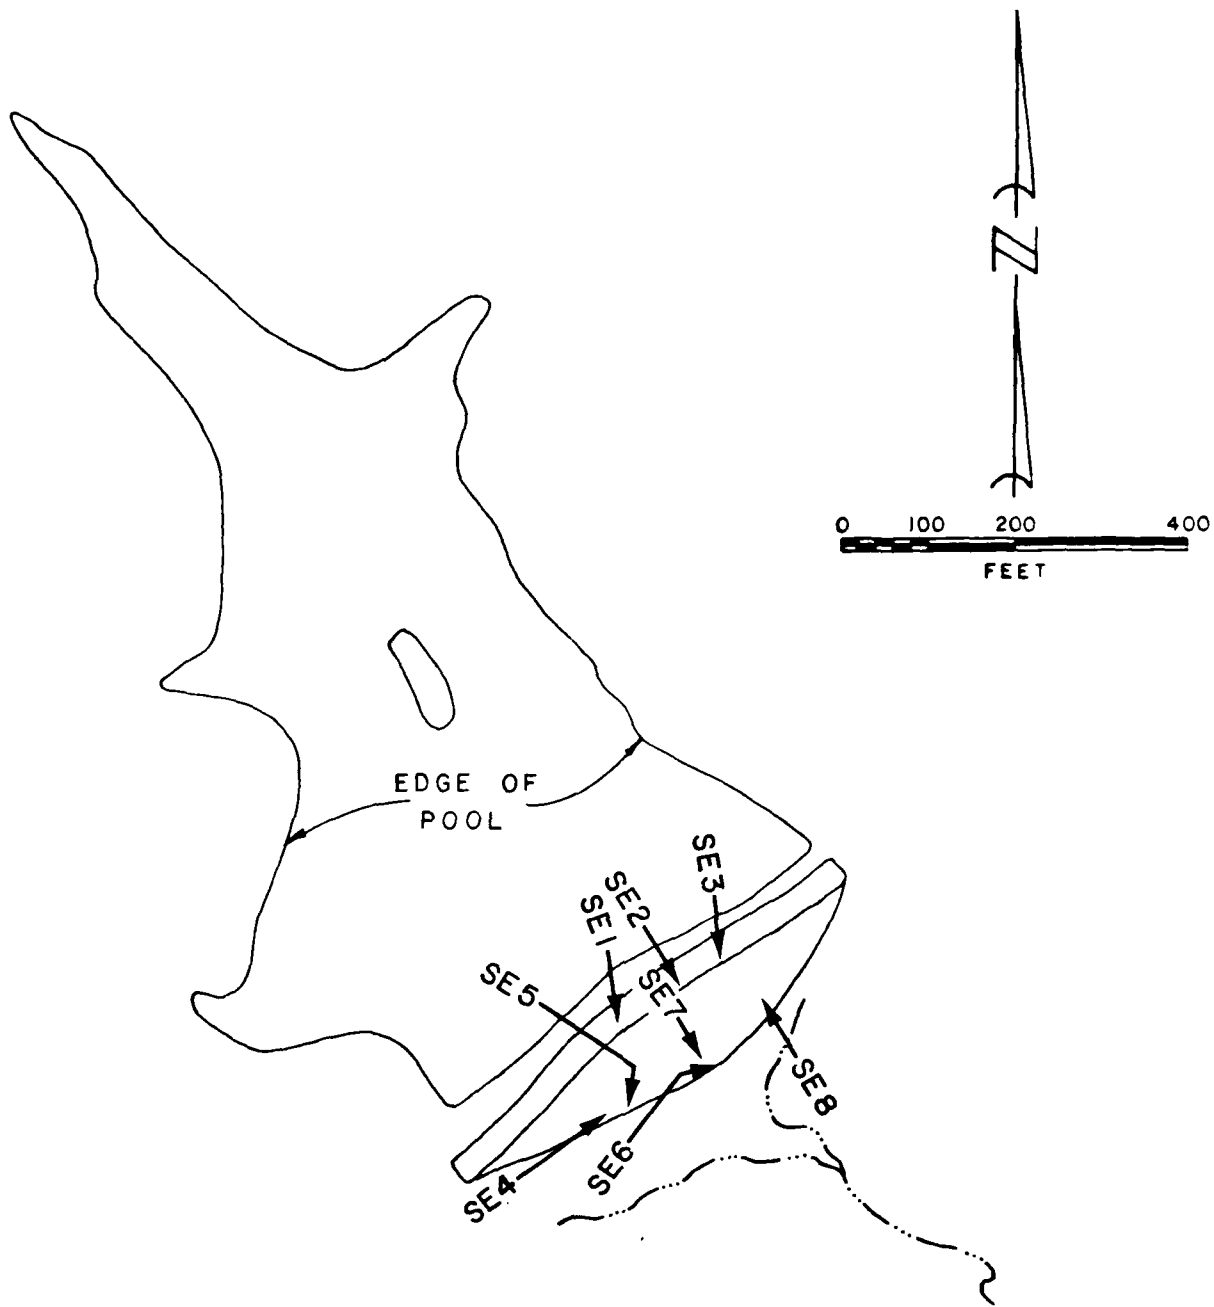
PHOTO INDEX 4
FOR
SEEPAGE

On the downstream face of the dam extensive areas with free water were observed. These areas extended from beyond the toe of the embankment to a height exceeding 20 feet above the low point of the toe. Characteristics of saturated soils, suggesting exiting of through seepage at the face of the embankment, were within about 15 feet vertically below the water surface in the pool. In this area, in the lower part, there were definite extensive areas of cattail growth, (SE-2, SE-4, SE-5, SE-6, SE-7) with isolated cattails growing at points well up the slope below the apparent phreatic surface (SE-3, SE-4, SE-8). The No-Name 448 dam has widespread through seepage. There is also underseepage along the contact between the base of the dam and the original ground surface. Although visual observation was impeded by heavy weed growth, more than a dozen shallow gullies were observed on the downstream face of the dam. These appear to be the result of the occurrence of larger quantities of seepage than were observed during the visual inspections. Several irregularities in the downstream slope were also observed. Whether these are evidence of possible sloughing or an artifact of the original construction work could not be determined because of the heavy weed growth. No visible location of piping erosion was identified. However, lack of pinpointing outwash of fines does not mean piping is not occurring and does not eliminate piping as a potential serious problem.
