**THE PLACE DAM  
WASHINGTON COUNTY, MISSOURI  
MO 30996**

**PHASE 1 INSPECTION REPORT  
NATIONAL DAM SAFETY INSPECTION**

**DECEMBER 1980**

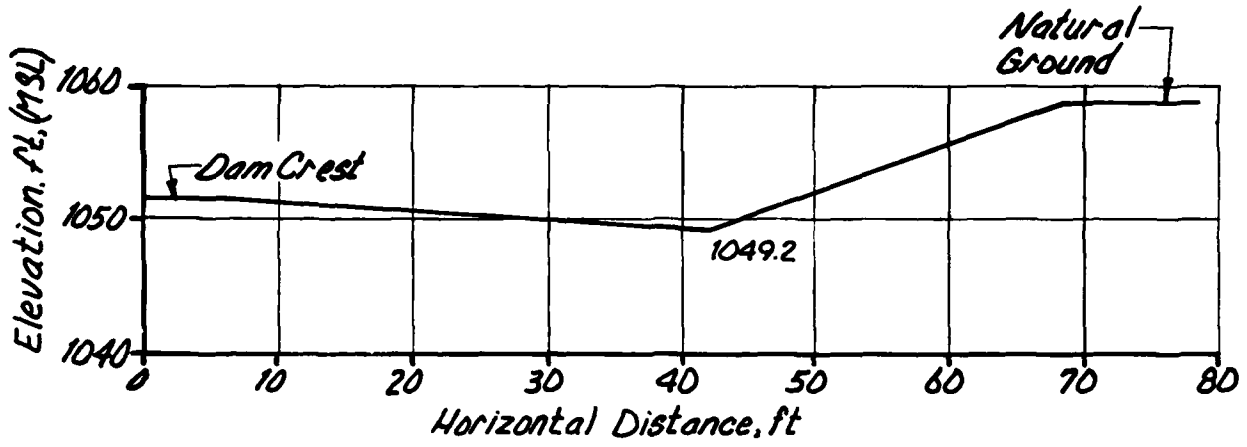
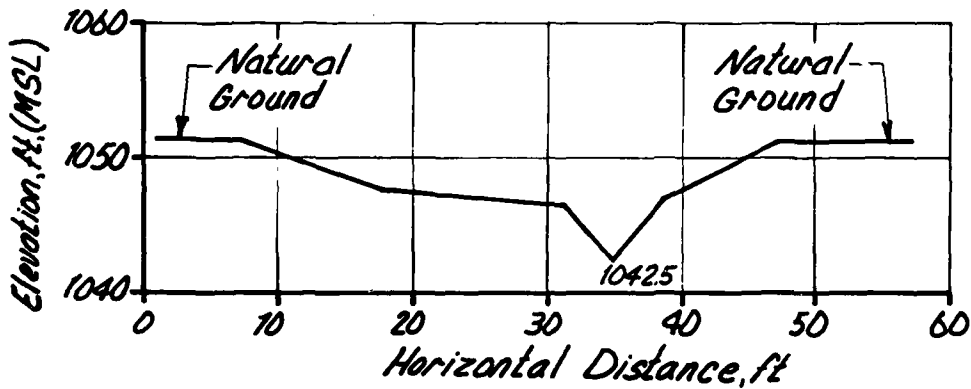
SECTION OF AUXILIARY SPILLWAY AND DISCHARGE CHANNEL	
THE PLACE	
MO. 30996	FIG. 3B

2. Auxiliary spillway. The auxiliary spillway is located at the right abutment. It is also unlined, uncontrolled and roughly "V" notch in shape (Photo 4). The gravelly clay soil is considered to be moderately erodible. Sparse weedy growth covers most of the surface. Erosion of the spillway does not appear to pose a safety hazard to the dam.
