**HORNSEY BROTHERS DAM  
WASHINGTON COUNTY, MISSOURI  
MO 30101**

# **PHASE 1 INSPECTION REPORT NATIONAL DAM SAFETY INSPECTION**

**PREPARED BY: U.S. ARMY ENGINEER DISTRICT, ST. LOUIS**

**NOVEMBER 1980**

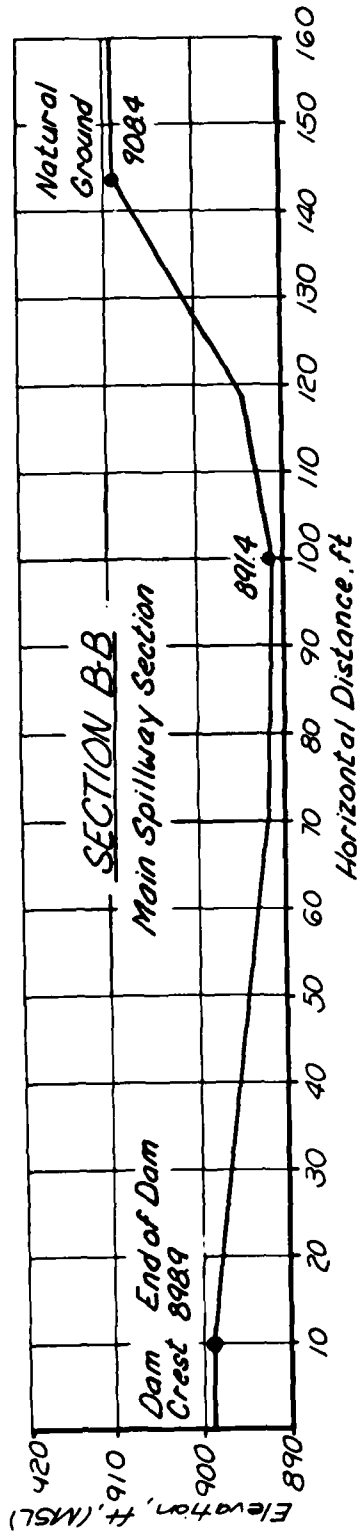
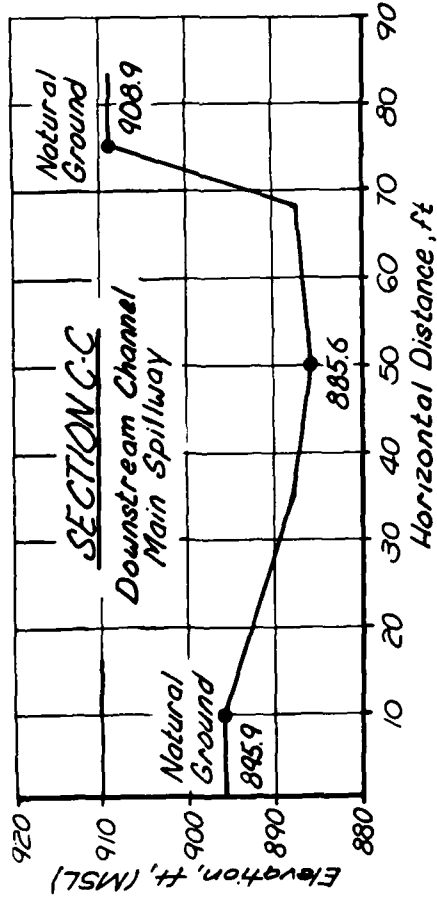
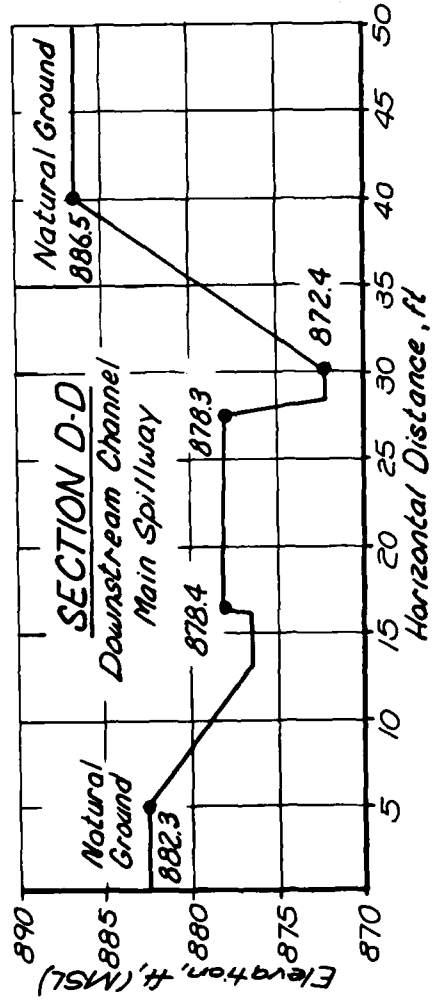
Fig. 3-B

3. Spillway. The ungated main spillway is located on the right abutment of the dam. The spillway and discharge channel were constructed by blasting the natural rock formation. The spillway shape is approximately trapezoidal. Because of the steepness of the discharge channel, cross-section B-B of the main spillway (Fig. 3B) acts as the control section for discharge.

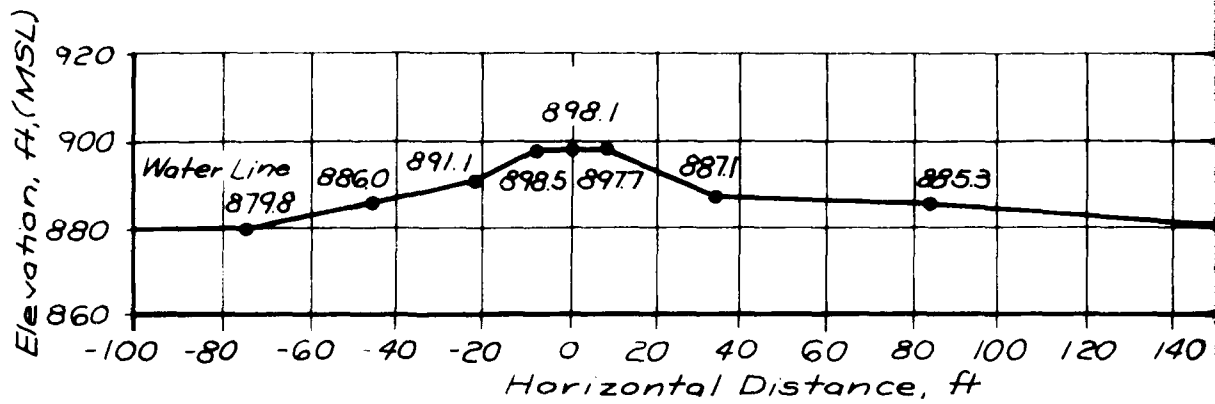
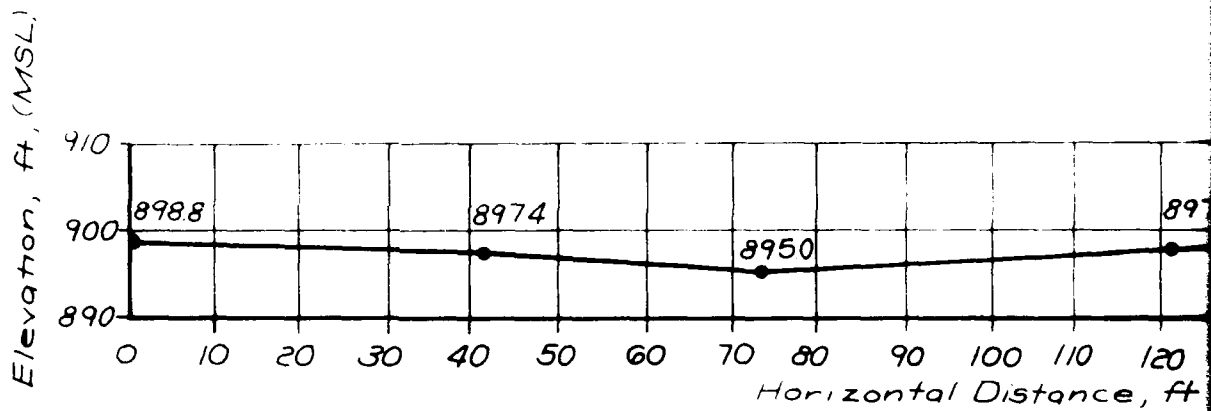
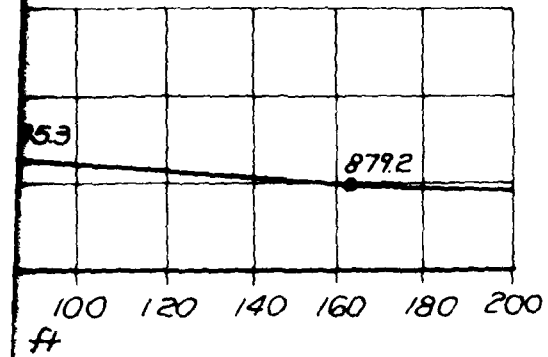
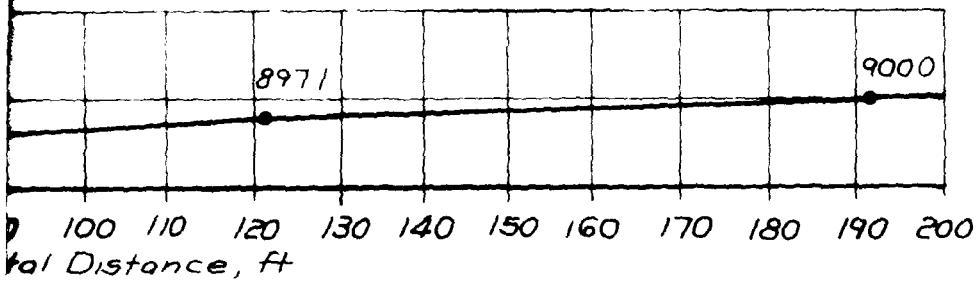
SECTIONS OF DAM AND AUXILIARY SPILLWAY	
HORNSEY BROTHERS DAM	
MO 30101	Fig. 3-C

An auxiliary spillway located at the left abutment (Overview Photo) consists of a low berm adjacent to the west end of the dam embankment, approximately 4 ft above the level of the main spillway and about 3 ft lower than the main embankment of the dam. Discharge from this spillway would flow near the toe of the dam, but would not be confined by any existing channel. The valley sides slope down toward this auxiliary spillway, and do not allow for unrestricted flow over the entire length of this low berm. Detailed surveying and backwater hydrologic analysis are beyond the scope of this Phase I study. However, four cross-sections perpendicular to the axis of the low berm have been surveyed and an approximate profile of the effective auxiliary spillway has been constructed and is shown in Fig. 3-C. There is no record of flow over the auxiliary spillway to date.
