ONLY WAY LAKE DAM

SALINE COUNTY, MISSOURI

**PHASE 1 INSPECTION REPORT
NATIONAL DAM SAFETY PROGRAM**

Only Way Lake Dam (MO 10111),
Missouri - Kansas City Basin,
Saline County, Missouri. Phase I Inspection
Report.

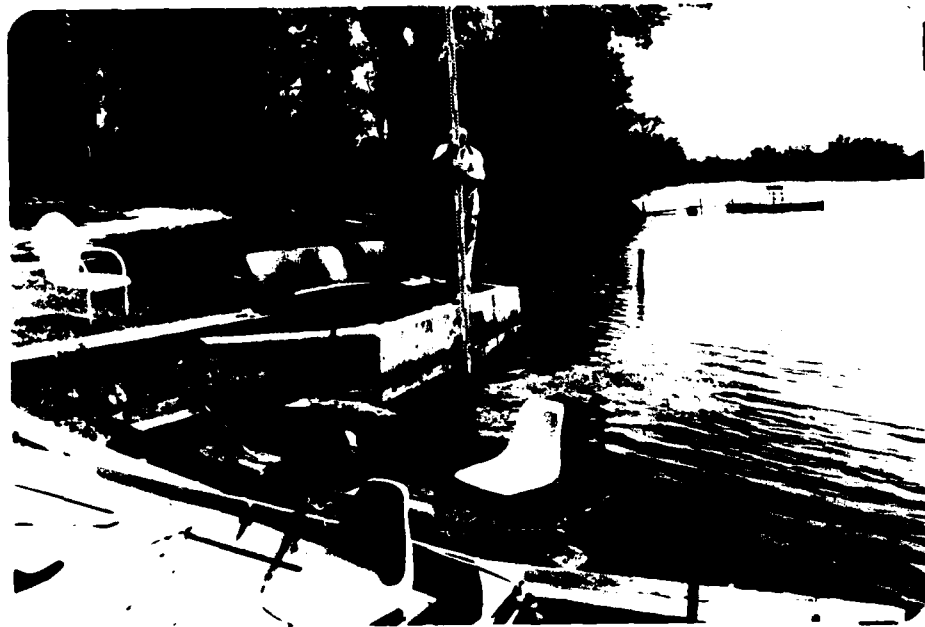
PHOTO NO. 15 - PRINCIPAL SPILLWAY INLET

- (1) Principal Spillway. The principal spillway is located in natural ground northwest of the dam. It consists of a concrete weir inlet and 2.2 ft. diameter steel oil barrels concreted in place outletting into a French drain. It was not possible to observe any of the steel barrel conduit. The conduit outlets into a gully which has been filled with rock and concrete rubble up to about elevation 822. The rock filled gully serves as a French drain exit for flows through the principal spillway. The inlet is protected with a mesh screen. The concrete head walls of the inlet structure are cracked in several places but the integrity of the structure does not appear to be endangered. Water was barely flowing over the inlet sill. The outlet end of the rock filled exit channel (French drain type) was observed to be stable with a trickle of discharge. No slumps or depressions were noted on the ground surface covering the pipe conduit.

- (4) The headwall of the principal spillway should be repaired to prevent further deterioration.
- (5) A program of regular inspection and maintenance should be initiated.
