GUDAITIS LAKE DAM
Washington County, Missouri
Missouri Inventory No. 30702

Phase I Inspection Report
National Dam Safety Program

Woodward-Clyde Consultants
Chicago, Illinois

for
Governor of Missouri
November 1980

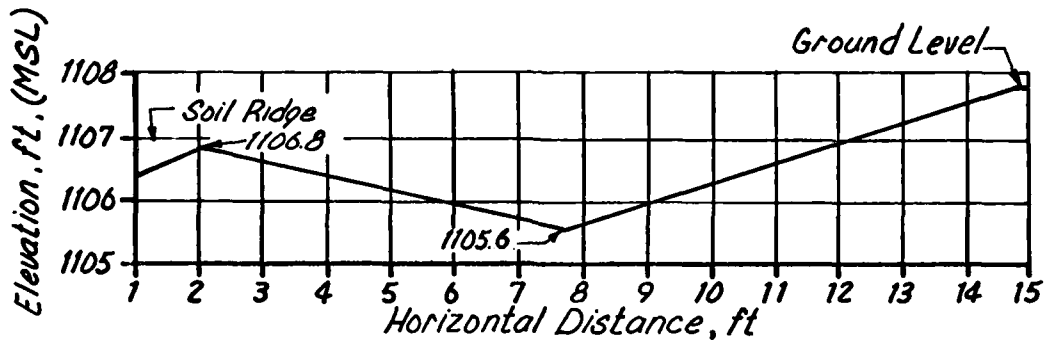
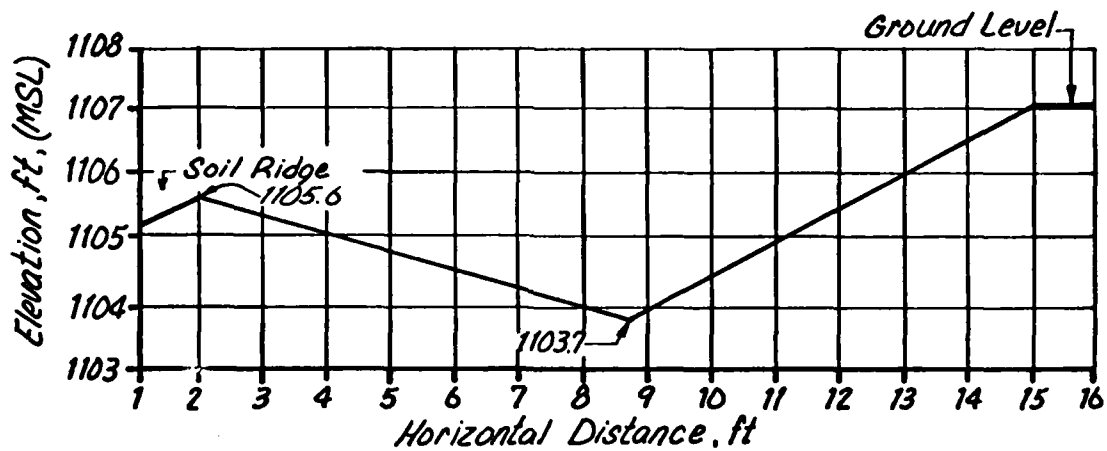
SECTIONS OF	
DISCHARGE CHANNEL	
GUDAITS LAKE DAM	
MO 30702	Fig. 3B

3. Spillway. The spillway is located at the southeast end of the dam (Photo 2). It is excavated in the natural ground and has little vegetative growth (Photo 3). The open channel spillway carries flow into the downstream discharge channel. The spillway discharge channel lies on the slope of the southeastern valley sidewall. Therefore, there is a possibility of flow spilling out of the discharge channel and eroding the bank of the channel. This may represent a potential danger to the downstream toe of the dam.
