**OLD MINES TAILINGS DAM  
WASHINGTON COUNTY, MISSOURI  
MO 30706**

**PHASE 1 INSPECTION REPORT  
NATIONAL DAM SAFETY PROGRAM**

Name of Dam	Old Mines Tailings Dam
State	Missouri
County	Washington
Stream	Mud Town Creek
Date of Inspection	24 August 1979

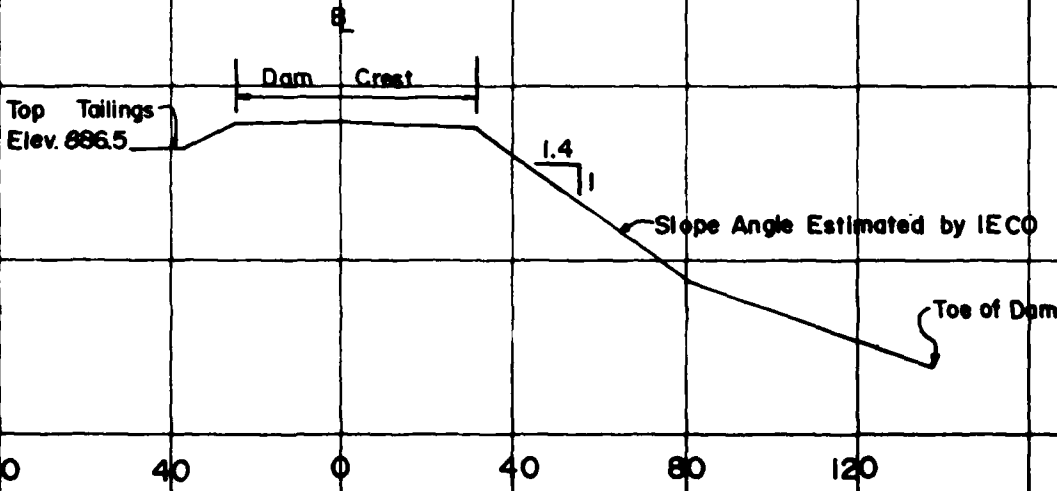
DAM CROSS SECTION AT STA. 12+10

<u>Photo No.</u>	<u>Description</u>
1	View toward right abutment showing upstream face and crest of dam and impounded barite tailings.
2	Downstream face of dam showing buldge in lower half of dam at Station 12+10.
3	Typical seepage, and resulting ponded water and marshy condition at toe of dam.
4	Seep at toe of dam at Station 4+04.
5	View upstream in spillway approach channel.
6	View of spillway approach channel toward dam crest at the right abutment. The old spillway approach channel containing water is visible at the left of the photograph.
7	End of spillway approach channel at right abutment and depression in dam crest haul road over which spillway discharge would pass.
8	Freshly cleared, shallow downstream spillway channel adjacent to dam toe which terminates on the right abutment hillside.

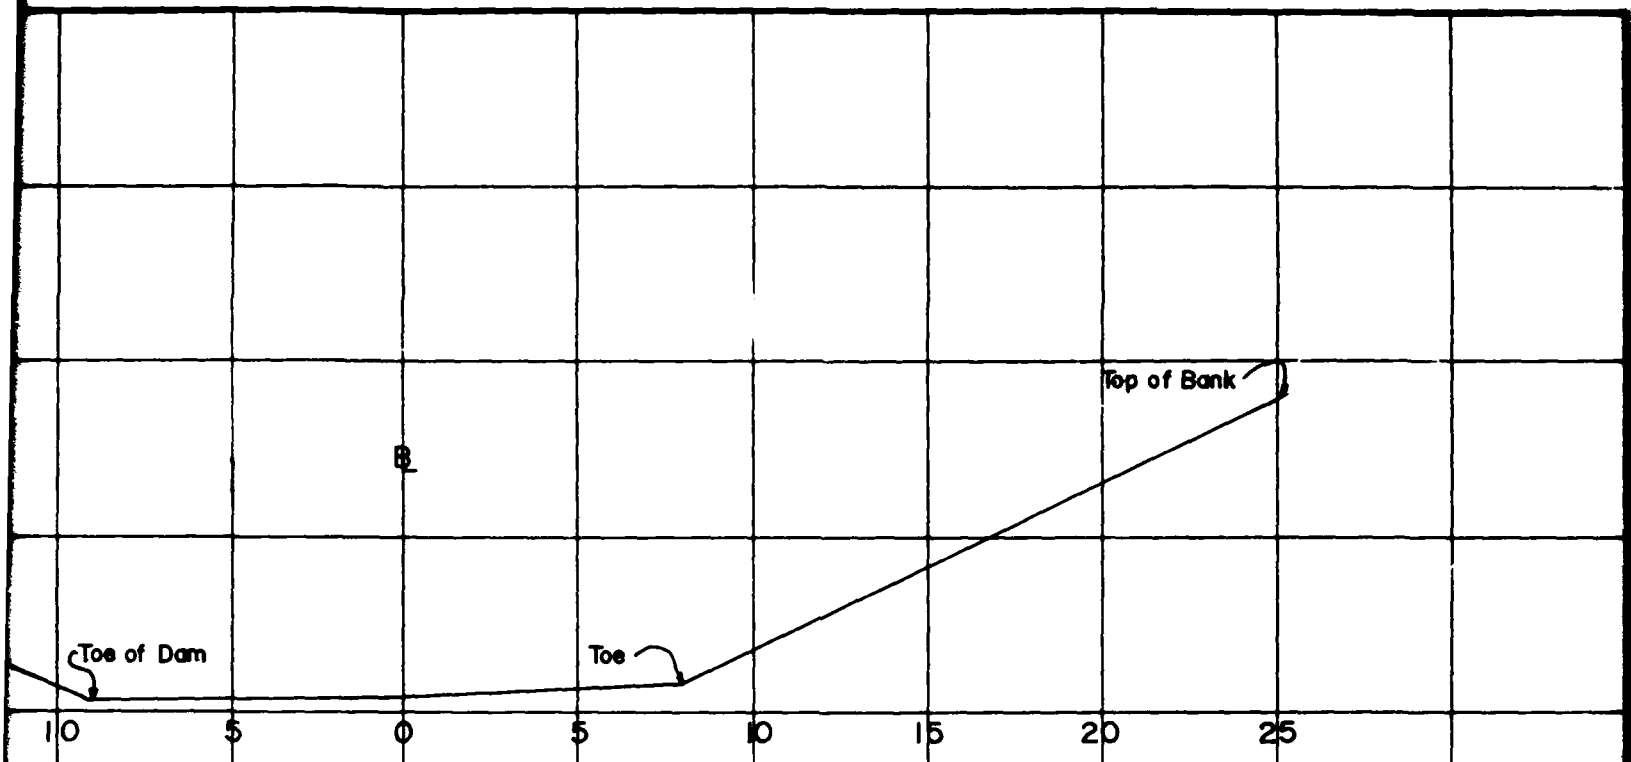
SPILLWAY CHANNEL CROSS SECTION AT STA 13+42

The channel downstream of the spillway crest is a shallow stripped section consisting of freshly cut clumps of clayey soil along the downstream toe, which terminates on the right abutment hillside. The profile is shown on Plate 6B. At the location where the channel rounds the dam crest to proceed down the abutment, the channel bottom slopes toward the toe of the dam. Beyond the point where the cleared section terminates, flow would pass over the natural ground and would be channeled through erosion gullies caused by seepage and through sections of open cut trapezoidal channels which appear to have been associated with earlier spillways, meandering down the right abutment hillside adjacent to the dam to the natural stream channel. No erosion was observed in the spillway or spillway approach channel; however, these channels were recently constructed and had probably not functioned prior to inspection.
