NATIONAL DAM SAFETY PROGRAM. LITTLE CHOCONUT WATERSHED SITE 2E --ETC(U)

| REPORT DOCUMENTATION PAGE | | READ INSTRUCTIONS<br>BEFORE COMPLETING FORM |
|---|---|---|
| 4. TITLE (and Subtitle)<br>Phase I Inspection Report<br>Little Choconut Watershed Site 2E Dam<br>Susquehanna River Basin, Broome County, N.Y.<br>Inventory No. 723 | | 5. TYPE OF REPORT & PERIOD COVERED<br>Phase I Inspection Report<br>National Dam Safety Program |
| 9. PERFORMING ORGANIZATION NAME AND ADDRESS<br>Flaherty-Giavara Associates<br>One Columbus Plaza<br>New Haven, CT 06510 | | 8. CONTRACT OR GRANT NUMBER(s)<br>151 DACW51-81-C-9996 |
| 13. MONITORING AGENCY NAME & ADDRESS (if different from Controlling Office)<br>Department of the Army<br>26 Federal Plaza New York District, CoFE<br>New York, NY 10287 | | 12. REPORT DATE<br>11 30 June 1981 |

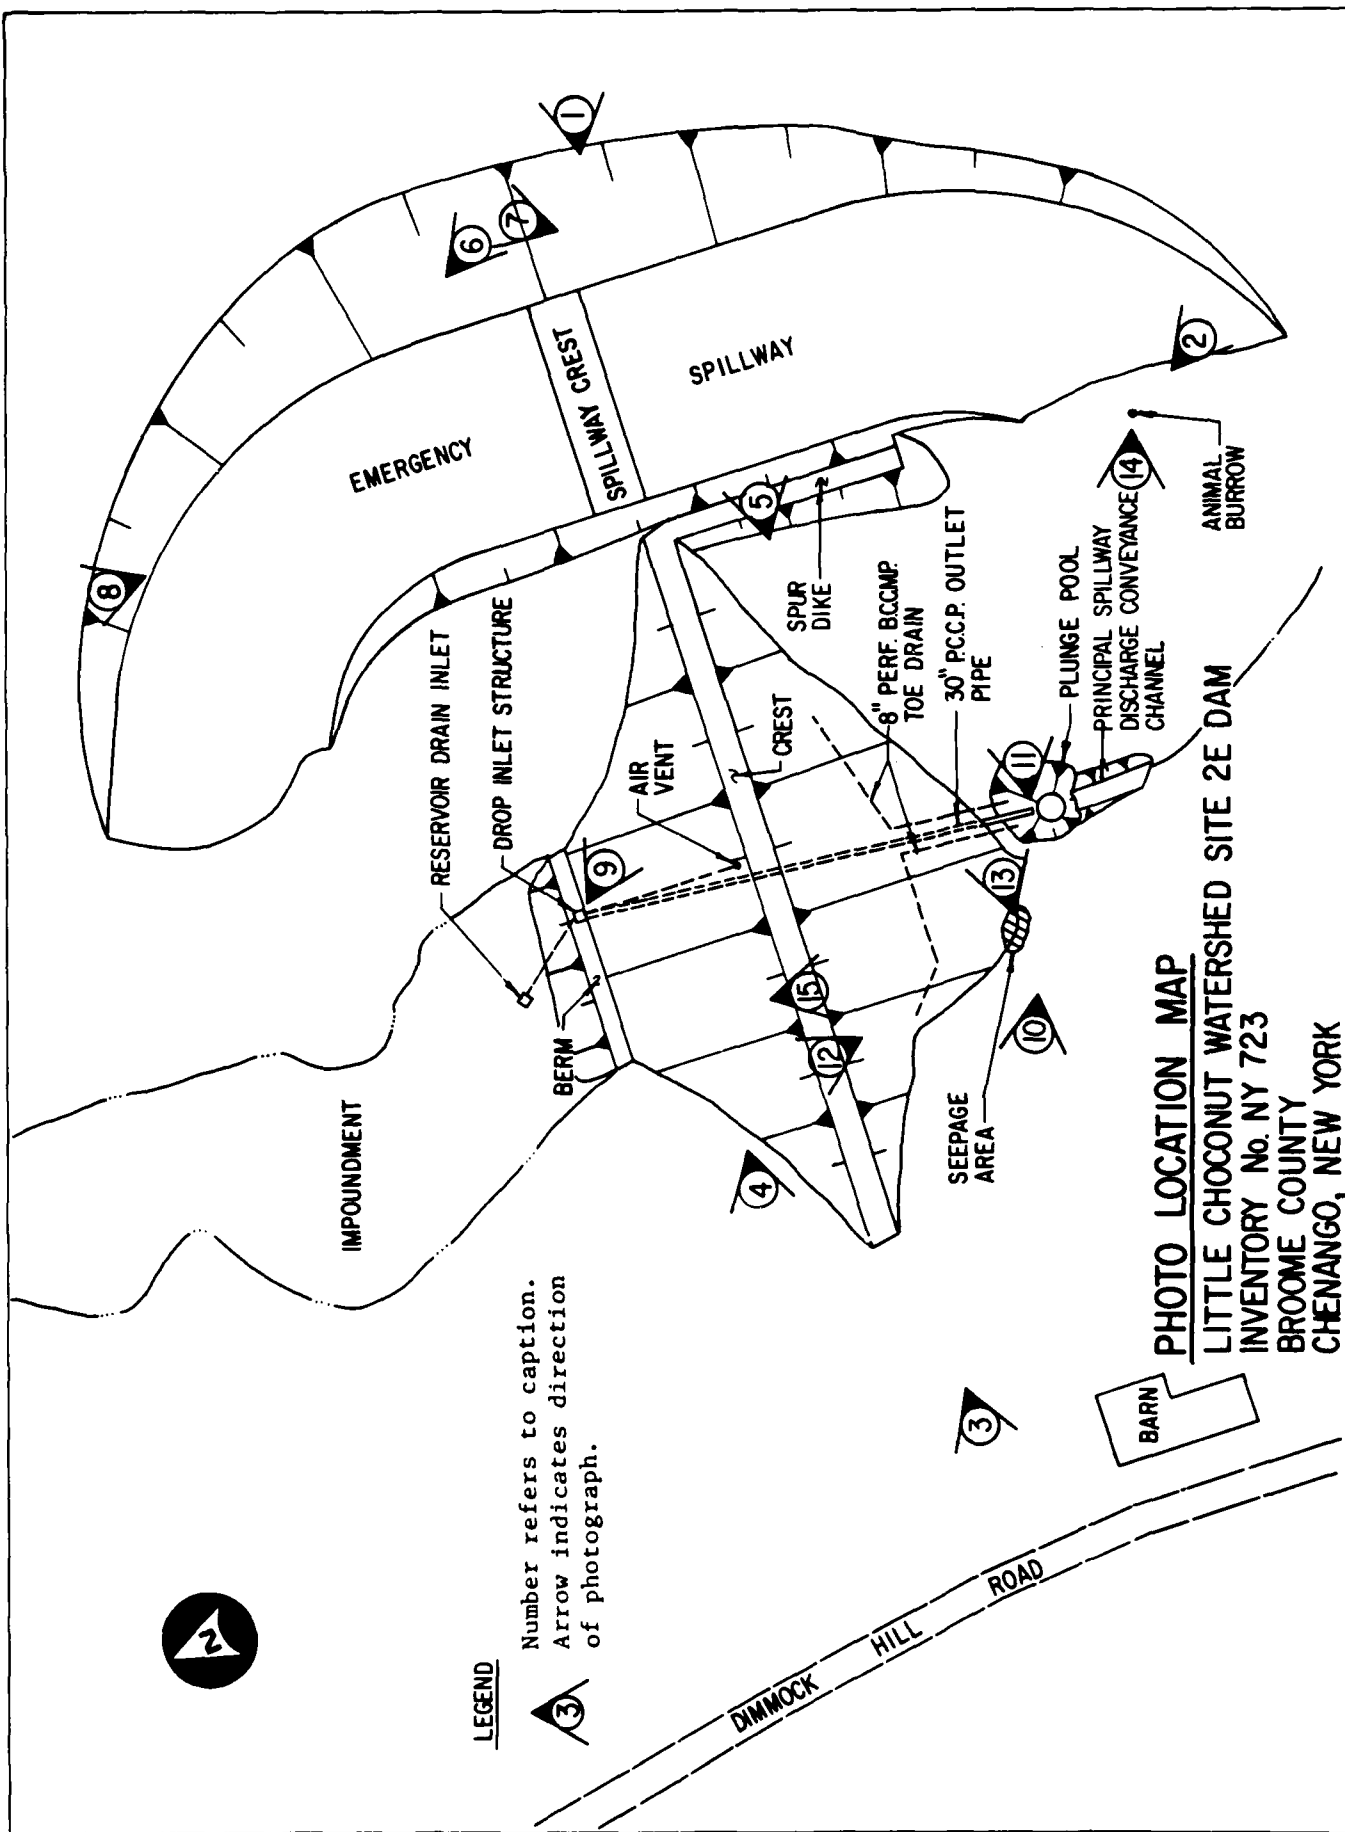
PHOTO #2: Overview of downstream face of dam

2. The grass has been cut short on the relatively level surfaces, but is about 18 inches high on the embankment and cut slopes (See Photos No. 2, 3, 4, 5, 6, 7 and 8). However, the absence of brush is indicative of past periodic cutting.

1. Repair the small eroded area on the downstream slope at the right abutment using granular fill and broken stone to permit drainage.
2. Mow the grassed slopes of the embankment and emergency spillway channel at least annually.
3. Restore the riprap support or shorten the toe drain outlet pipes.
4. Control access and vehicular traffic and take necessary measures to prevent further rutting of the crest.
