**HOUSATONIC RIVER BASIN
TOWN OF AMENIA
DUTCHESS COUNTY, NEW YORK**

**THORNES DAM
NY 00793**

PHASE I INSPECTION REPORT

Thornes Dam (Inventory Number NY 00793).
Housatonic River Basin. Town of Amenia.
Dutchess County, New York. Phase I Inspection
Report.

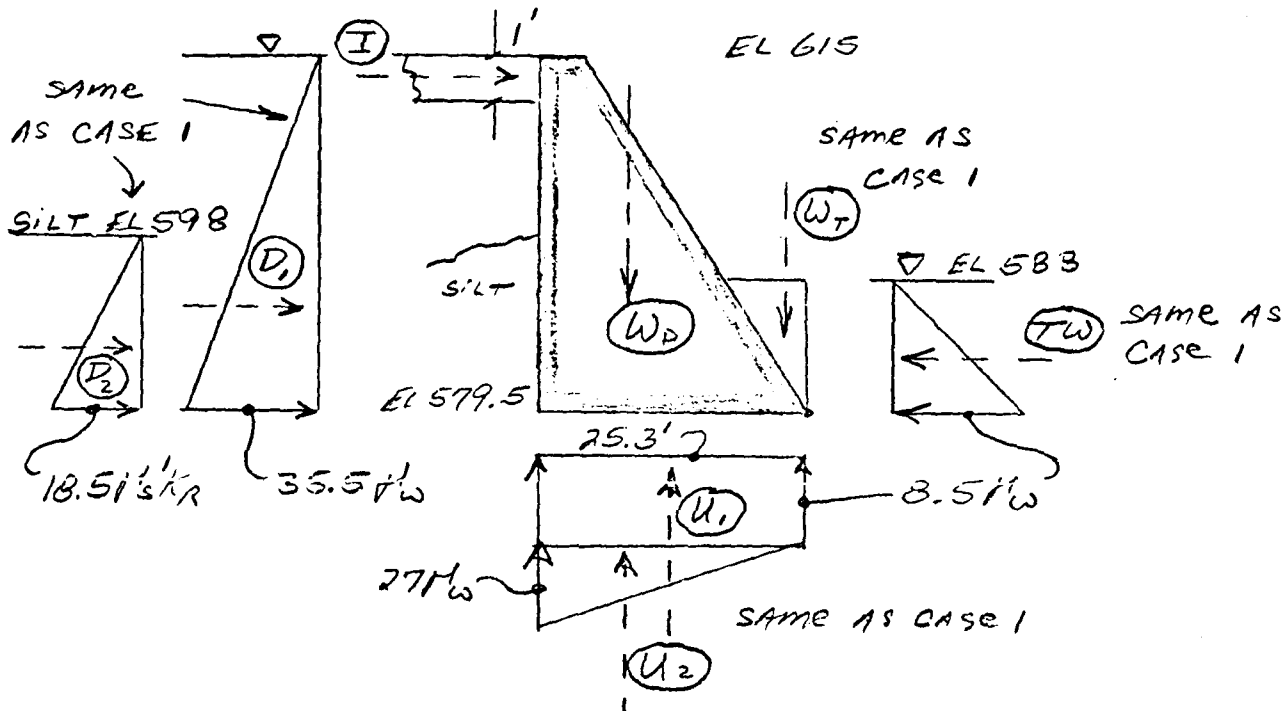
CASE 2 Normal pool plus ice load. Use ice load of 5k/ft for ice 1' thick.
OVERTURNING

Resisting Forces x Moment Arm About toe = MR
All same as Case 1, sheet 2 → $\Sigma MR = 1343.47 \text{ Ftk}$

Driving Forces
normal H₂O pressure, silt press. & normal uplift
same as Case 1, sheet 2 →

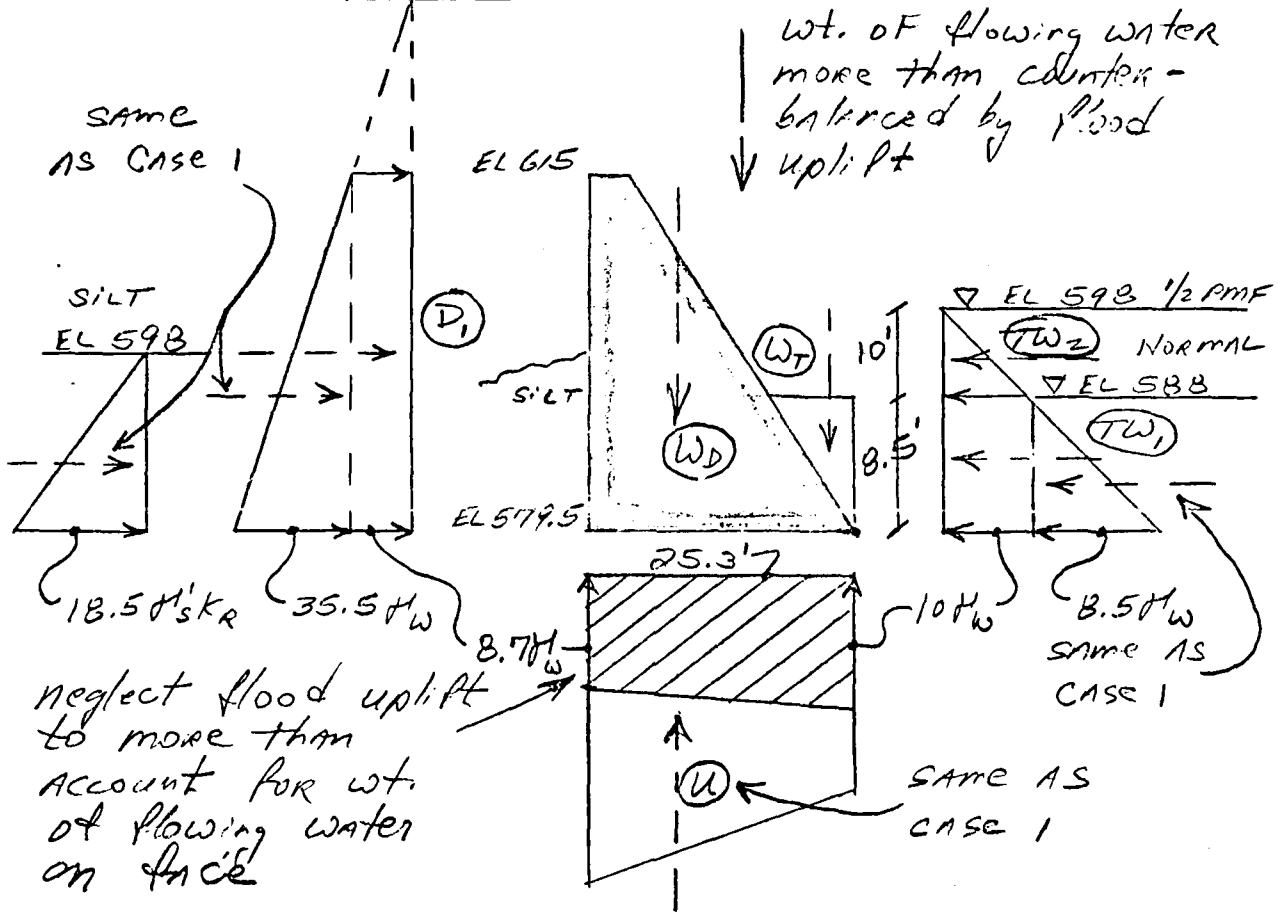
CASE 3 - 1/2 PMF pool, full HW & TW uplift, remainder same as Case 1.

▽ 1/2 PMF EL 623.7

Wt. of flowing water more than counter-balanced by flood
↓ uplift
