SUNNEN LAKE DAM  
WASHINGTON COUNTY, MISSOURI  
MISSOURI INVENTORY NO. 30111

PHASE I INSPECTION REPORT  
NATIONAL DAM SAFETY PROGRAM

| Date of Inspection | 25 August 1978 |

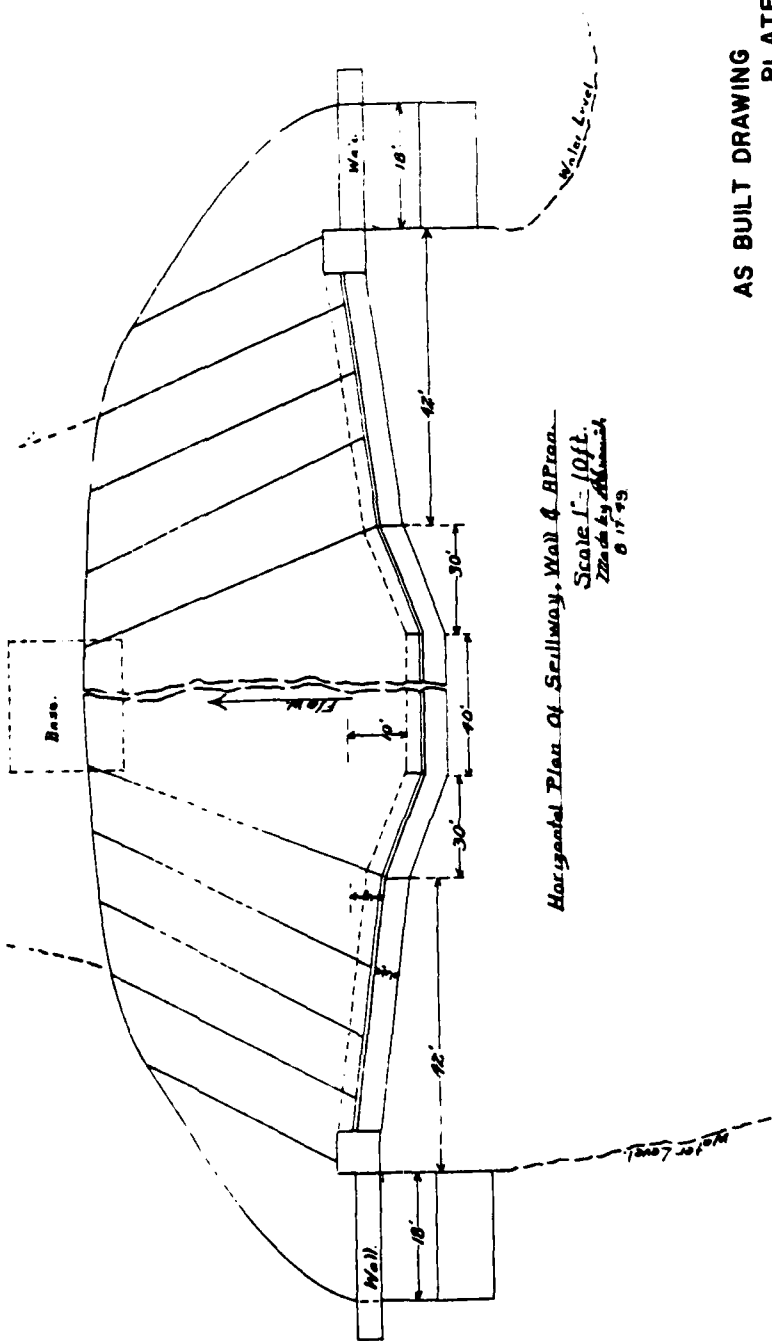
AS BUILT DRAWING  
PLATE 4

(1) The spillway consists of a concrete weir with a downstream concrete apron. The concrete apron provides a trapezoidal outlet channel transitioning to a rock outlet channel. The concrete weir was raised about 2 feet in the 1950's and, therefore, not in agreement with the as-built drawings (Plate 4). Two 1-foot square blockouts with steel plates, possibly removable, are located 2 feet below the weir crest; removing these plates would allow lowering the lake 2 feet.
