NATIONAL DAM SAFETY PROGRAM. BUICK MINE TAILINGS DAM (MO 301621)-ETC(U)

# PHASE 1 INSPECTION REPORT NATIONAL DAM SAFETY INSPECTION

| REPORT DOCUMENTATION PAGE | | READ INSTRUCTIONS<br>BEFORE COMPLETING FORM |
|---|---|---|
| 4. TITLE (and Subtitle)<br>Phase I Dam Inspection Report<br>National Dam Safety Program<br>Buick Mine Tailings Dam (MO 30162)<br>Reynolds County, Missouri | | 5. TYPE OF REPORT & PERIOD COVERED<br>9 Final Report |

# BUICK MINE TAILINGS DAM

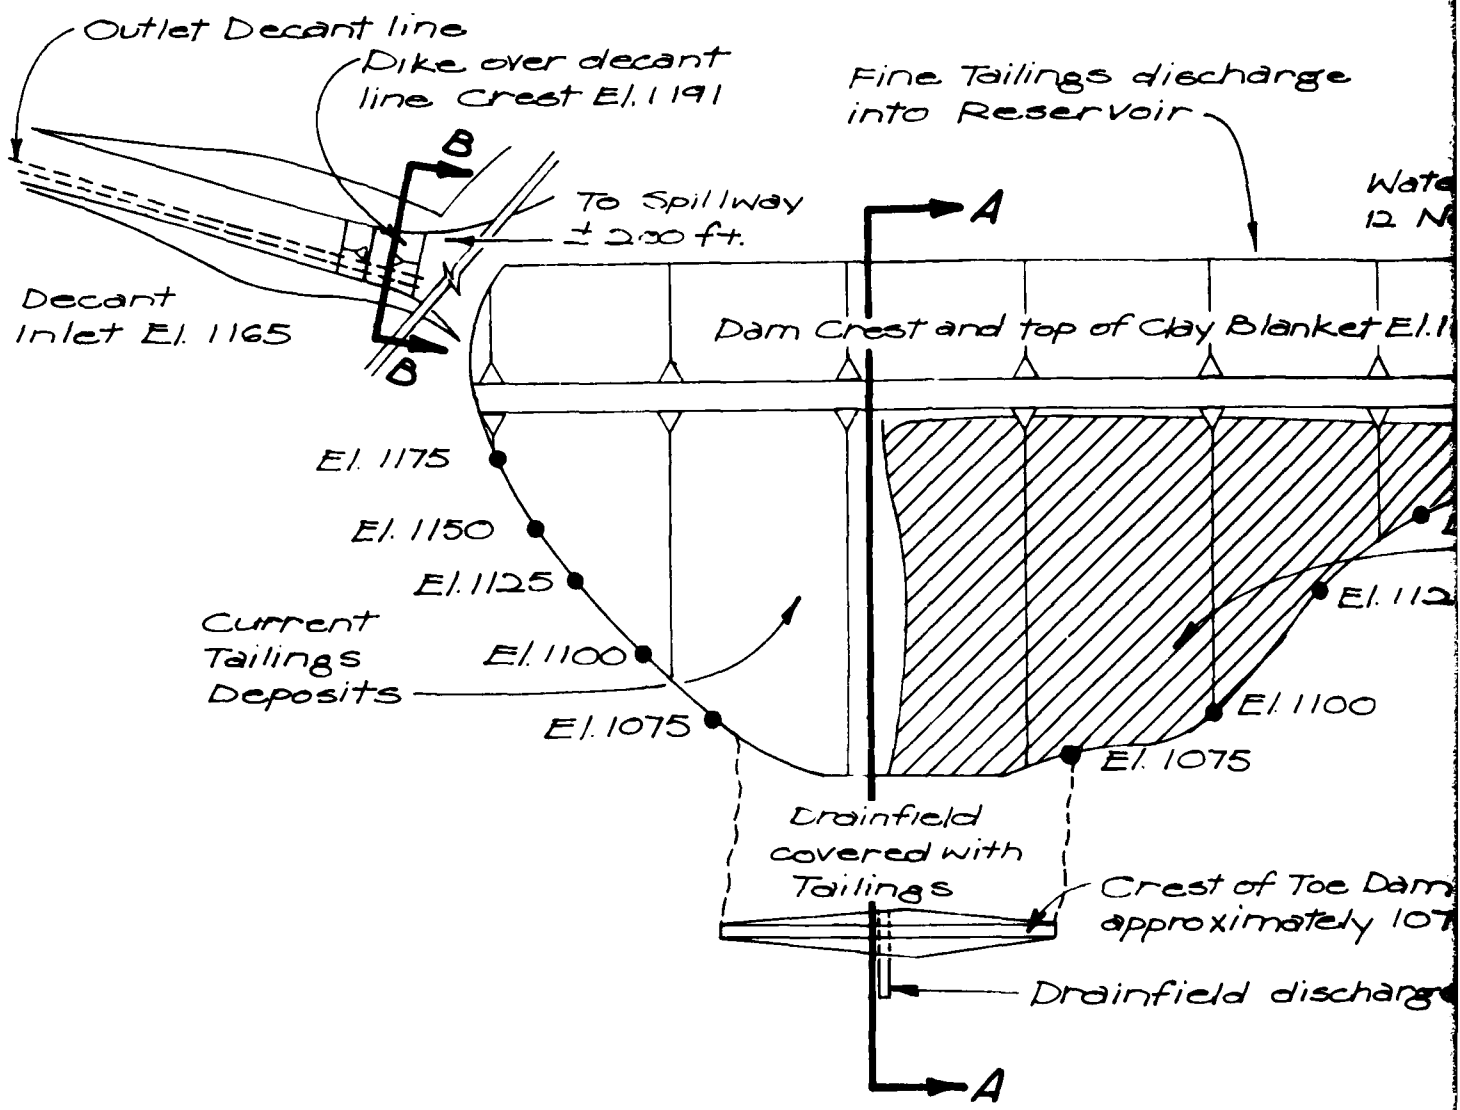
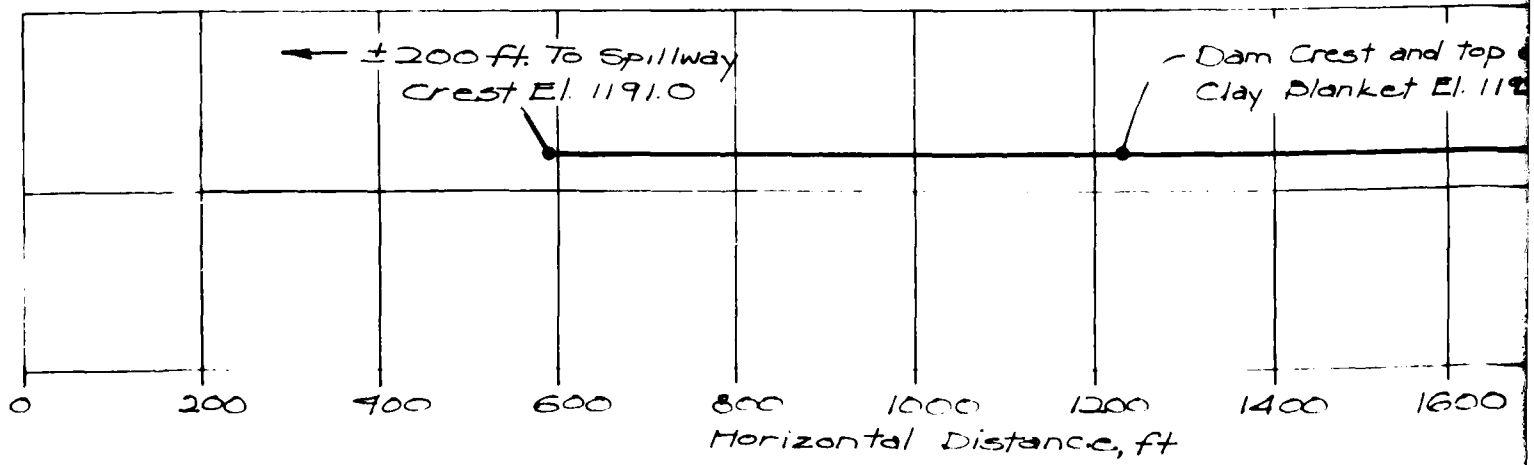
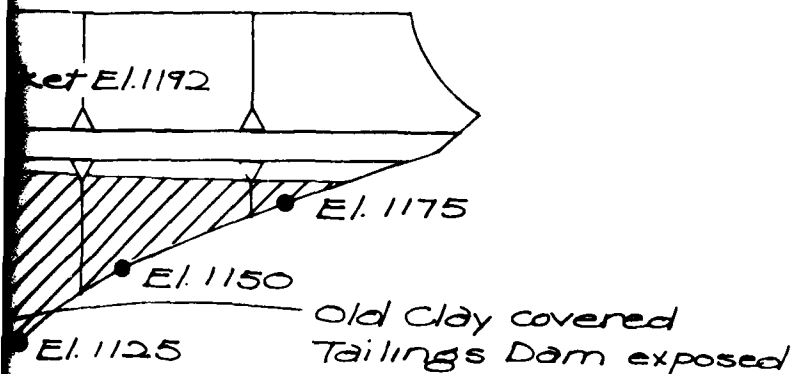
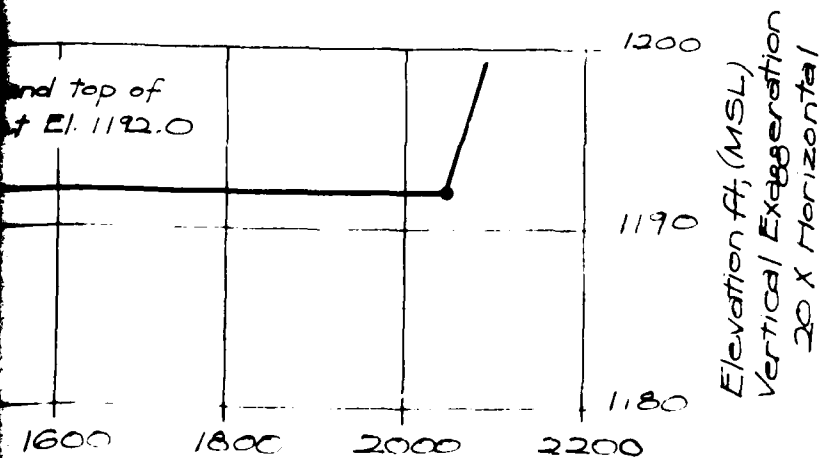
Fig. 3-A

Note:  
Permanent Spillway, to be  
located on the south-east  
bank of impoundment, not  
yet constructed at time of  
inspection.
