SUBJECT: Blackwell Mine Dam (MO 30709) Phase I Inspection Report

**BLACKWELL MINE DAM**  
Washington County, Missouri  
Missouri Inventory No. 30709

**Phase I Inspection Report**  
**National Dam Safety Program.**

PHASE I REPORT  
NATIONAL DAM SAFETY PROGRAM

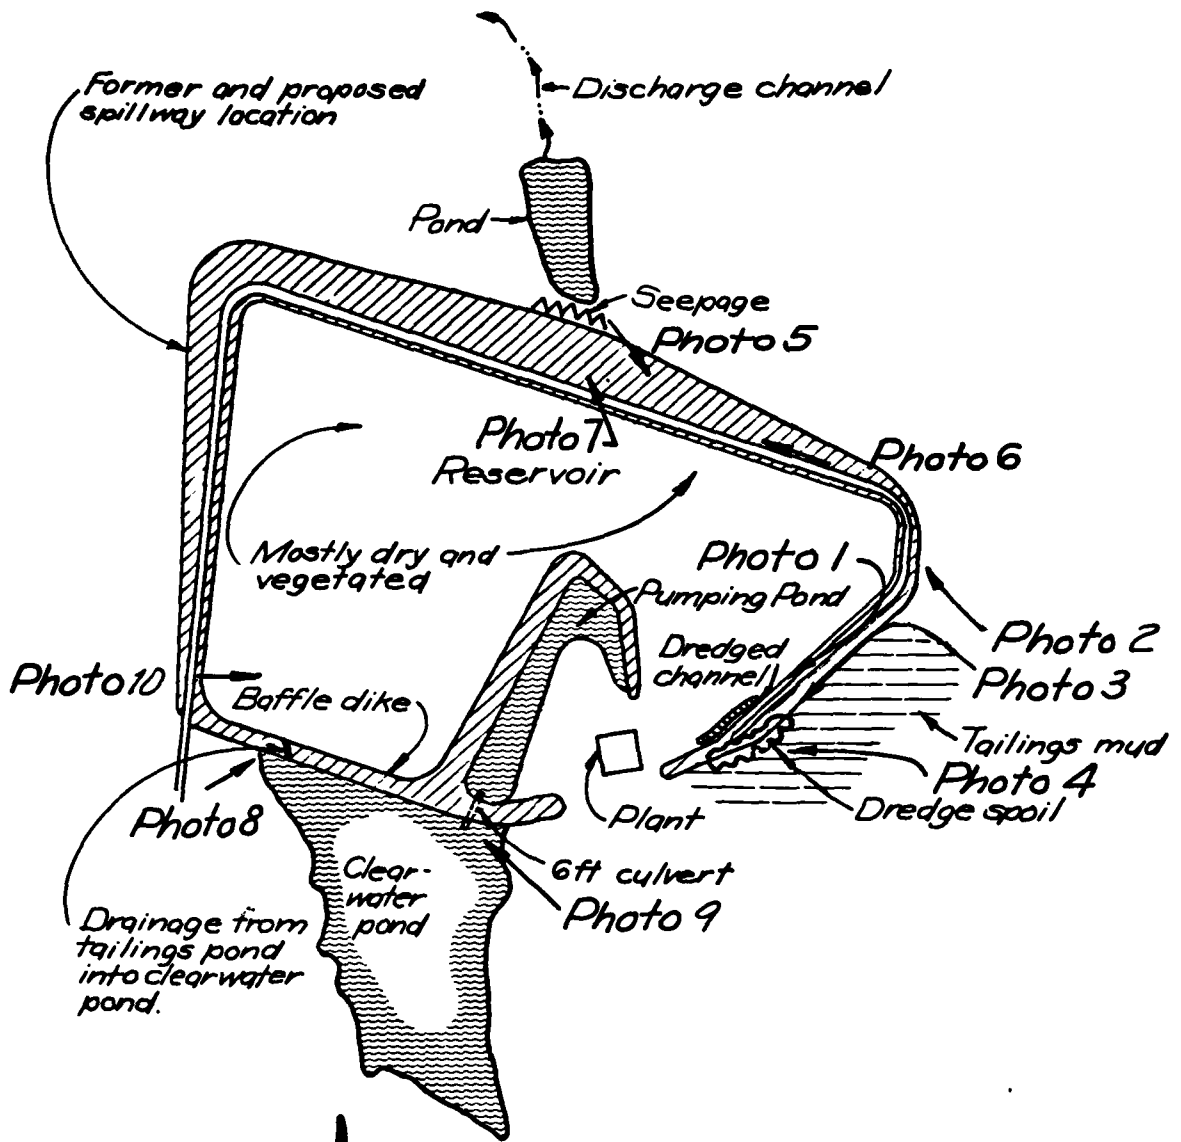
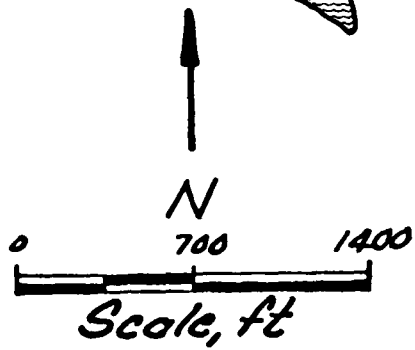
<b>PHOTO LOCATION SKETCH</b>	
<b>BLACKWELL MINE DAM</b>	
MO 30709	Fig. A-1

Along the east margin of the embankment, dredging has been done to maintain a channel deep enough to prevent overflow of the mill discharge water (Photo 1). East of and outside the embankment in this area, tailings mud has been deposited in excess of 3 ft deep (Fig A1, Appendix A; Photo 2). This
