**DESOTO MINING COMPANY**  
**PIT AND PLANT "A" DAM**  
Washington County, Missouri  
Missouri Inventory No. 30468

**Phase I Inspection Report**

**National Dam Safety Program ,**

**PHASE I INSPECTION REPORT  
NATIONAL DAM SAFETY PROGRAM  
DESOTO PIT AND PLANT "A" DAM, MISSOURI INVENTORY No. 30468**

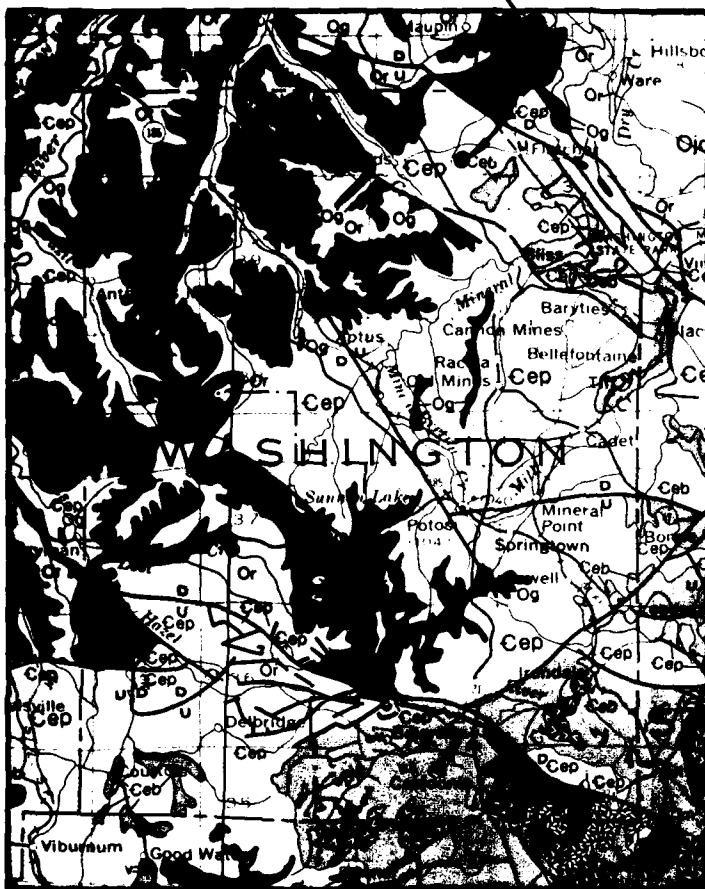
FIG 3B

3. Spillway. There is no formal designed spillway at this facility. The term "informal spillway" has been assigned to the low area to the south of the south end of the dam (see Figs. 3a and 3b). This overflow area has a moderate to high erosion potential as the stoney clay residual soil is only vegetated by grass, brush and small trees. This soil has been observed to be highly erodible when stripped of vegetation and exposed to high flow velocities.
