PHASE I INSPECTION REPORT  
NATIONAL DAM SAFETY PROGRAM

SUBJECT: Desoto Mining Co. Pit & Plant 'B' Dam (MO 30469) Phase I Inspection Report

**DESOTO MINING CO.**  
**PIT & PLANT "B" DAM**  
Washington County, Missouri  
Missouri Inventory No. 30469

**Phase I Inspection Report**  
**National Dam Safety Program .**

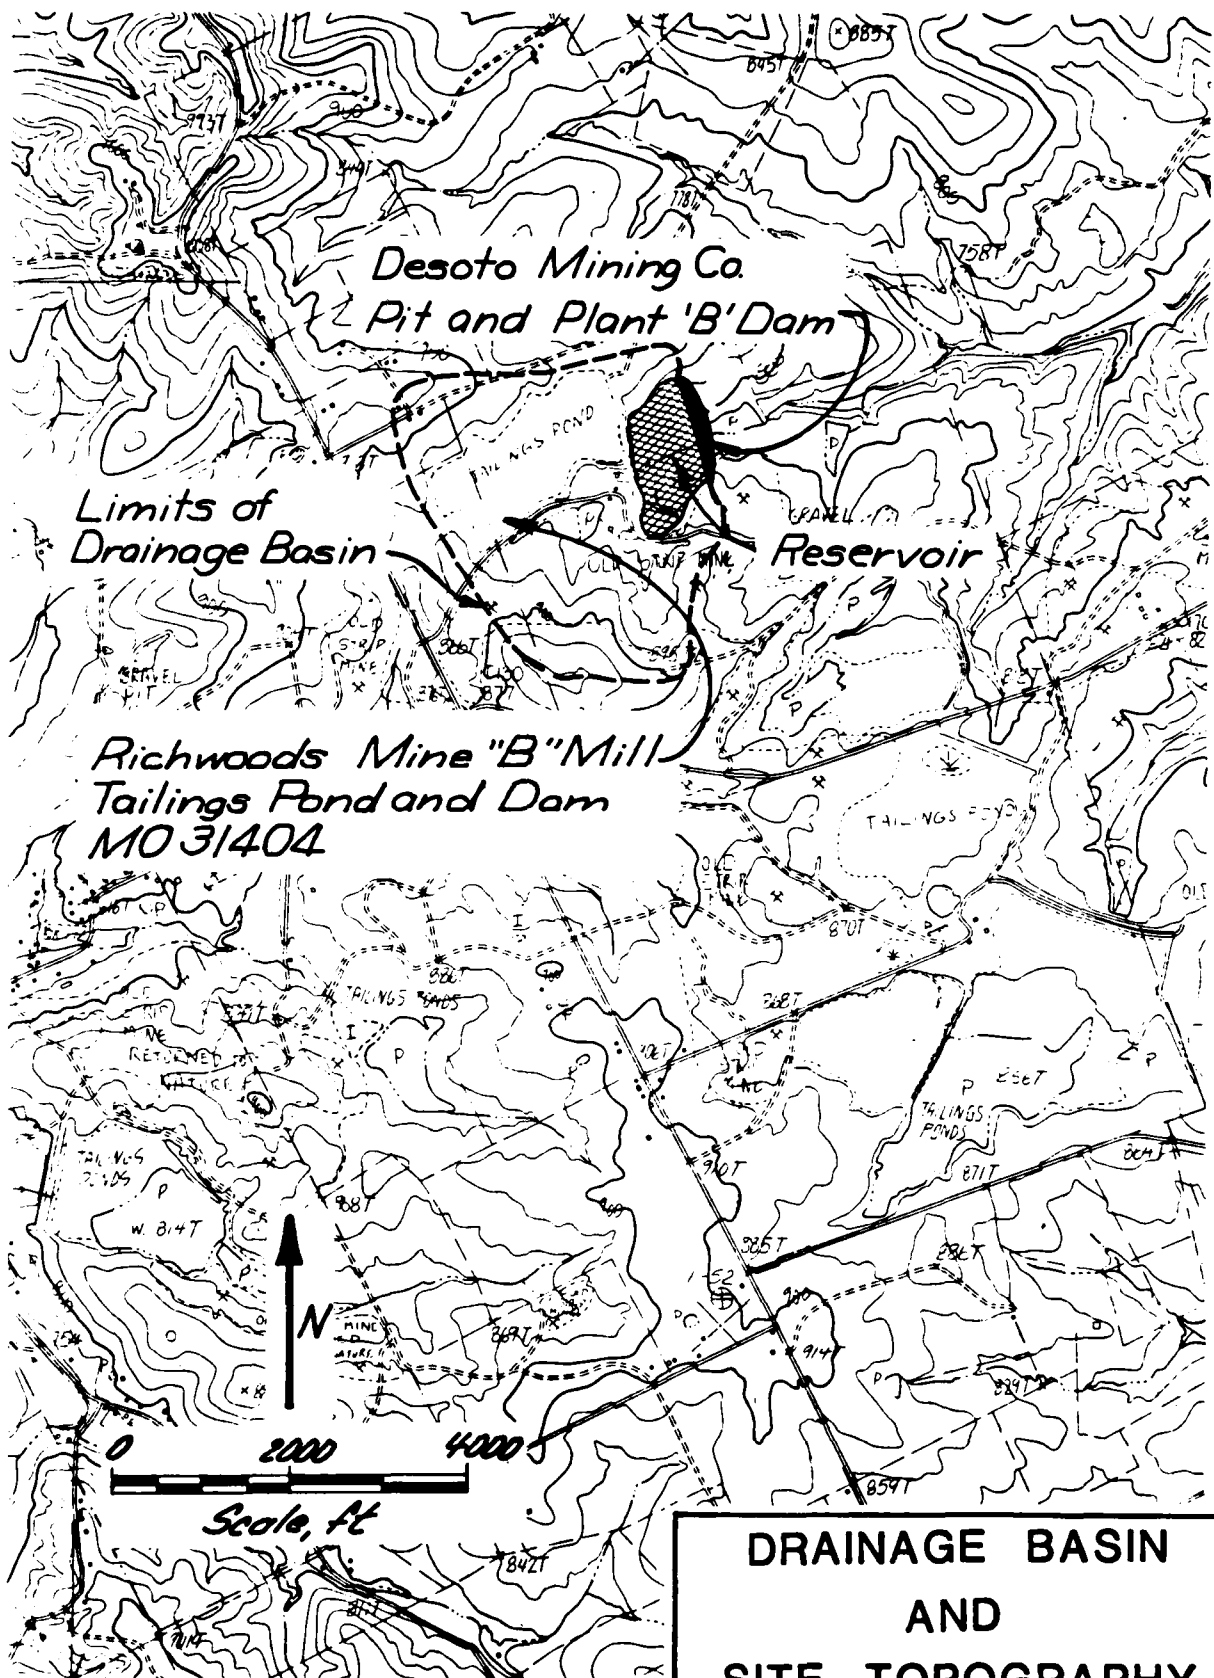
Fig. 2

- a. Drainage area. The drainage area was measured as .37 mi<sup>2</sup> on the advance print of the USGS Richwoods NE 7.5-minute quadrangle map (Fig. 2). This includes the drainage area for the Richwoods Mine B Mill Dam immediately upstream from the Pit and Plant B Dam.

## DRAINAGE BASIN AND SITE TOPOGRAPHY

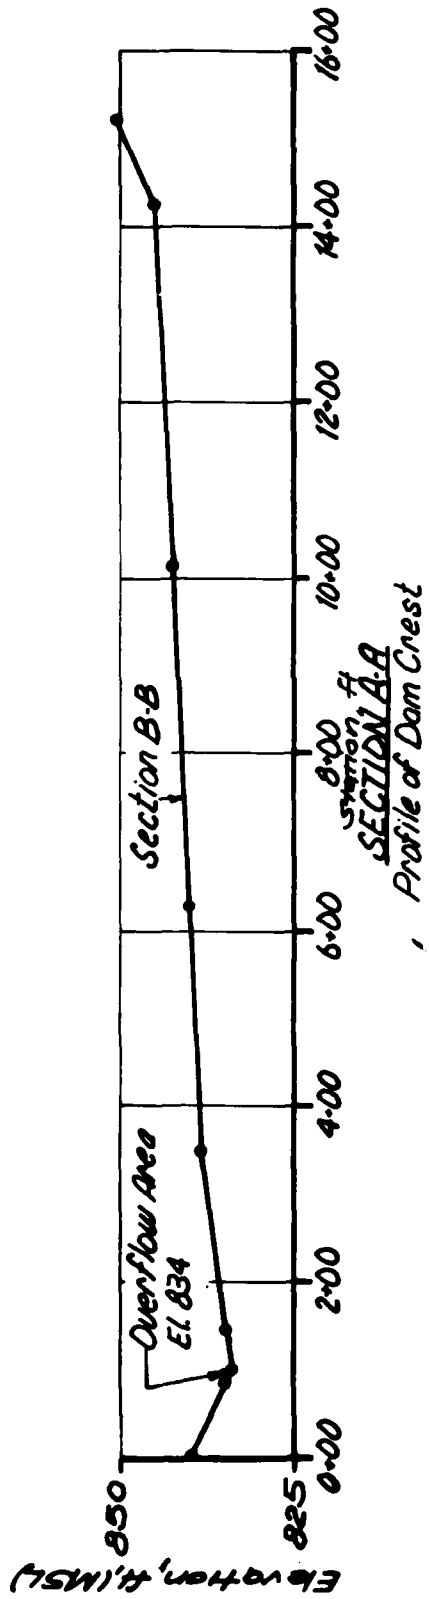
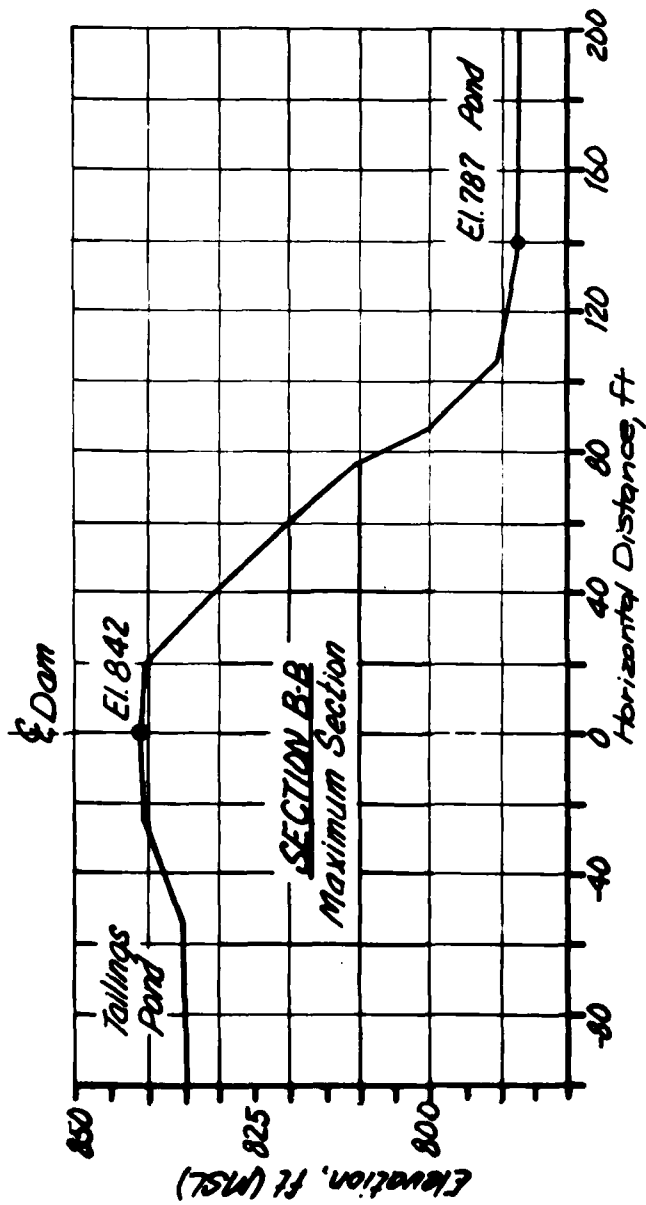
Fig. 3-B

PROFILE AND

SECTION OF DAM
