**NO NAME 550 DAM
WASHINGTON COUNTY, MISSOURI
MO 30711**

**PHASE 1 INSPECTION REPORT
NATIONAL DAM SAFETY PROGRAM**

NO NAME 550 DAM
WASHINGTON COUNTY, MISSOURI

PHASE I INSPECTION REPORT
NATIONAL DAM SAFETY PROGRAM

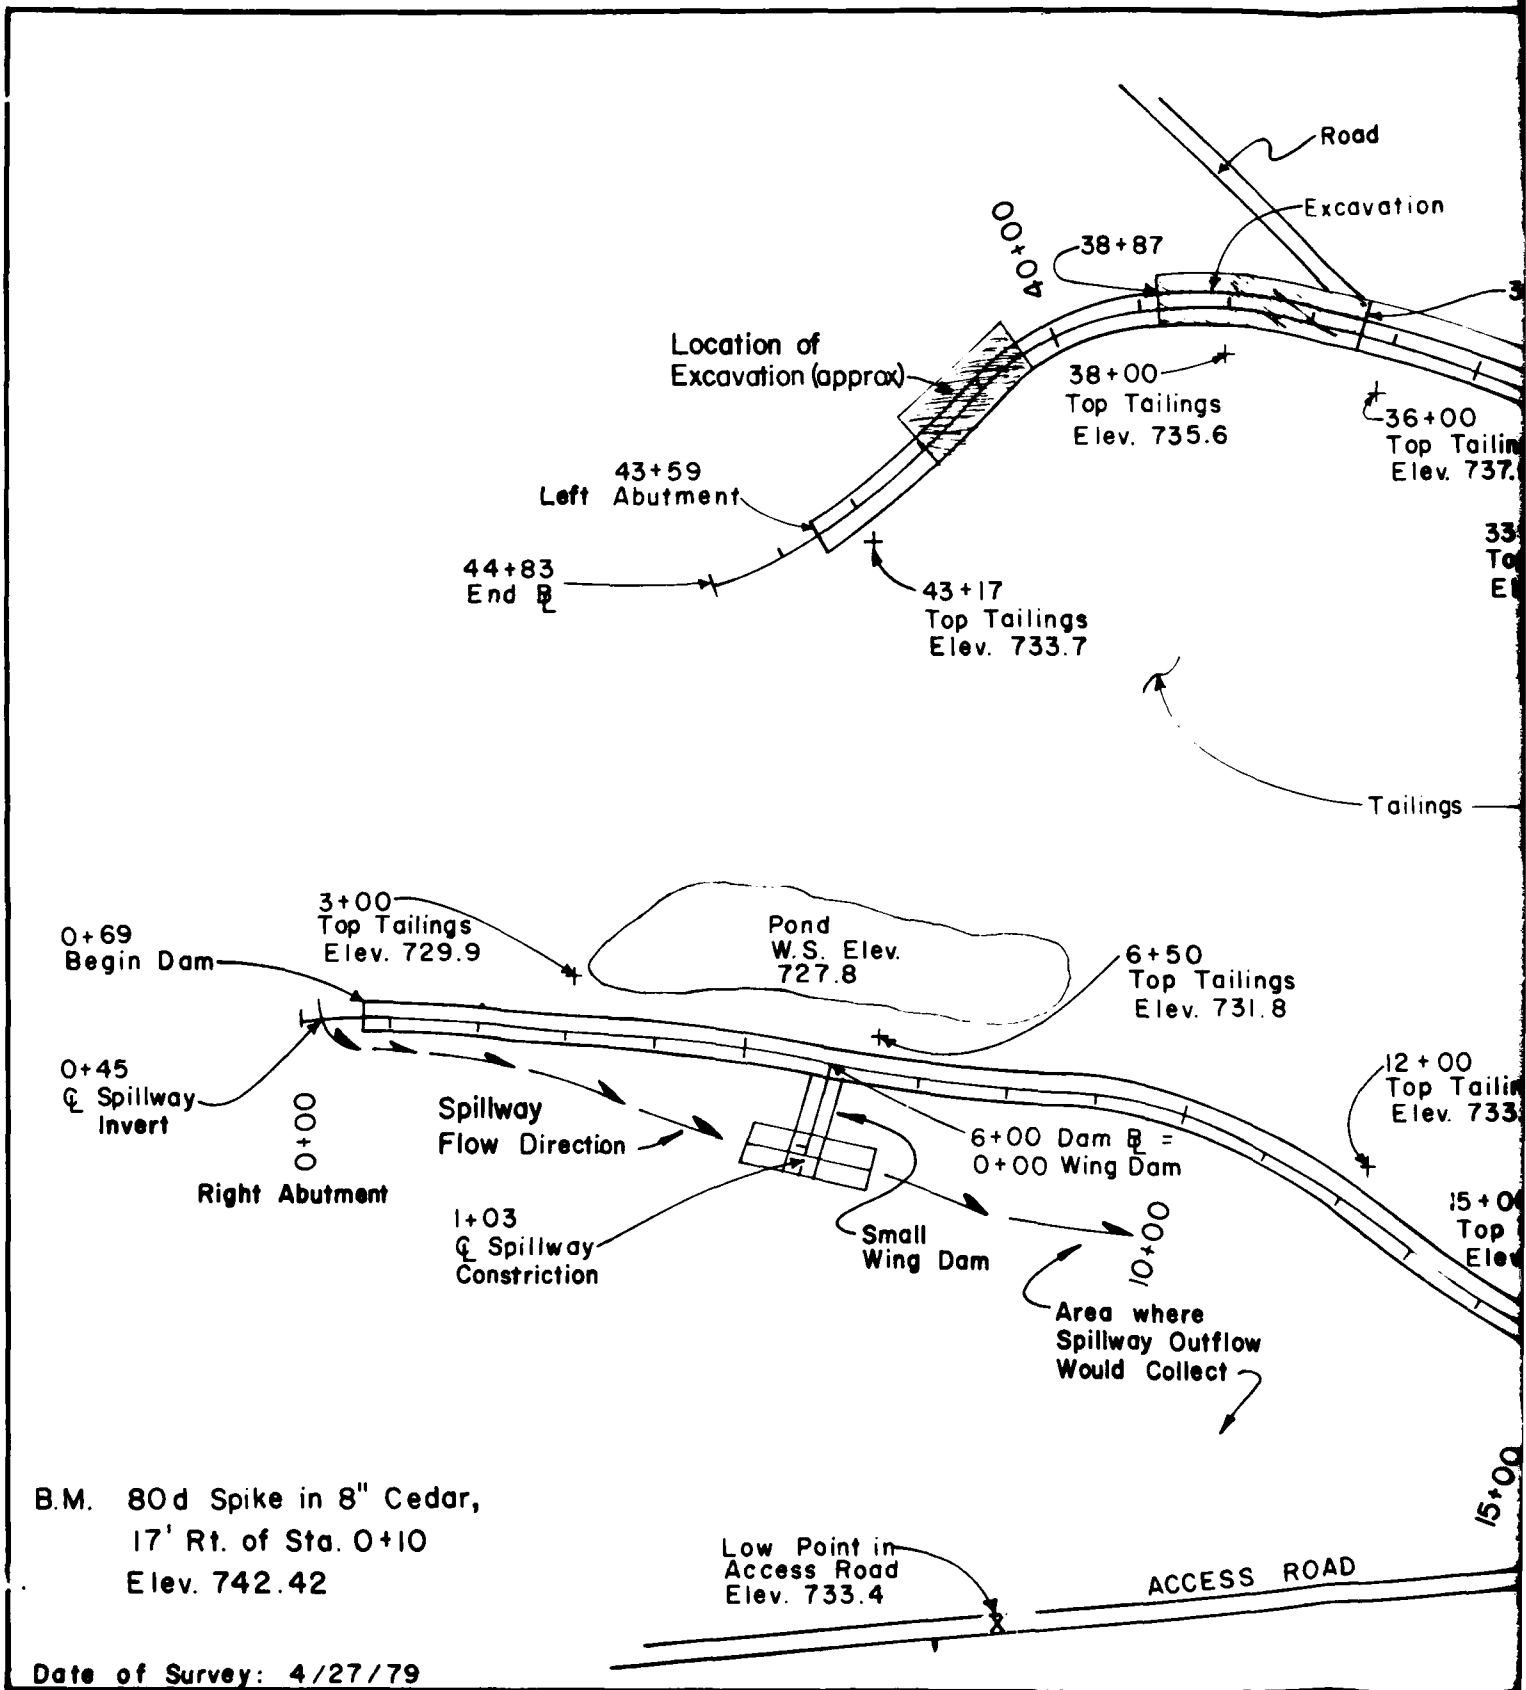
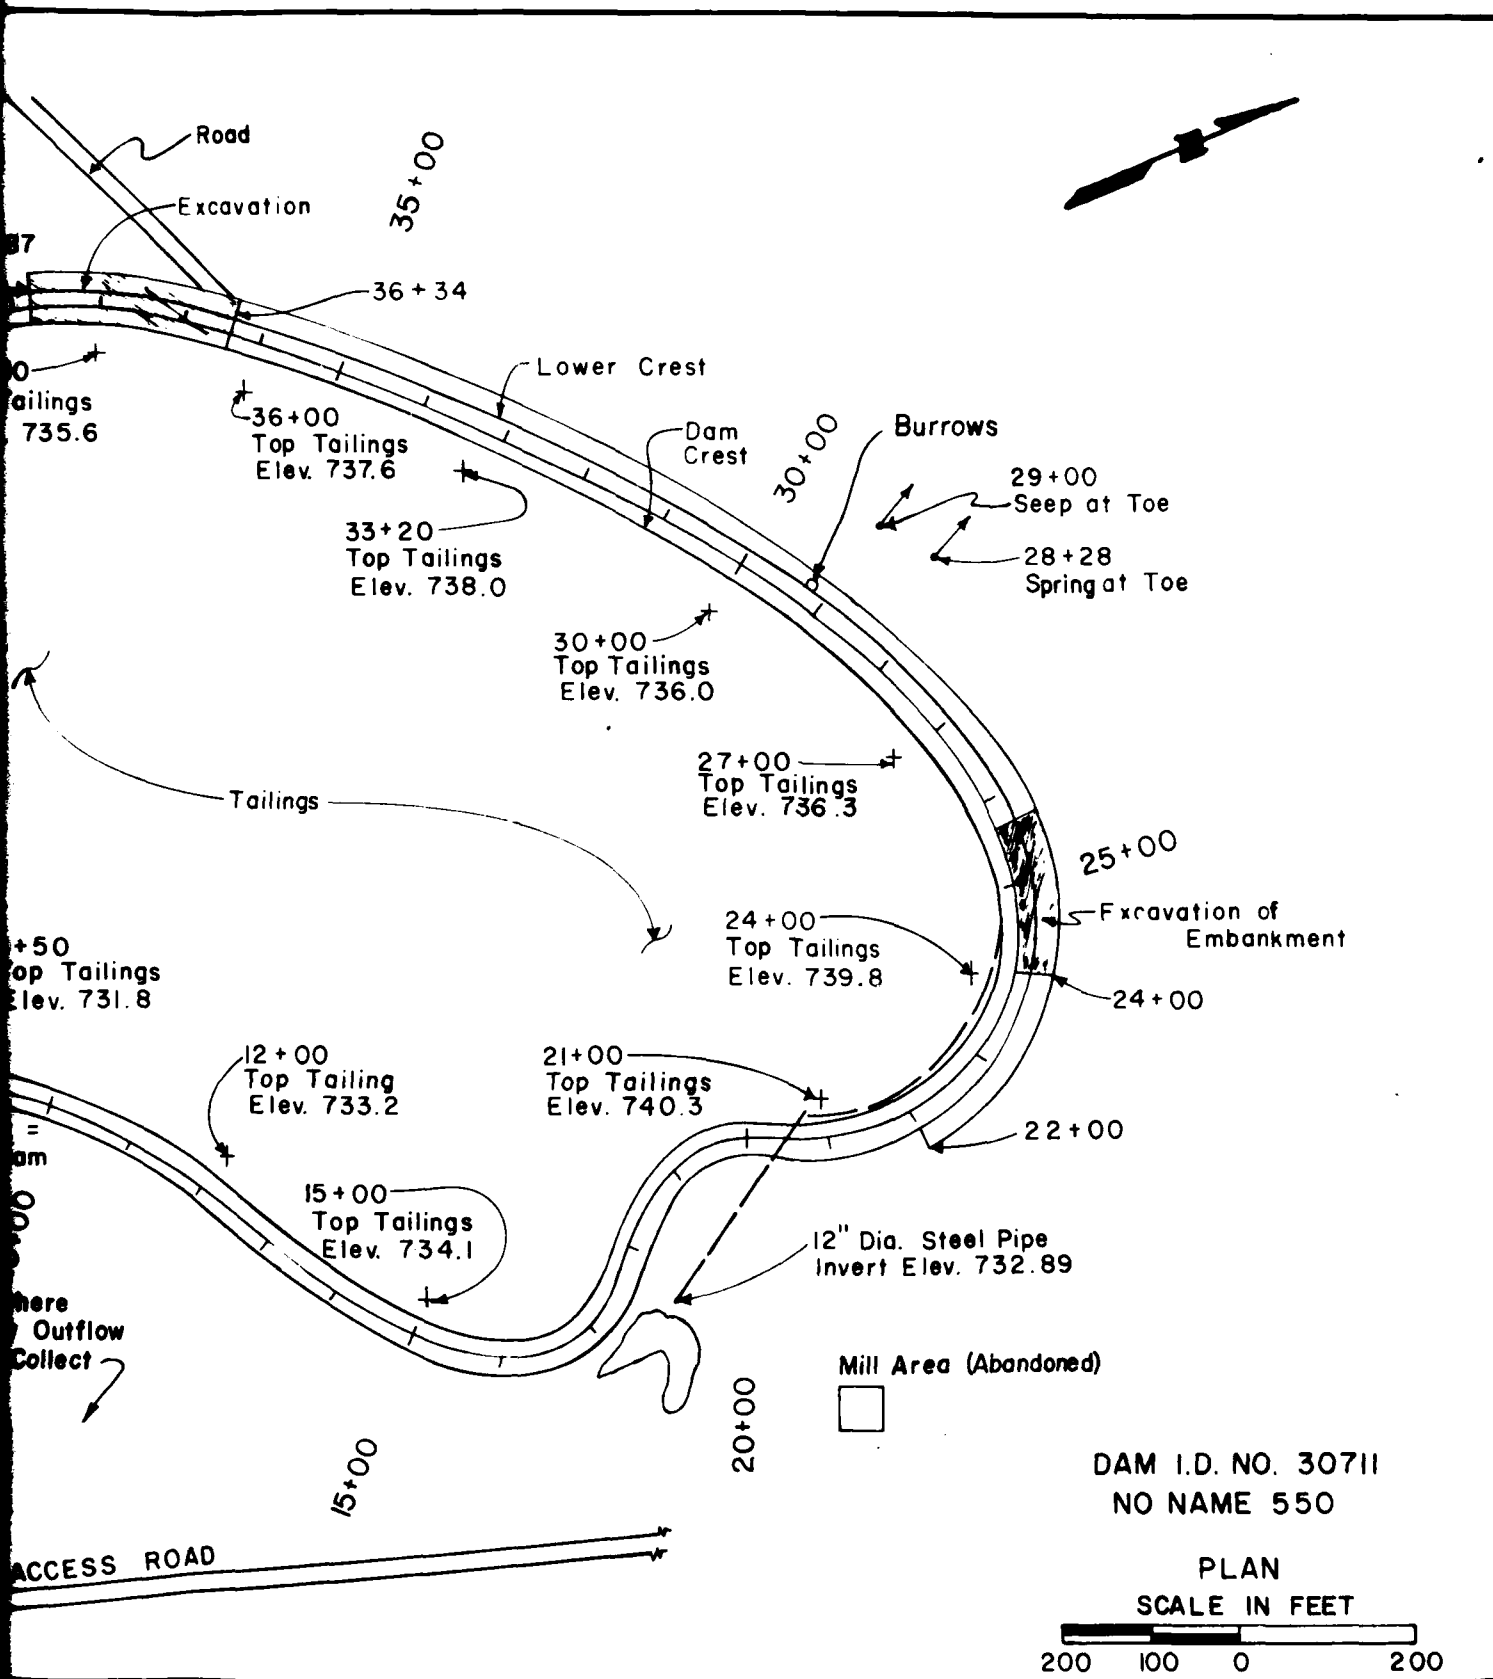
PLATE 3

c. Dam. The plan of the dam is shown on Plate 3. Profiles and sections are shown on Plates 4, 5, 6, and 7. A little vegetation is growing on the slopes of the dam. Some trees were buried during the dam enlargement process, and these were exposed in places on the downstream slope of the dam.

An inactive 12-inch diameter pipe from the mill site enters the embankment at Station 20+60 and extends along the crest in broken sections to Station 25+00. Location of this line is shown on Plate 3. No diversion ditches are located at the damsite.
