CITY LAKE DAM

CASS COUNTY, MISSOURI

**PHASE 1 INSPECTION REPORT
NATIONAL DAM SAFETY INSPECTION**

Name of Dam	City Lake Dam
State Located	Missouri
County Located	Cass County
Stream	Town Creek
Date of Inspection	12 April 1979

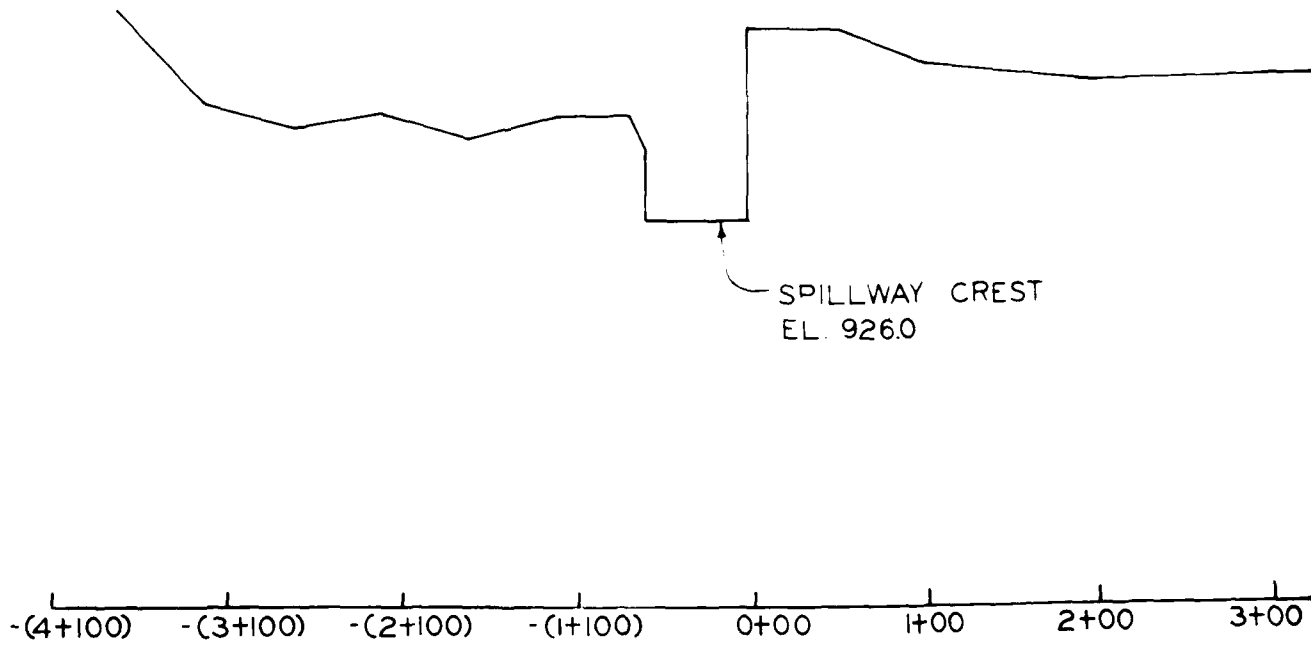
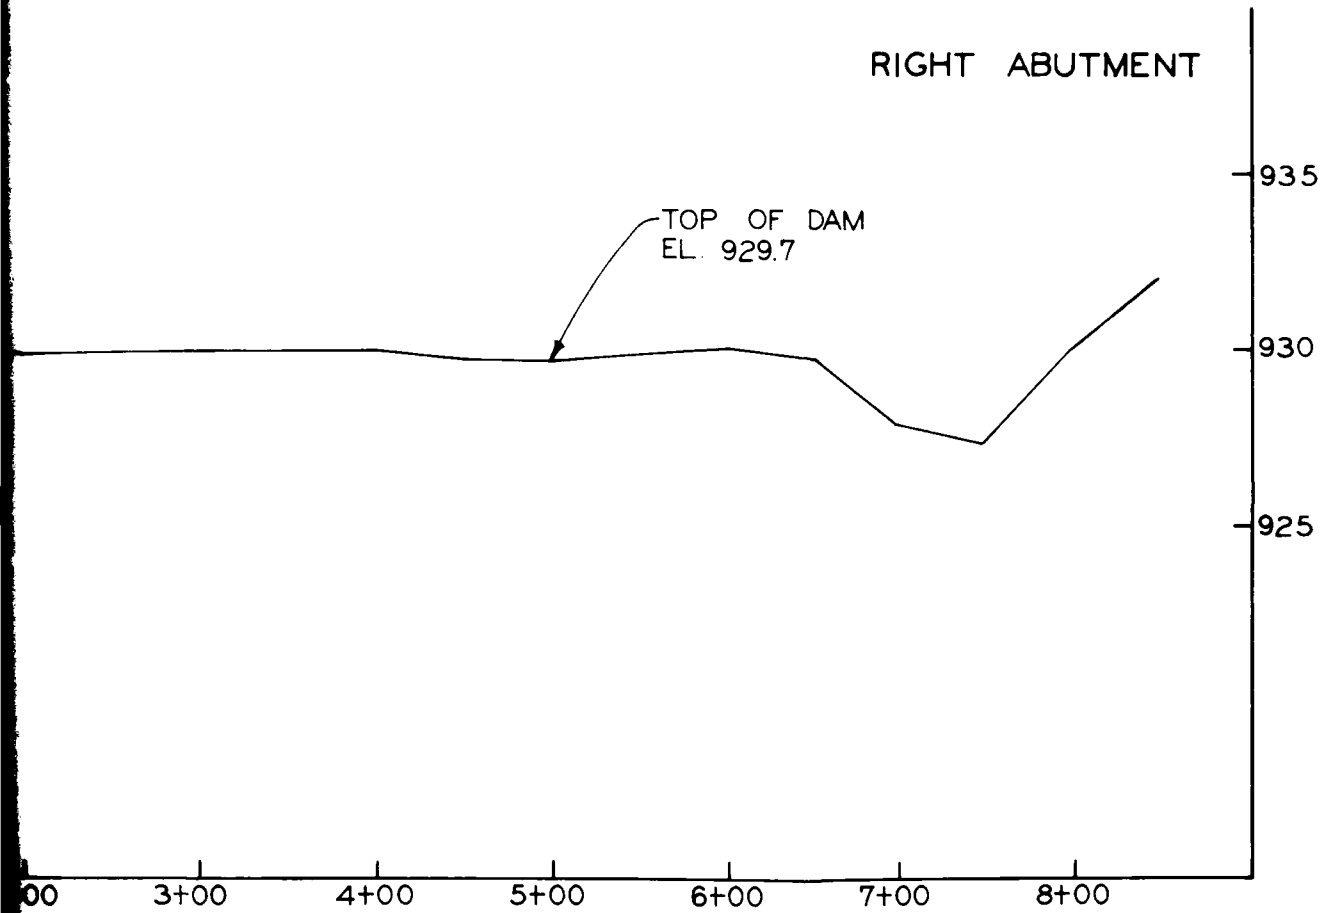
CITY LAKE
LONGITUDINAL
SECTION OF DAM

(3) The abutments at each end of the dam are lower than the dam itself. These low sections will act as emergency spillways in conditions of high inflows (see Plate 4).

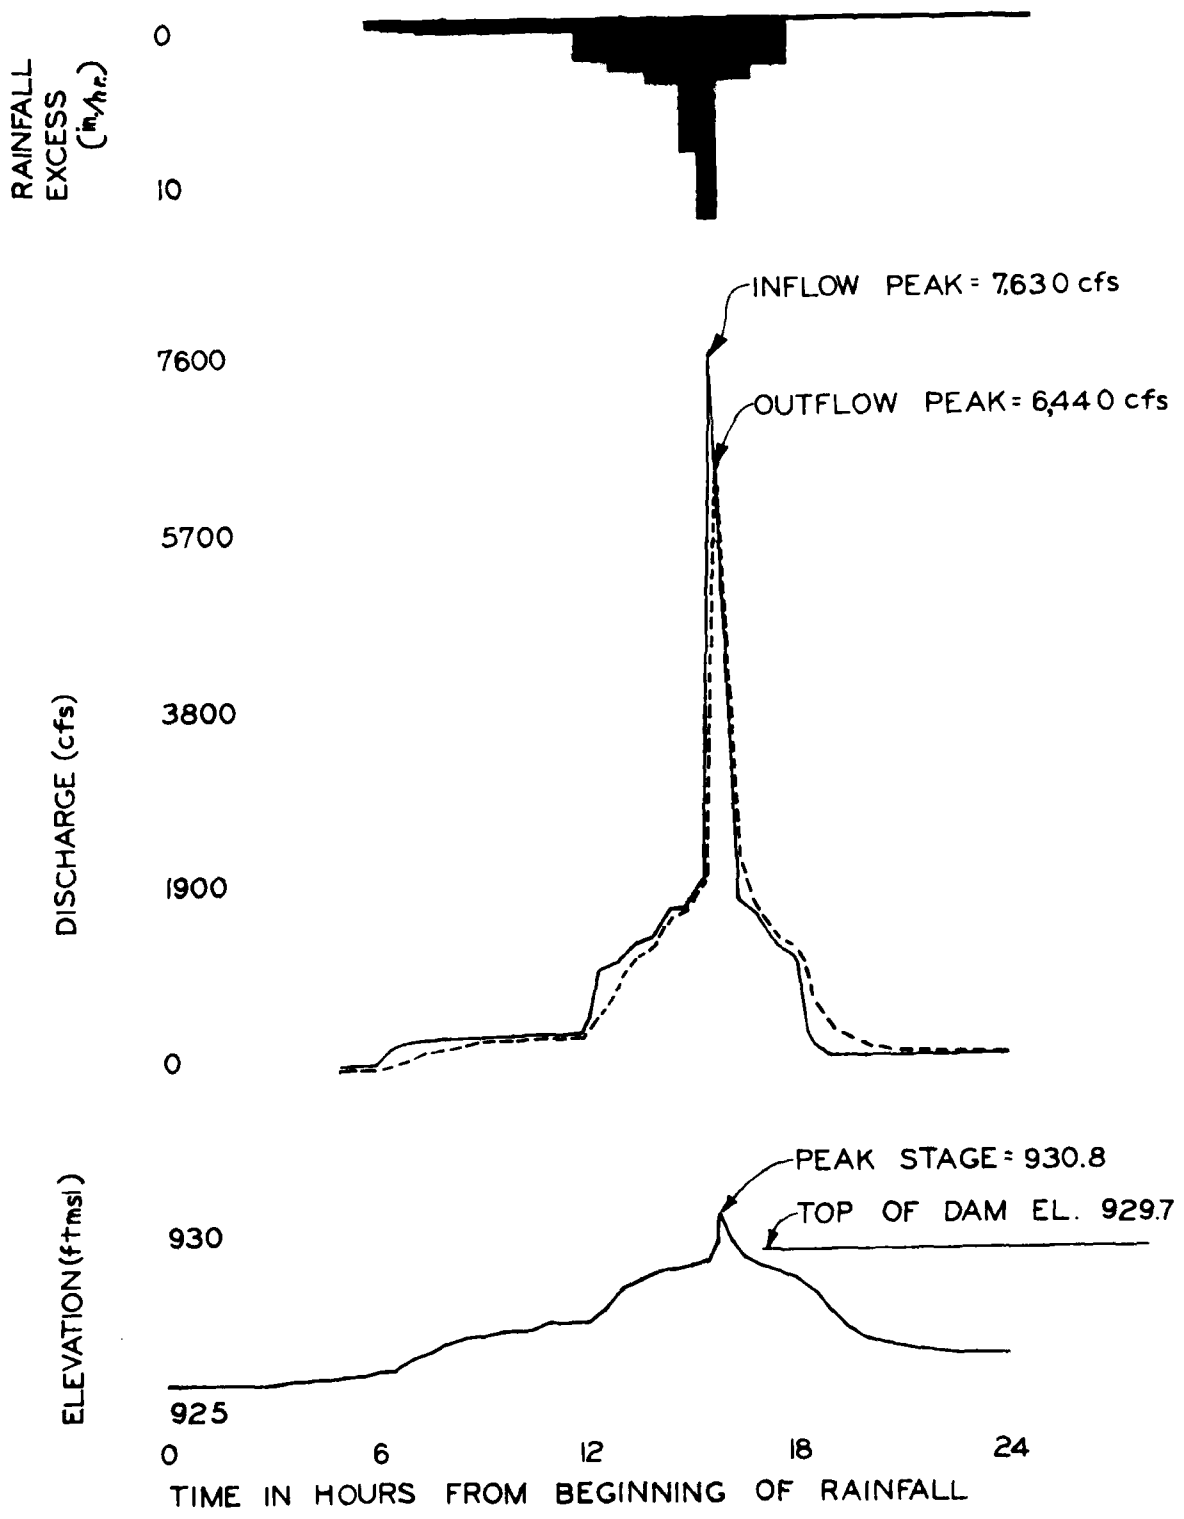
CITY LAKE DAM
 PROBABLE MAXIMUM FLOOD
 HYETOGRAPH, HYDROGRAPH AND
 STAGE-TIME CURVE

4. Floods are routed through the spillway using HEC-1, modified Puls to determine the capability of the spillway. Inflow and outflow hydrographs are shown on Plates A-1, A-2, and A-3.
