BURTON-DUENKE DAM #5  
CAMDEN COUNTY, MISSOURI  
MO 31608

## PHASE 1 INSPECTION REPORT NATIONAL DAM SAFETY PROGRAM

PREPARED BY:  
BLACK & VEATCH  
CONSULTING ENGINEERS  
KANSAS CITY, MISSOURI

APRIL 1981

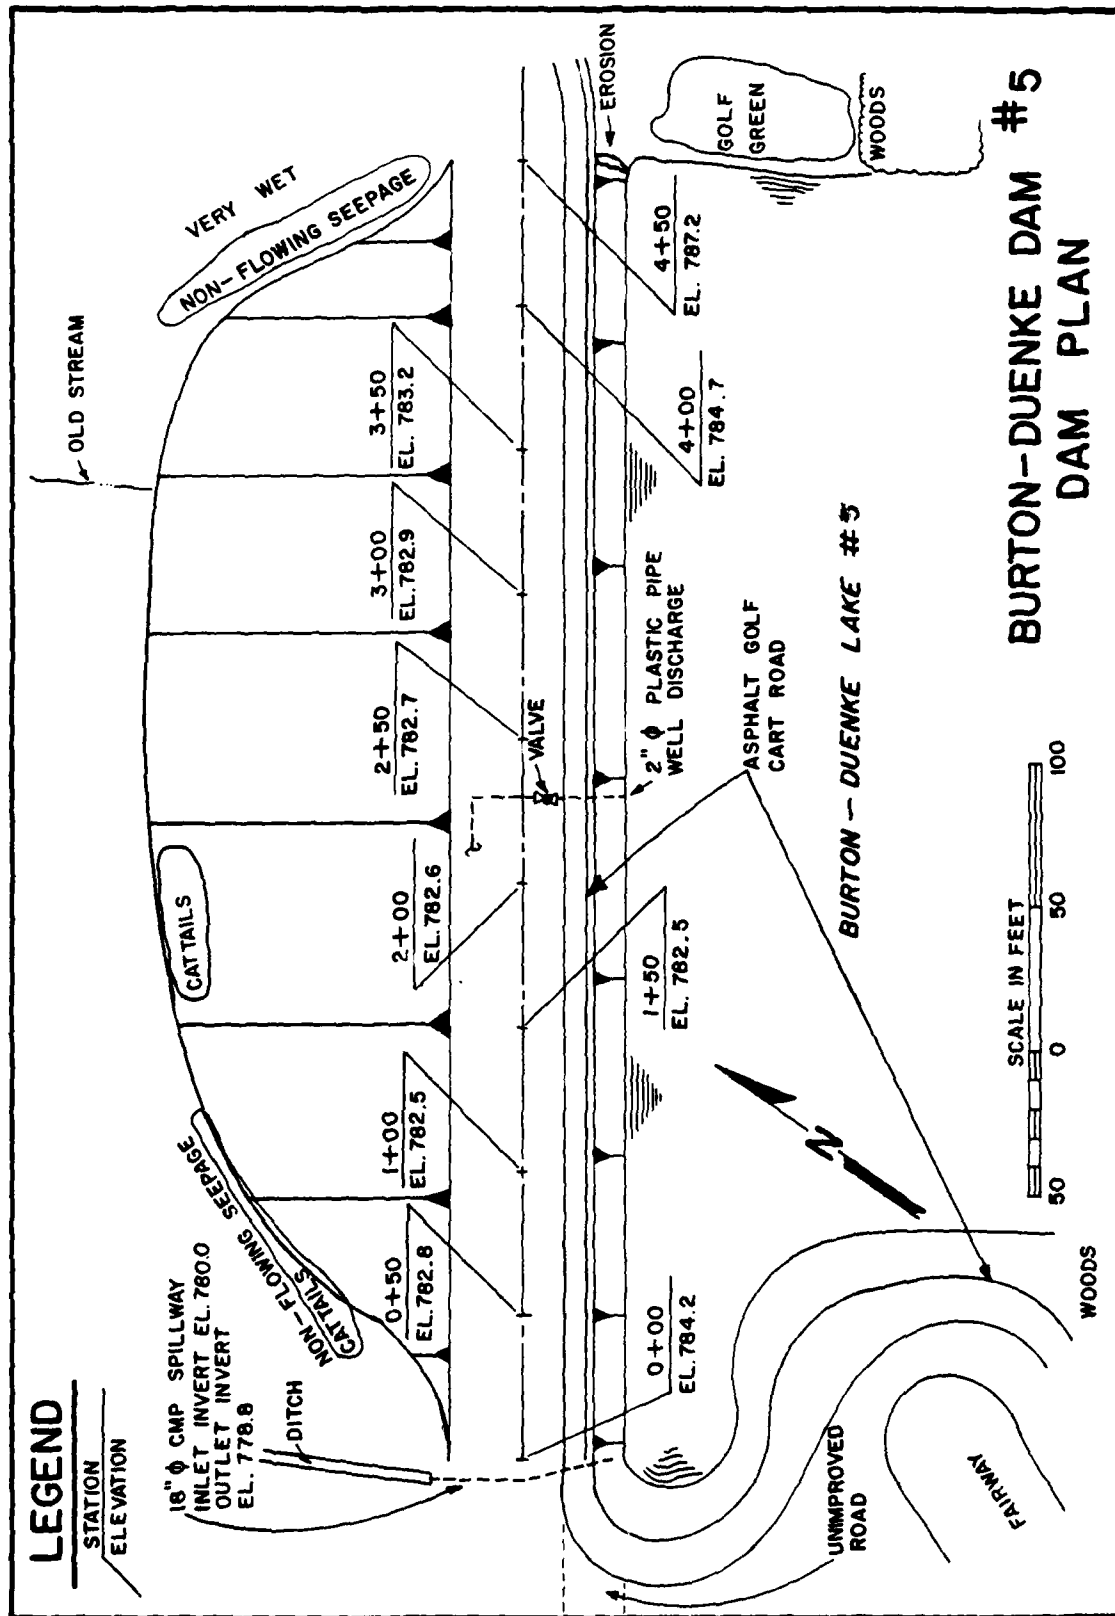
PLATE 3

- (1) Top of dam - 782.5 (see Plate 3)
- (2) Spillway inlet invert - 780.0
- (3) Streambed at toe of dam - 739.1
- (4) Maximum tailwater - Unknown.
