EVALUATION OF MEMBRANE-TYPE MATERIALS FOR STREAMBANK EROSION PROTECTION

MISCELLANEOUS PAPER GL-81-4

Dewey W. White, Jr.

August 1981

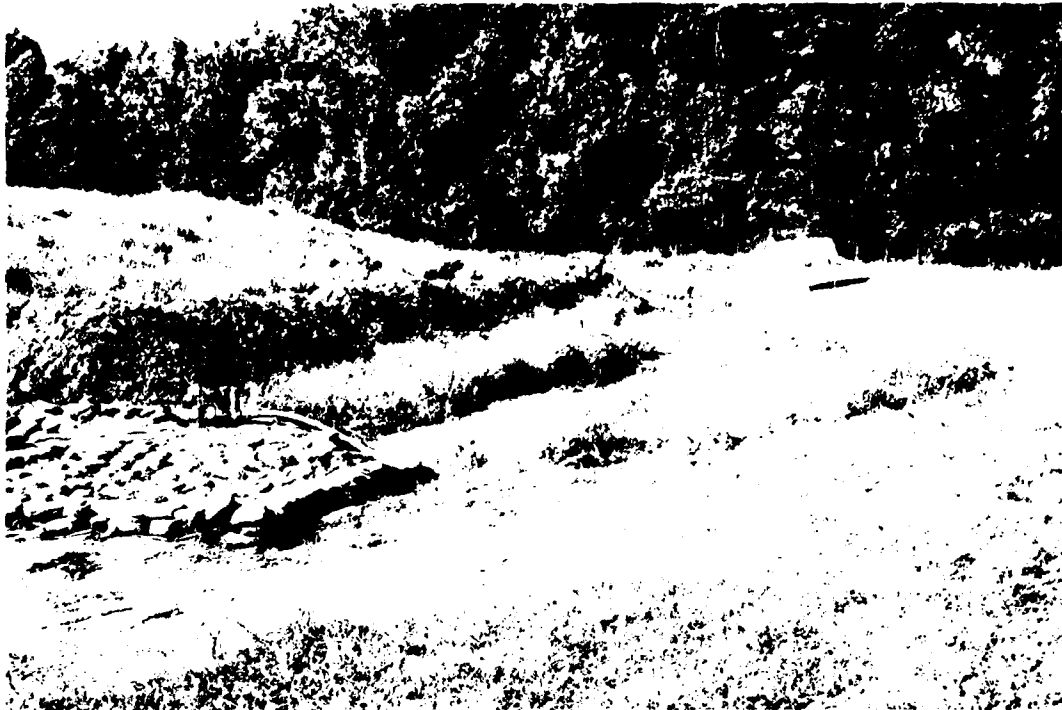
Photo 9. View (looking downstream) of test area after a heavy rain with water between the dams

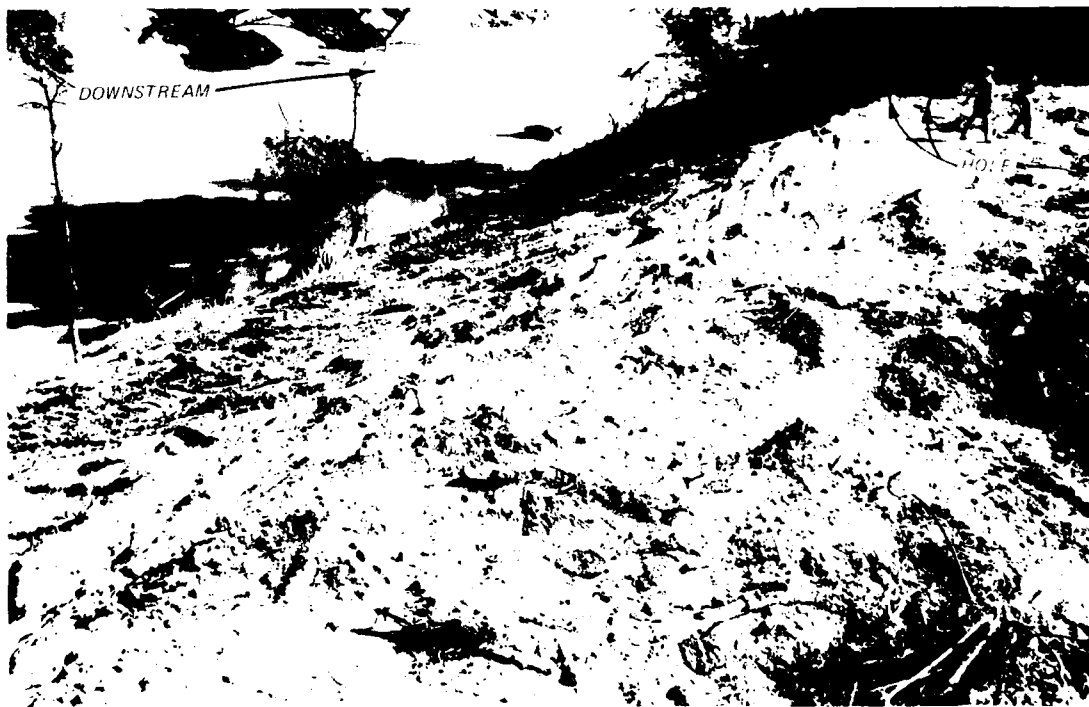
Photo 40. View of bank area with vegetation removed (note hole in bank). This area of bank selected for stepped MESL item (Item 8)

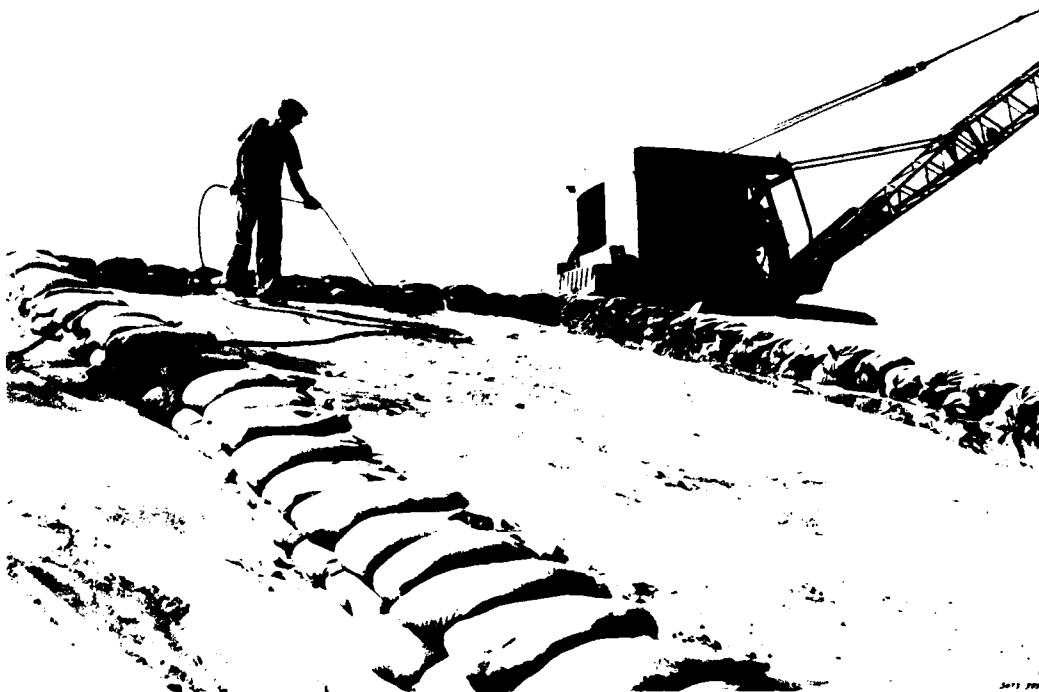
- c. MESL, Item 6. The installation methods used to place this item were similar to those described in paragraph 18c for the MESL item (Item 6) on Durden Creek. However, there were two differences between the methods used on this item and Item 6 on Durden Creek. The form constructed around the periphery (Photo 52) of this item was made with bagged dry concrete mix. After placement, the bags were sprayed with water, and the mix was allowed to cure before the backfill was placed within the form (Photo 53), compacted, and encapsulated with membrane. Edges and ends of the membrane were anchored as shown in Plate 11, sheets 1 and 5. Photo 51 shows the completed test item.

Photo 52. Form constructed of bagged concrete mix on MESL Item 6; bags being sprayed with water to cure mix in bags

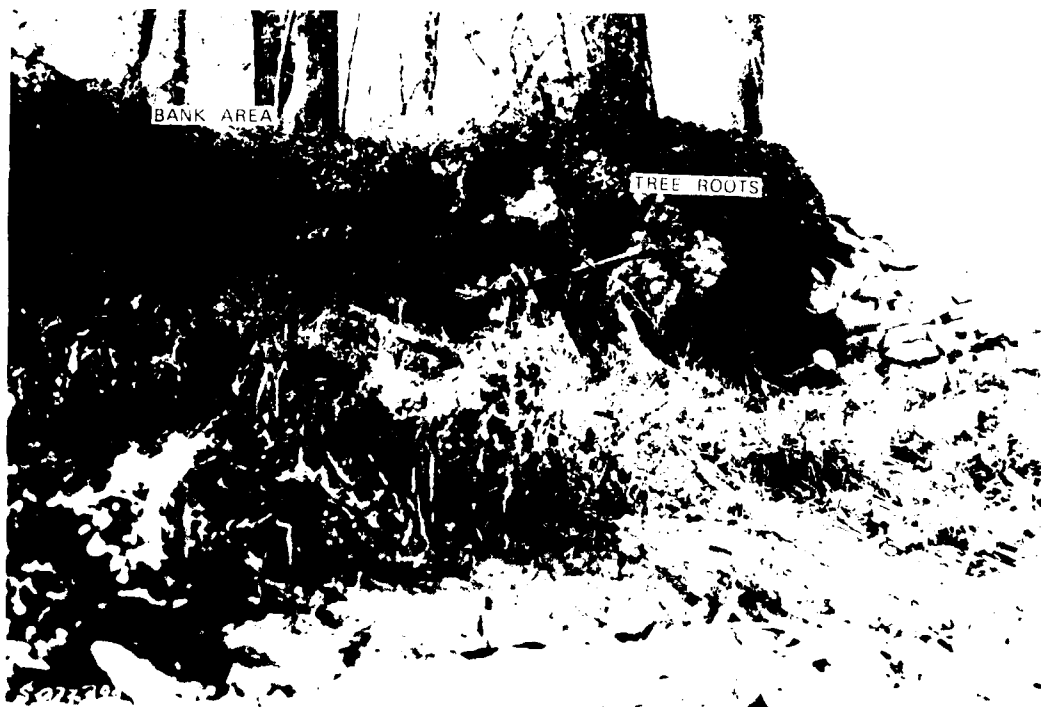
Photo 53. Area just below test Item 8 (note soil around tree roots and bank area had eroded prior to installation of test materials)

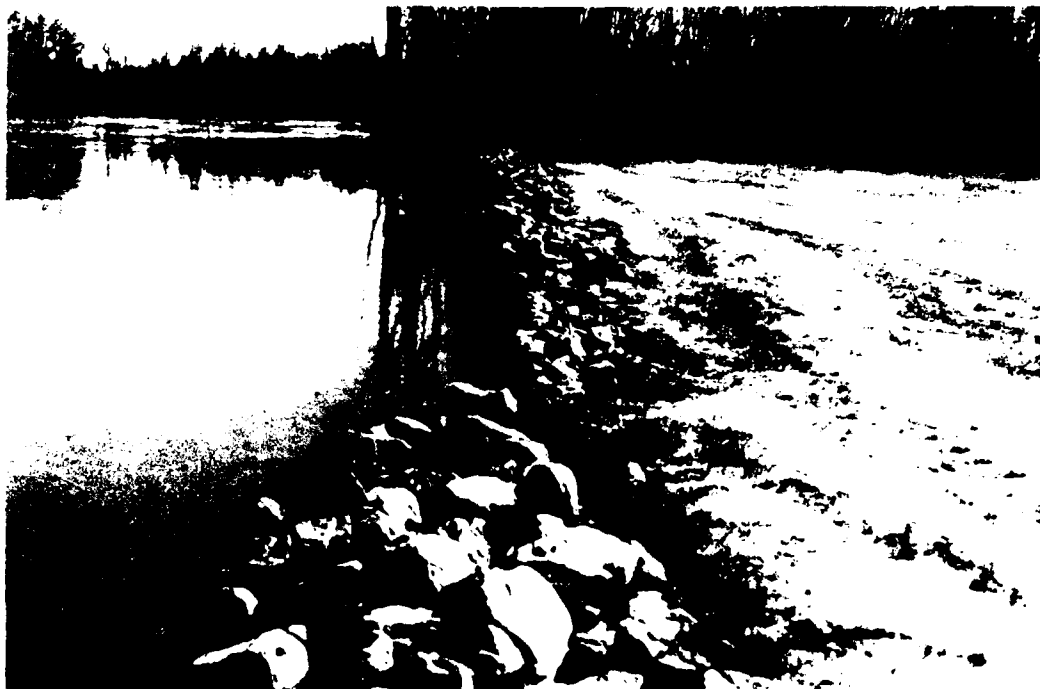
34. In mid-November 1979 (Photo 64) the river began a slow rise with slight fluctuations until the latter part of November, at which time it rose to the top bank during the first week in December (Photo 65). After the peak stage was reached near the top bank, the water level fell slowly until it reached a level between the half bank and the toe of the materials. It fluctuated around this level until 10 January 1980. Large deposits of silt were left on the test materials each time the water level of the river dropped slowly (Photo 66). From this time until the latter part of February, the water level was such that at least 50 percent or more of the test bank was covered with water because of heavy local and upstream rains. During the last week of February 1980, the water level dropped slowly for several days, and then there was a sudden drop of 10.7 ft in 48 hr (Table 3). The water level at this time was below the toe of the materials. Some shifting and sluffing of the bank at the toe of the materials (Photo 67) occurred as well as along the riverbank in areas not associated with the test area (Photos 68 and 69). There was no damage observed to the materials on the test items although the riprap at the toe anchor ditches had shifted.

Photo 65. View looking downriver at water at top bank and covering test area

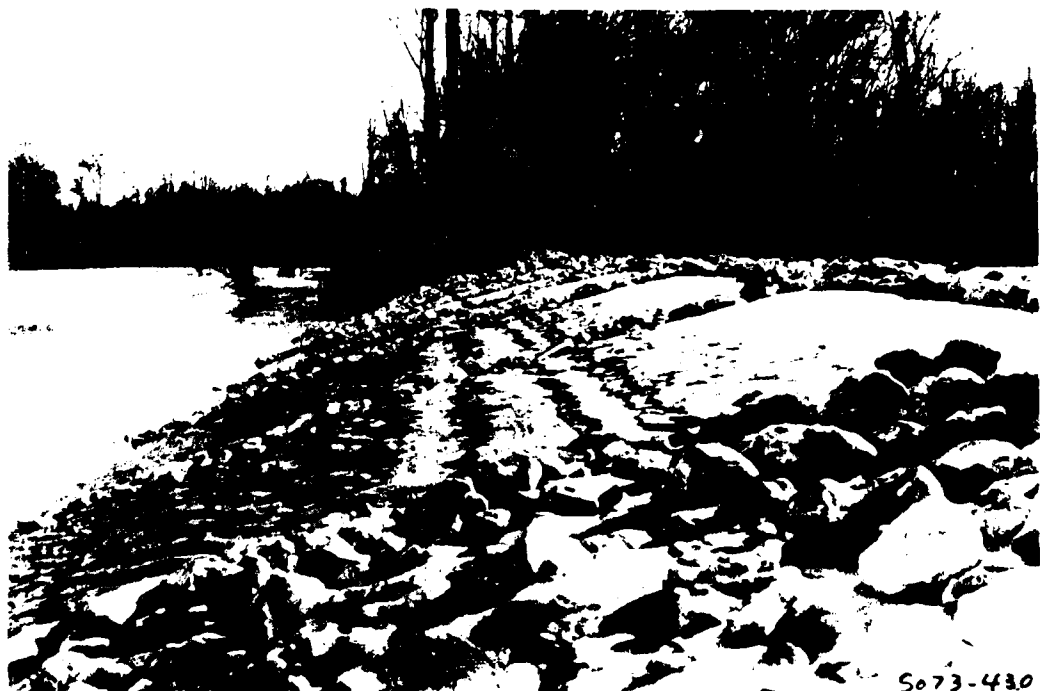
Photo 66. View looking downriver of test items (note large deposits of silt left on materials as water level dropped)

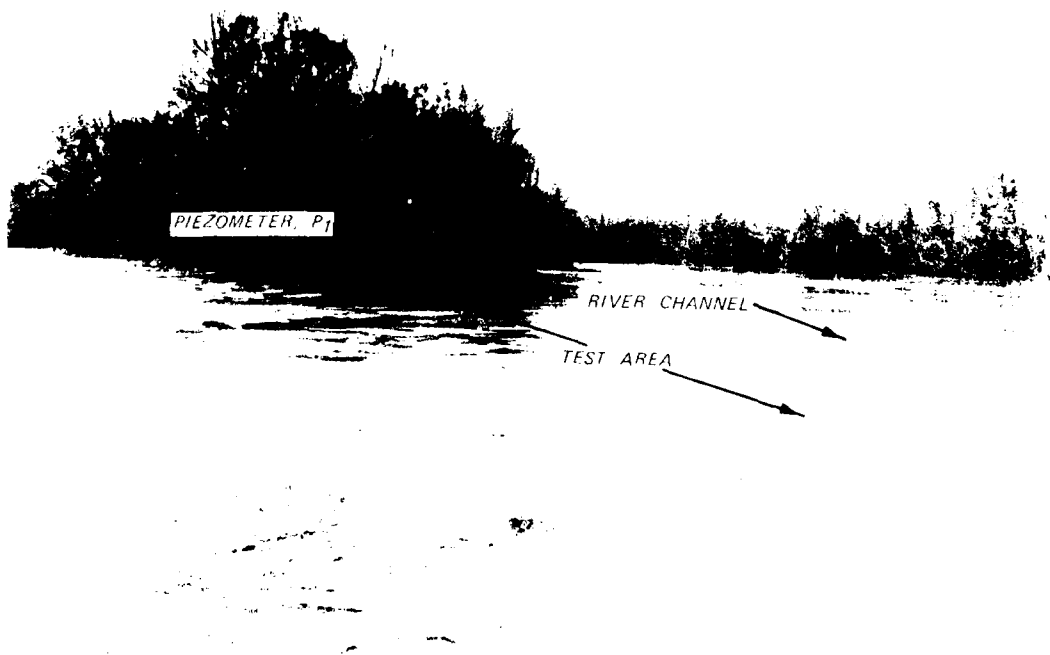
Photo 70. View (looking upriver) of test area covered by 2 ft of water, 31 Mar 1980
