# Sneak Circuit Analysis of F-4C Flight Control System

DOCUMENT NO. D2-118545-1

MODEL NO. F-4C CONTRACT NO. F33657-74-C-0686

SEPTEMBER 17, 1974

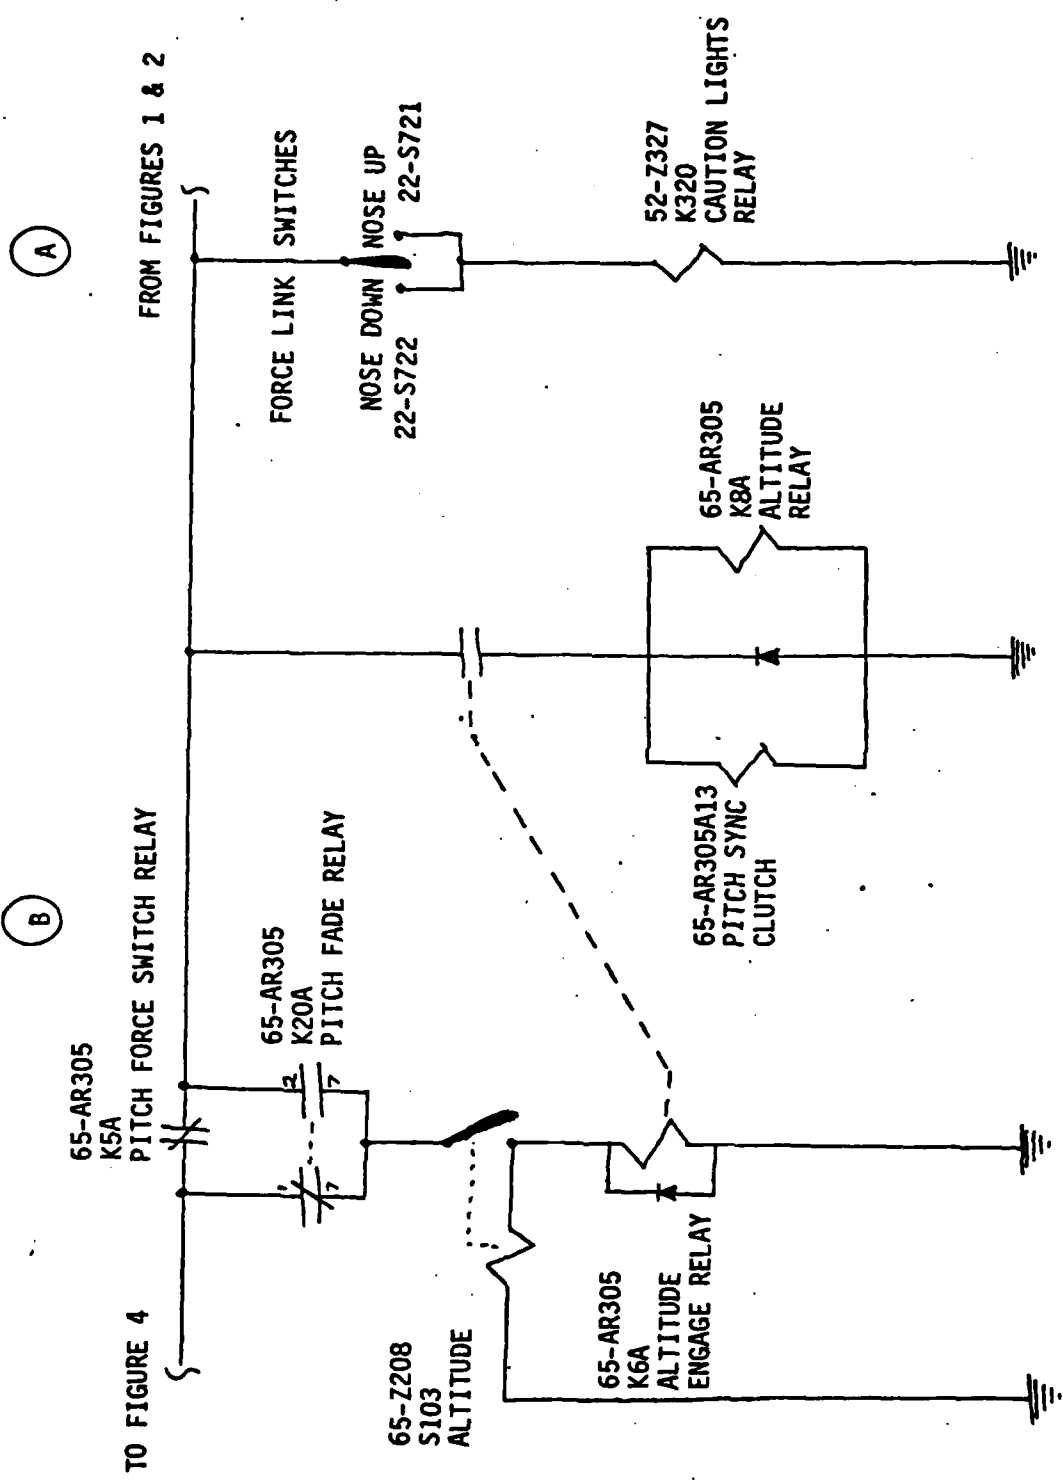
FIGURE 3  
 AFCS RELAY SWITCHING

- Path A. As shown in Figure 3, if one of the 5 pound Warning Light Force Link Switches (22-S721 and 22-S722) is closed, power could be inadvertently fed to the Caution Lights Relay (K320) in ref. des. 52-Z327 which will turn on the A/P Pitch Trim Indicator, giving a false indication.

- Path B. If the Pitch Fade Relay (K20A - not shown) in ref. des. 65-AR305 has been energized so that relay contacts 2 and 7 in Figure 3 are closed, or if neither K20A nor the Pitch Force Switch Relay (K5A) in ref. des. 65-AR305 has been energized, a path will be established to the Altitude Switch (S103) in ref. des. 65-Z208. If it is depressed, it will activate its holding coil and the Altitude Engage Relay (K6A) in ref. des. 65-AR305. This will close the K6A relay contacts, allowing current to flow to the Pitch Sync Clutch in ref. des. 65-AR305A13 and to the Altitude Relay (K8A) in ref. des. 65-AR305. This will enable the Altitude Hold Circuitry even though AFCS is disengaged.

- Path E. As shown in figure 5, if the FWD or AFT Pitch Force Switch (S202) in ref. des. 65-MT223 is thrown, the Pitch Force Relay (K5A) may be energized. If it energizes, it would cause relay chatter since its contacts in figure 3 are between it and the power source.

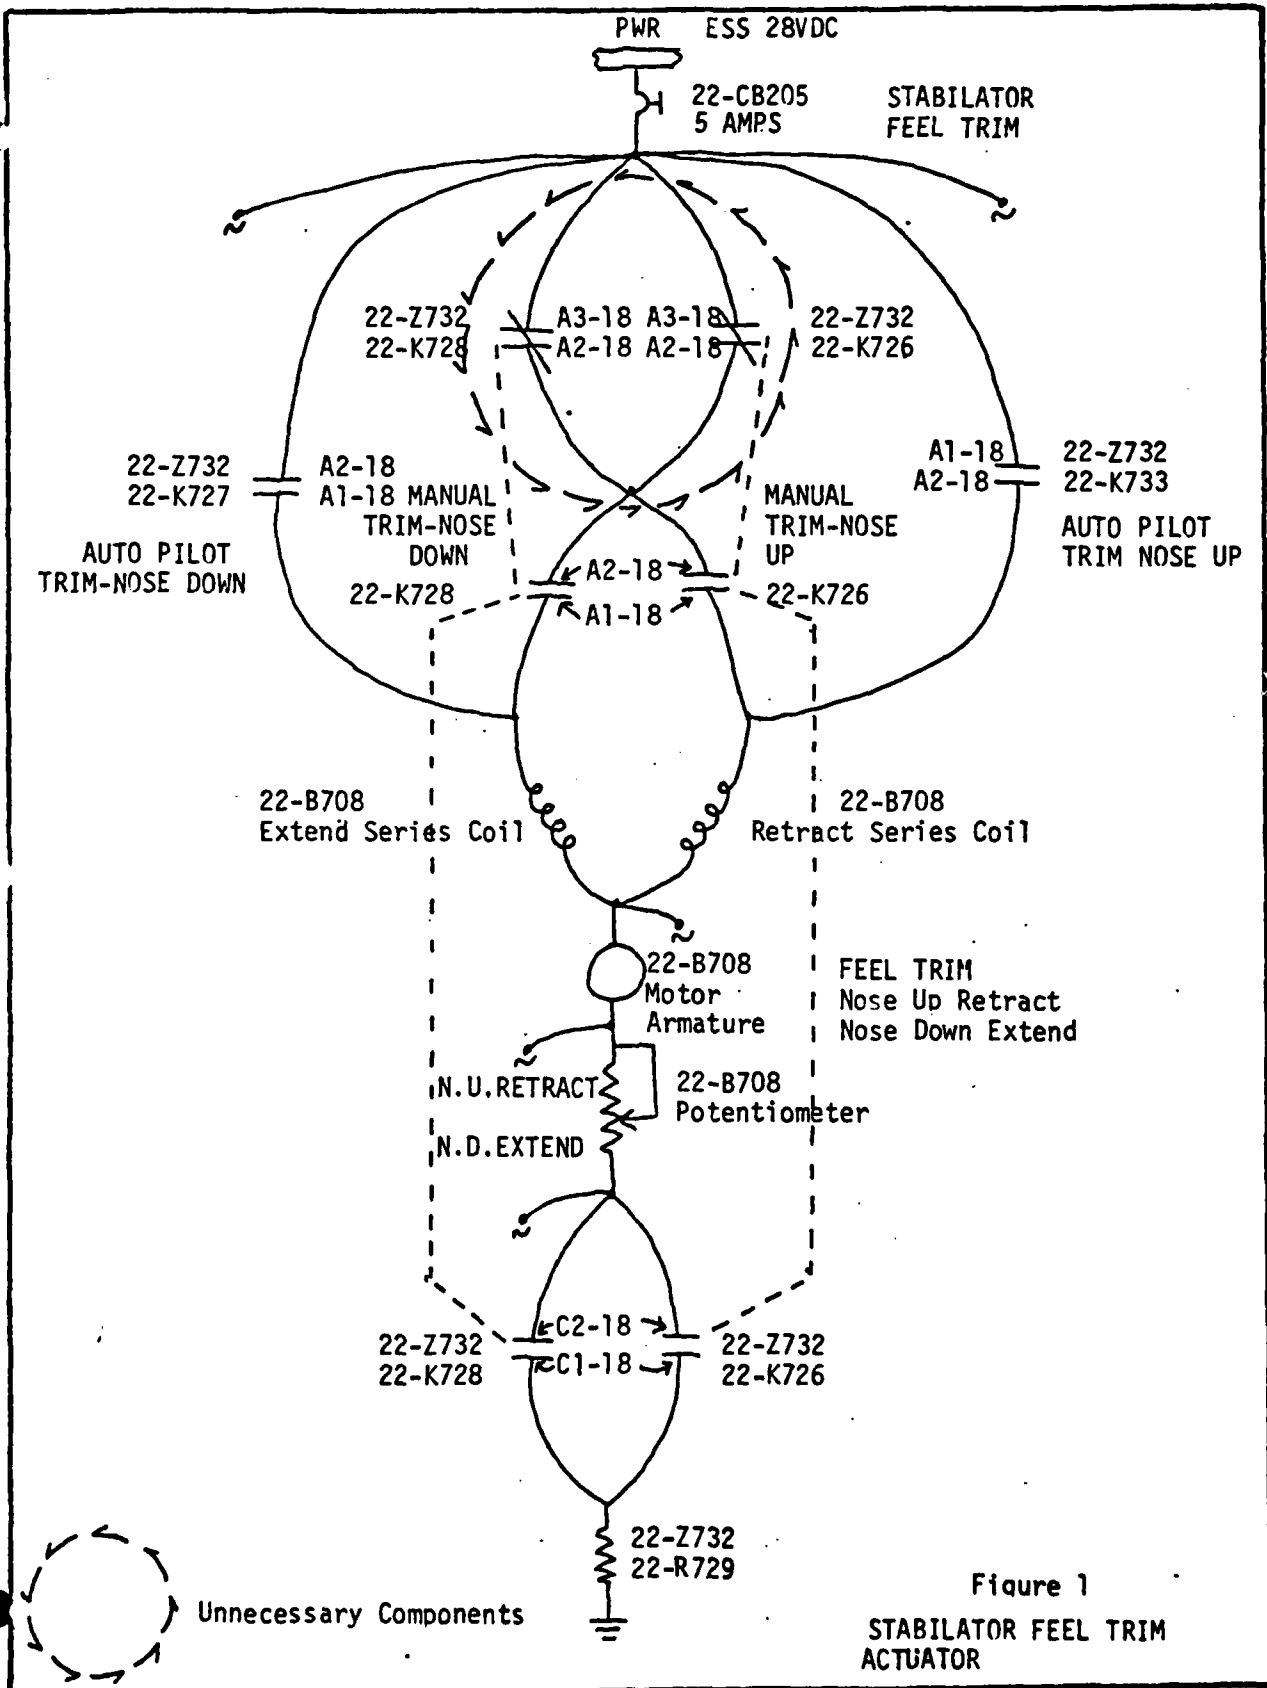
Figure 1  
STABILATOR FEEL TRIM  
ACTUATOR

The Manual Trim-Nose Up Relay (22-K726) and the Manual Trim-Nose Down Relay (22-K728), shown in Figure 1, cannot be energized at the same time. Therefore, the normally closed contacts (A3-18/A2-18) of either 22-K726 or 22-K728 will provide continuity from Circuit Breaker 22-CB205 to the normally open contacts (A2-18/A1-18) of 22-K726 and 22-K728.

Delete the normally closed contacts (A3-18/A2-18) of 22-K726 and 22-K728 and replace them with continuity.

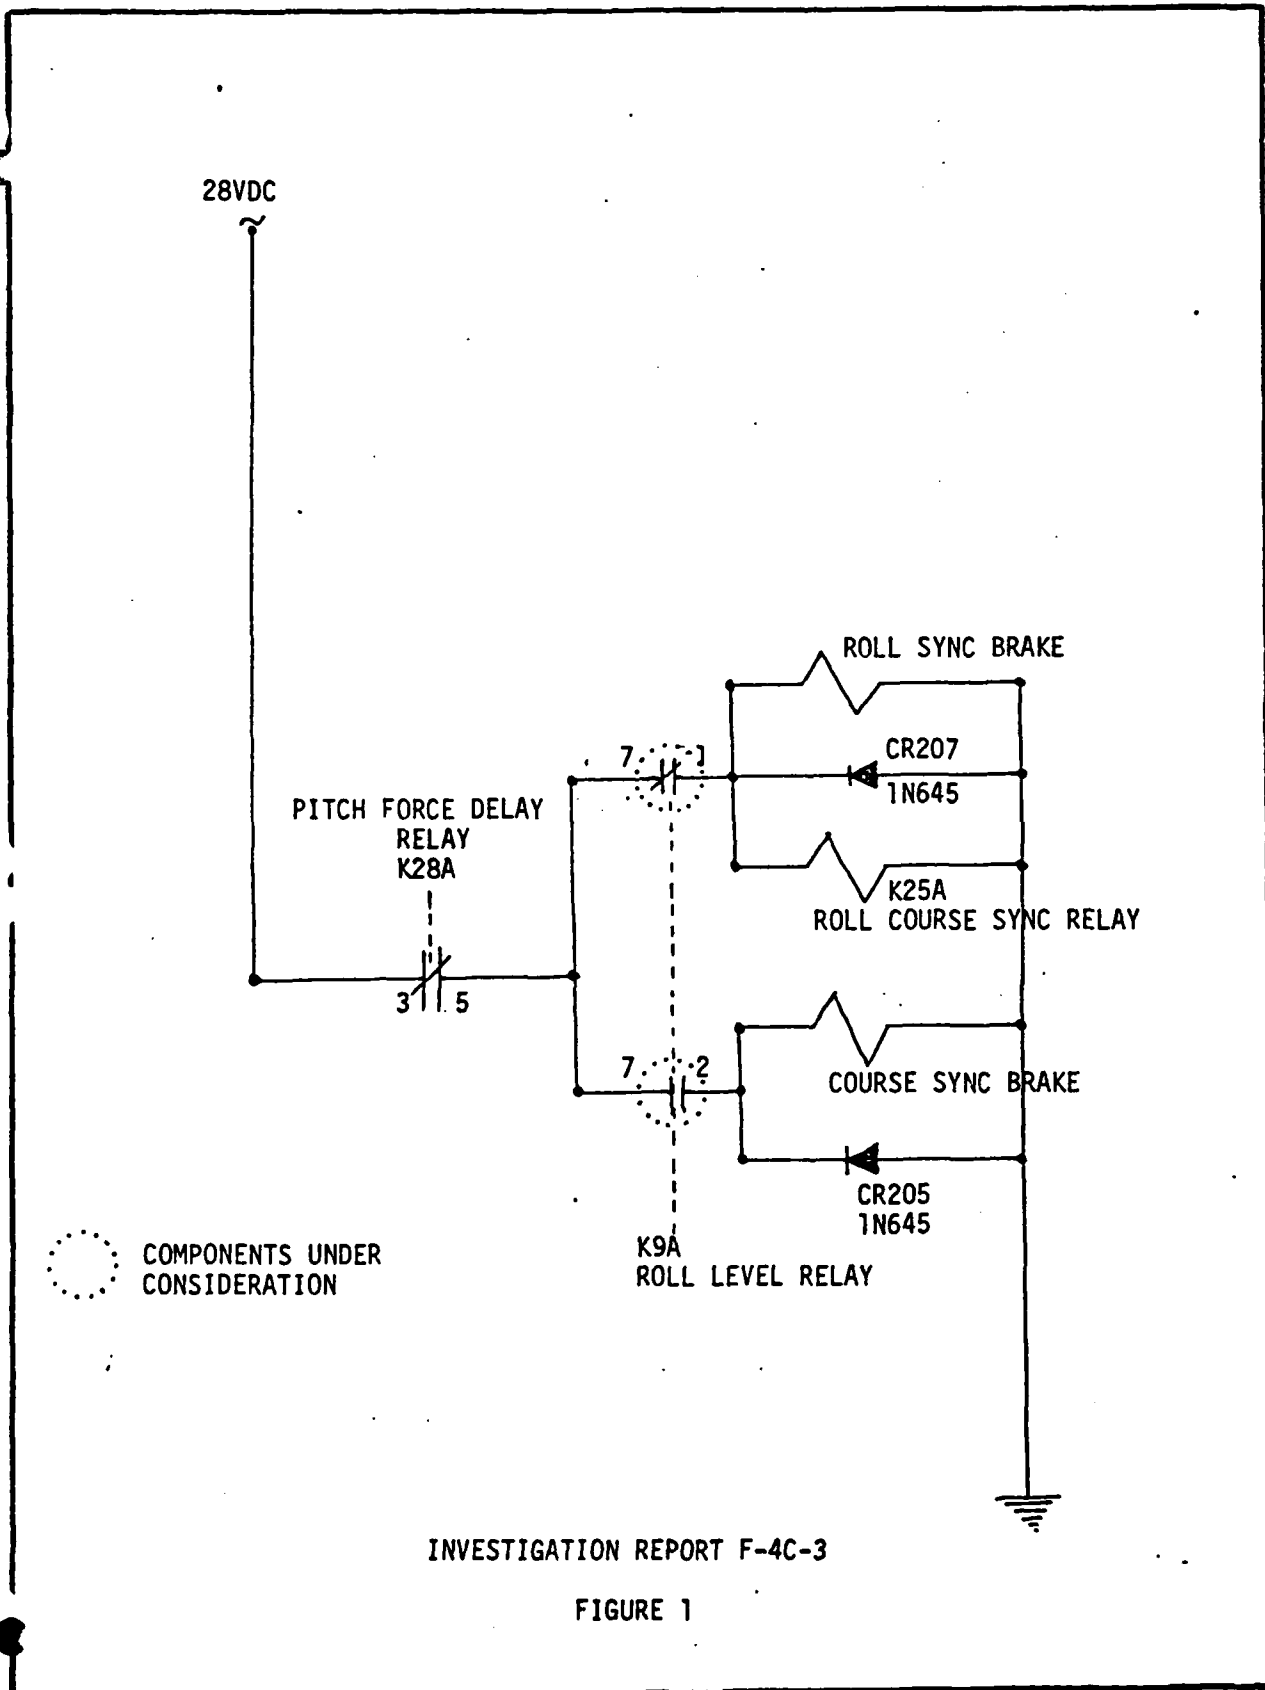
If the 1-7 contact of K9A hangs open (the 2-7 contact then being closed), power cannot be applied to the Roll Course Sync Relay (K25A) and the Roll Sync Brake (see figure 1). The Roll Sync Brake is used to establish a roll attitude for the autopilot. With it disabled, a bank angle cannot be maintained by the autopilot, however it can still hold the aircraft on a course heading.

If the 2-7 contact of K9A hangs open (the 1-7 contact then being closed), power cannot be applied to the Course Sync Brake (see figure 1). Therefore the established course cannot be maintained by the autopilot. The heading hold aspect of the AFCS is lost.

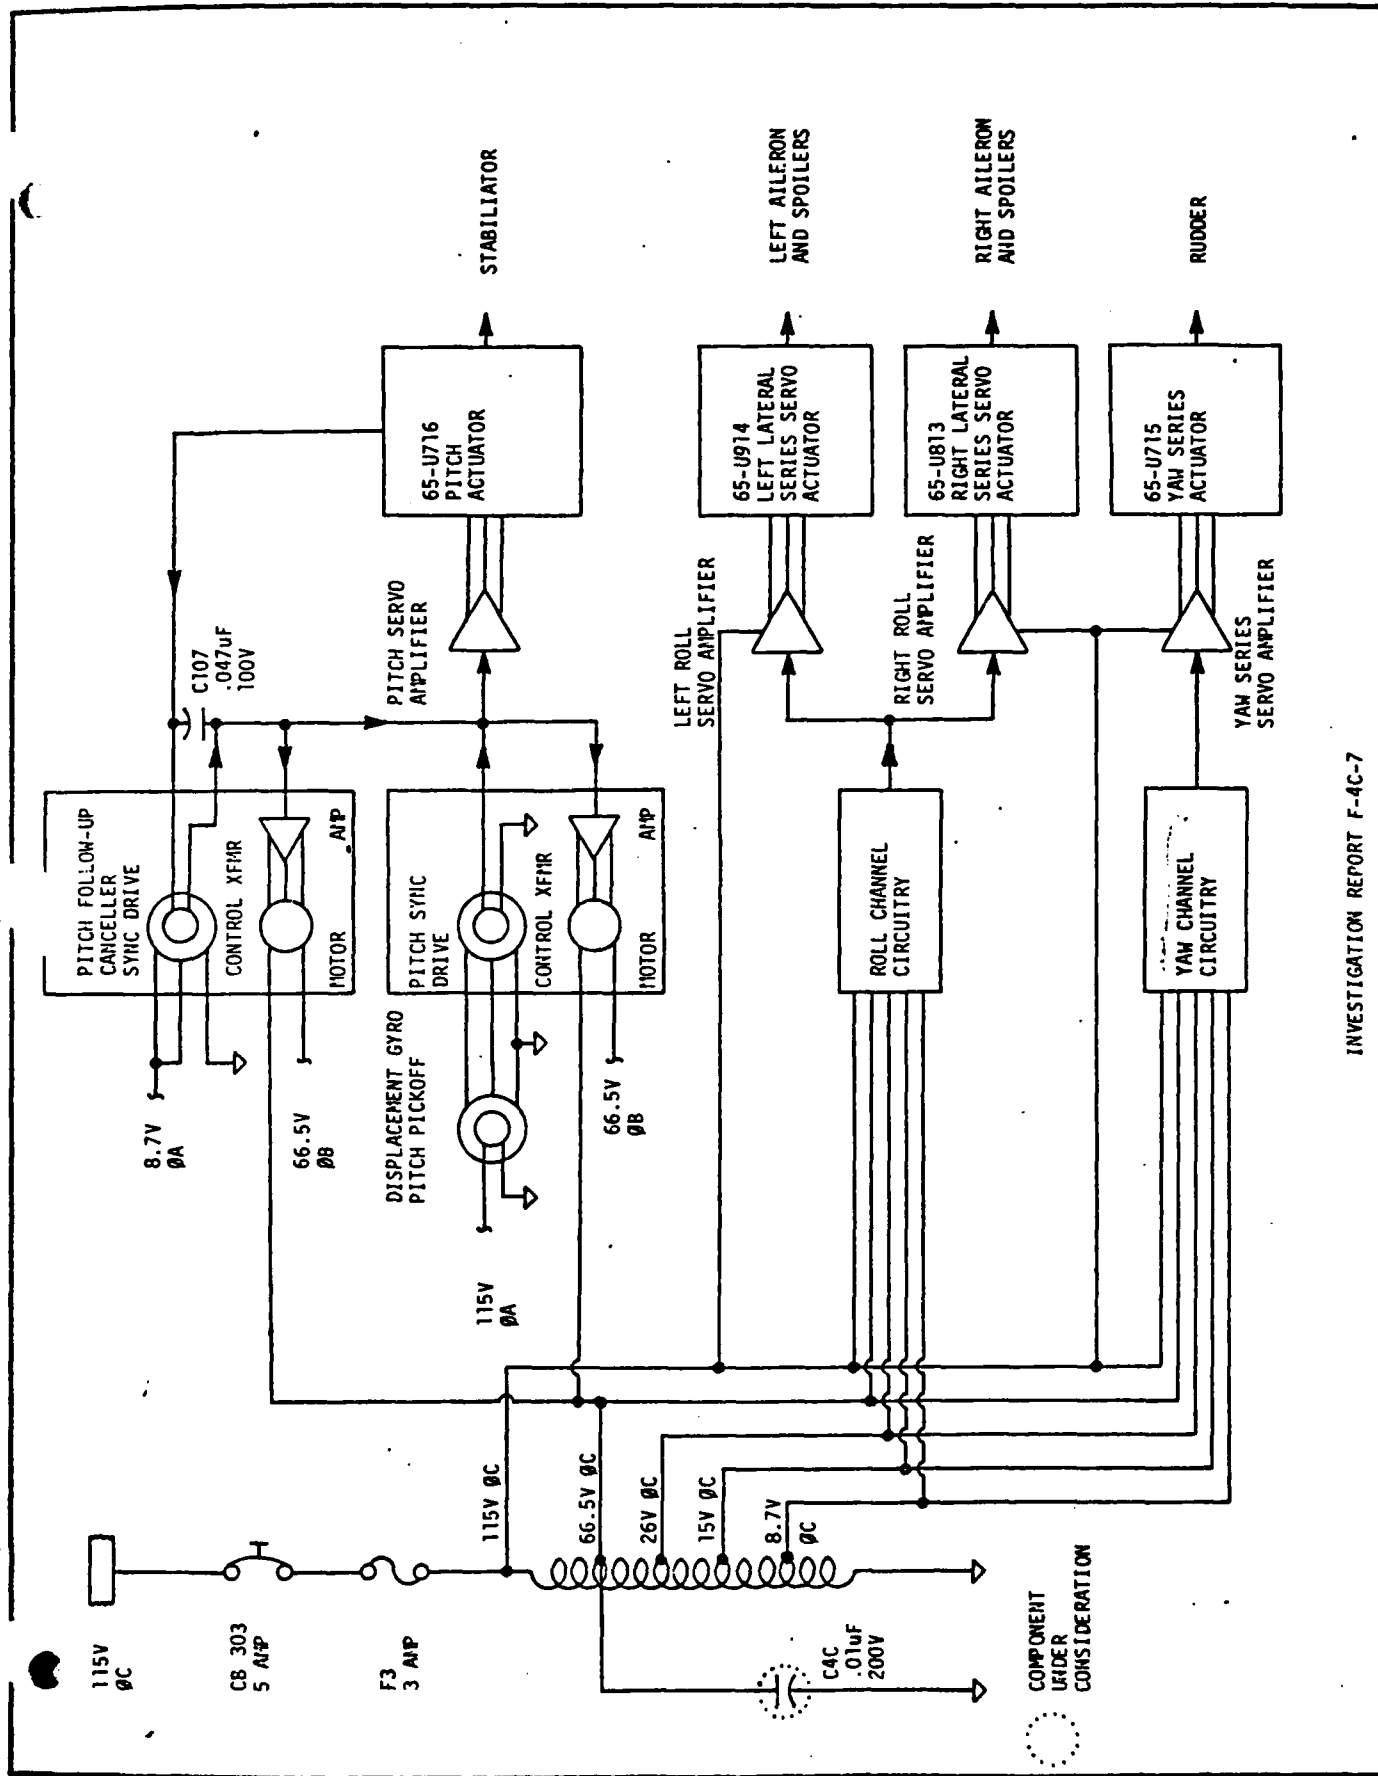
Phase C also provides power to the fixed phase windings of the Pitch Sync Drive and Pitch Follow-up Canceller Sync Drive motors. The pitch attitude at the time of capacitor C4C failure becomes the reference attitude for the pitch channel of the AFCS. If the aircraft is not at this attitude, the AFCS cannot be engaged. If it is, the AFCS can be engaged, but the attitude will not be maintained since the Pitch Follow-up Canceller Sync Drive will be unable to create artificial stabilator null positions to compensate for fuel consumption, stores release, etc. As these slow changes occur, the aircraft will gradually drift off its pitch reference attitude.

The result of a C4C capacitor failure is, therefore, total loss of the yaw and roll autopilot channels and for all practical purposes loss of the pitch autopilot channel.

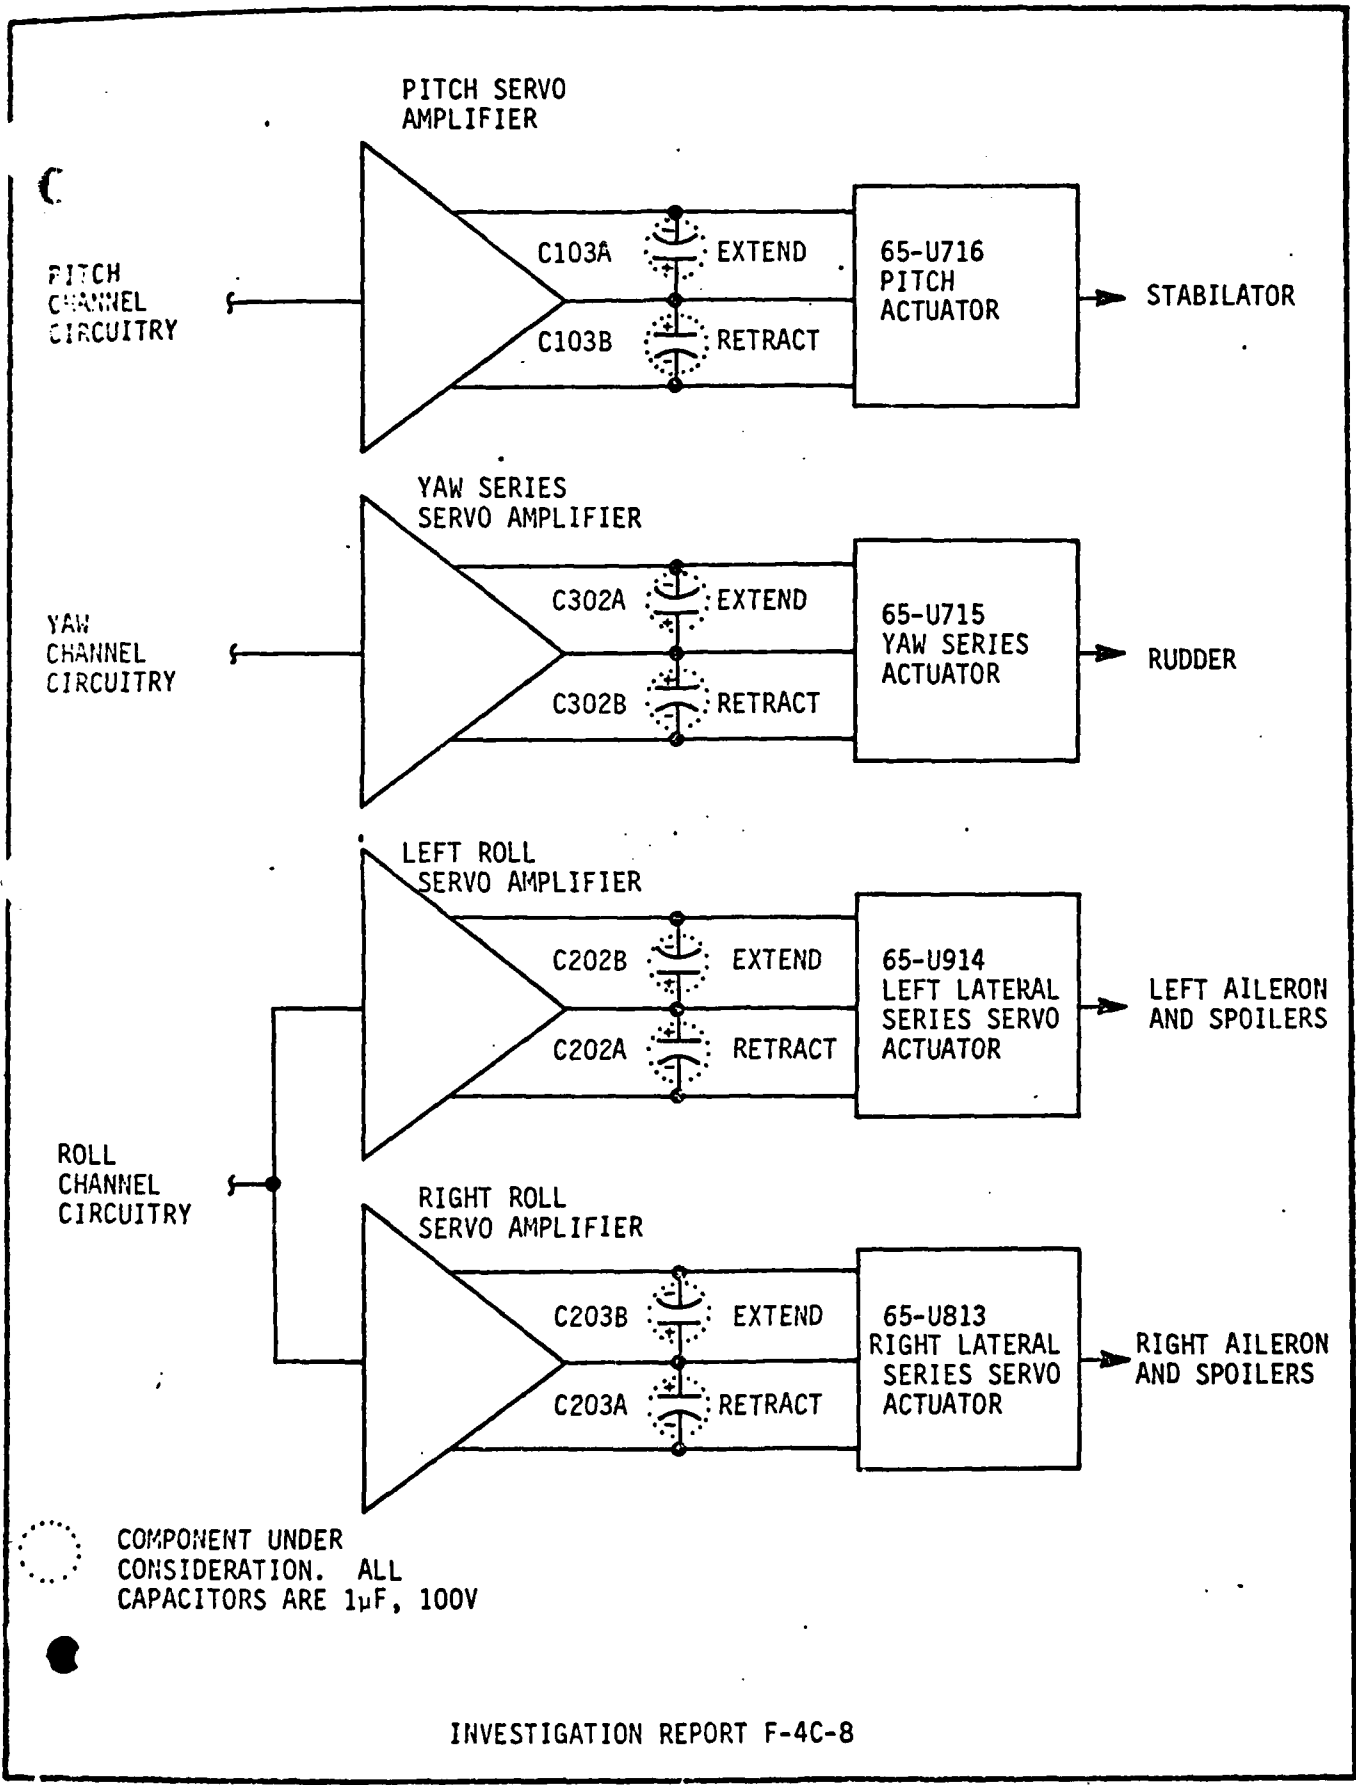
If capacitor C203A in the roll channel fails shorted, it will short the retract coil of the Right Lateral Series Servo Actuator. This will cause the Right Aileron Actuator to extend to its limit, moving the right aileron and spoilers to the full down position, causing the aircraft to roll left.

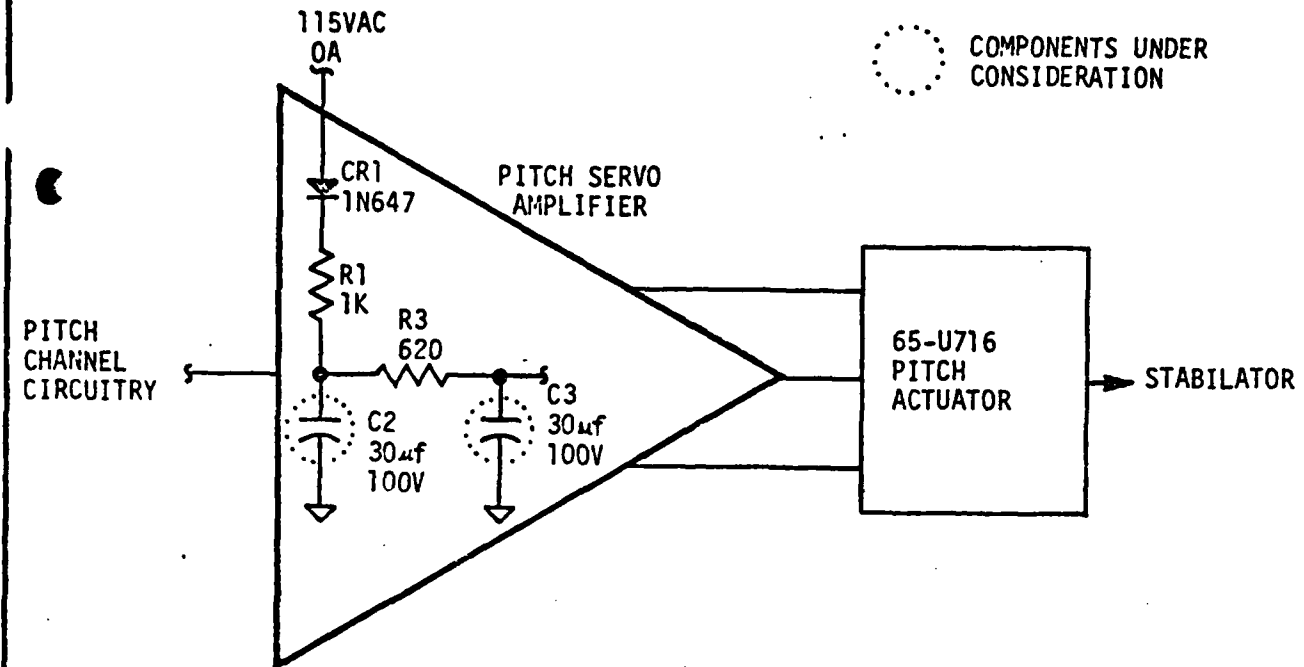
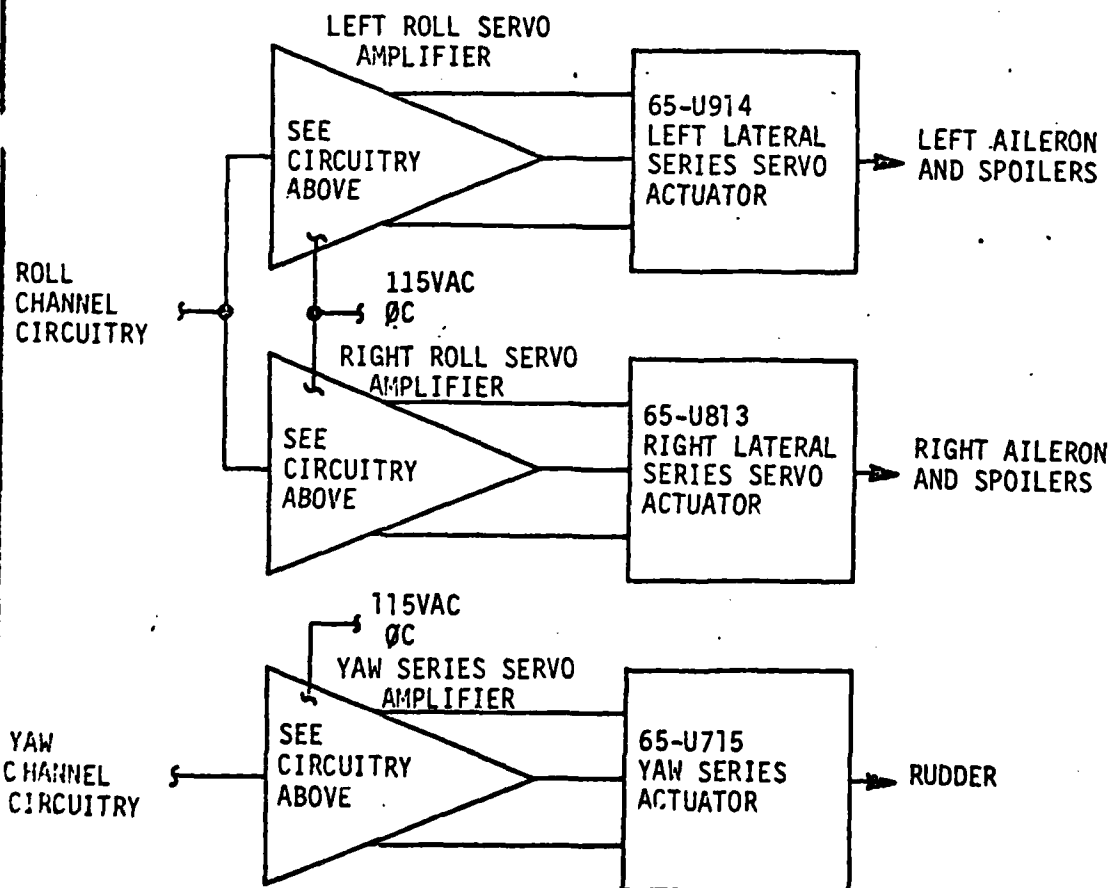
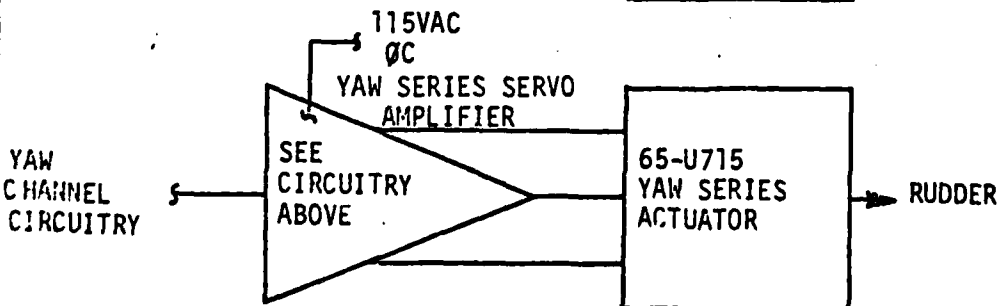
Capacitors C2 or C3 in the Yaw Servo Amplifier would short the power source for the amplifier if either of them fails shorted. There would then be no AFCS control over rudder movement.
