| REPORT DOCUMENTATION PAGE | | READ INSTRUCTIONS<br>BEFORE COMPLETING FORM |
|---|---|---|
| 4. TITLE (and Subtitle)<br>National Program of Inspection of Non-Federal Dams,<br>Tennessee. Colonial Country Club-16th Hole Dam<br>(Inventory Number TN 15774) near Memphis, Tennessee,<br>Shelby County, TN. Wolf River Basin | | 5. TYPE OF REPORT & PERIOD COVERED<br>Phase I Investigation Report |

PHASE I INSPECTION  
COLONIAL COUNTRY CLUB 16th HOLE DAM  
SHELBY COUNTY, TENNESSEE

PHASE I INSPECTION REPORT  
NATIONAL DAM SAFETY PROGRAM  
TENNESSEE

Name of Dam Colonial Country Club - 16th Hole  
County Shelby  
Stream Tributary Fletcher Creek  
Date of Inspection April 2, 1981

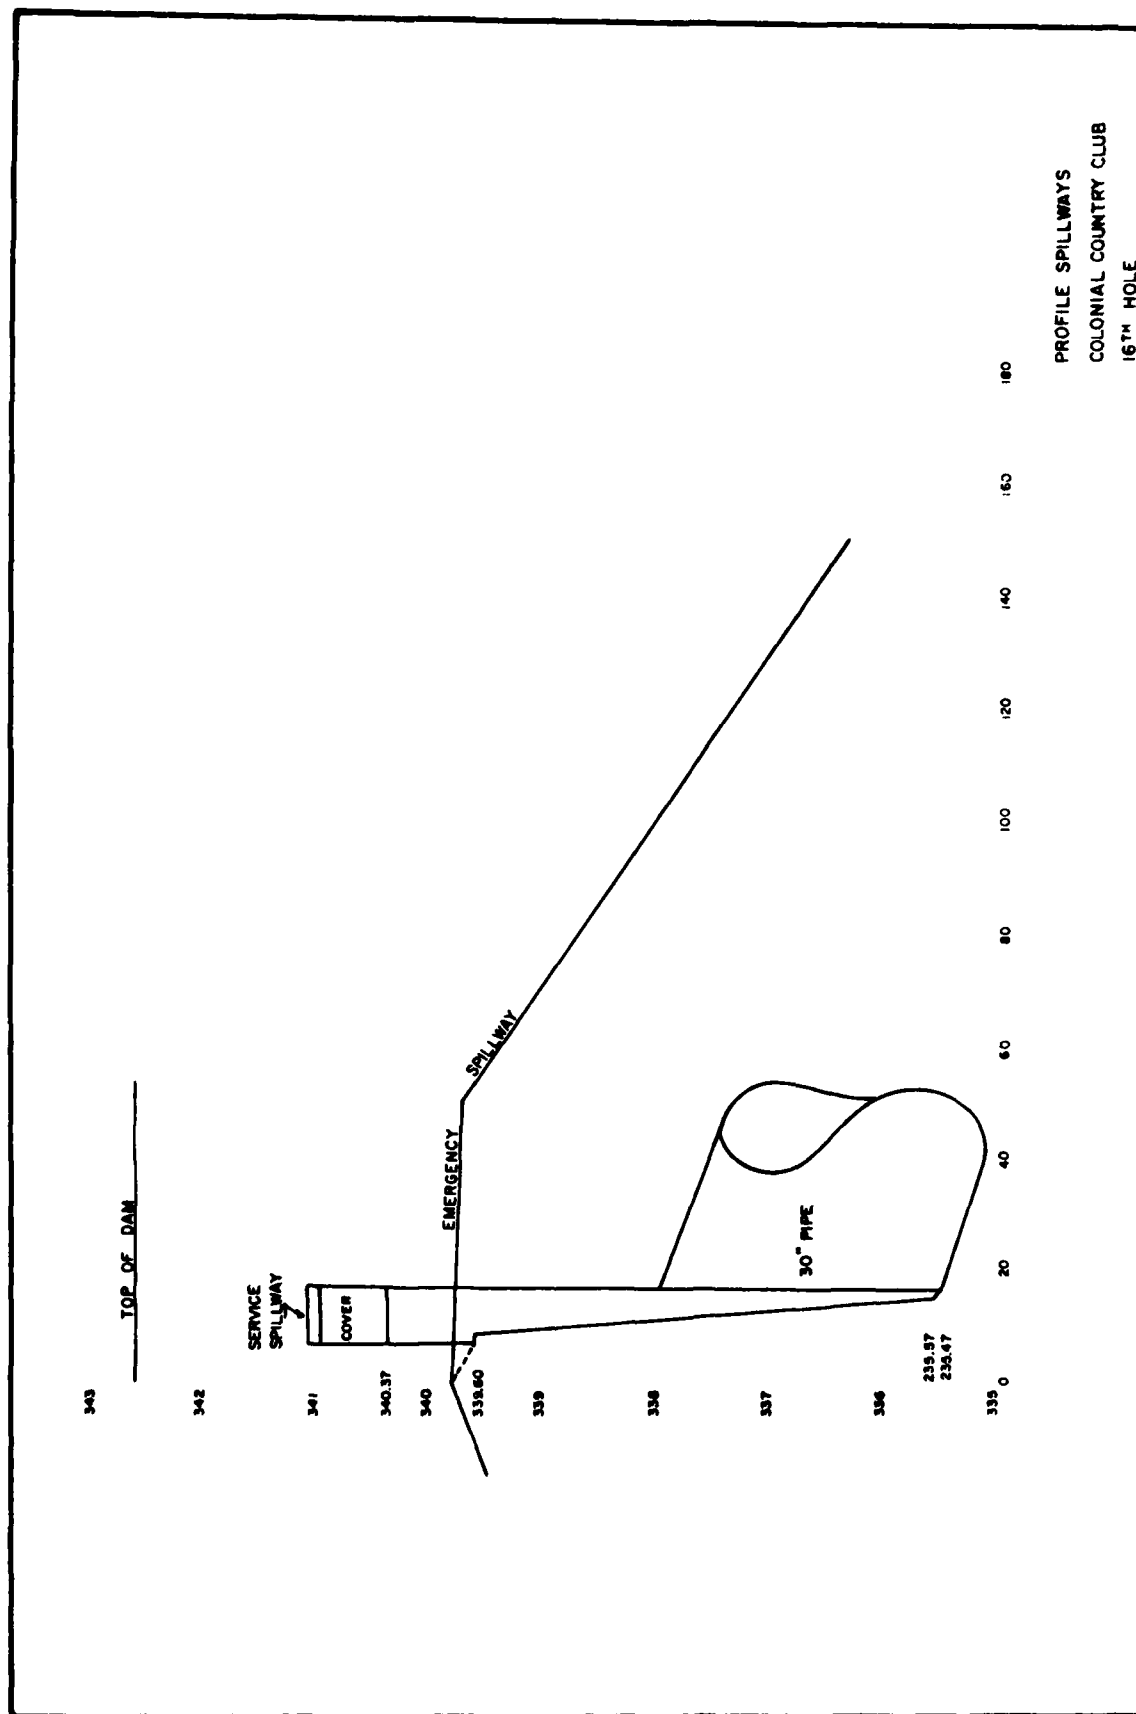
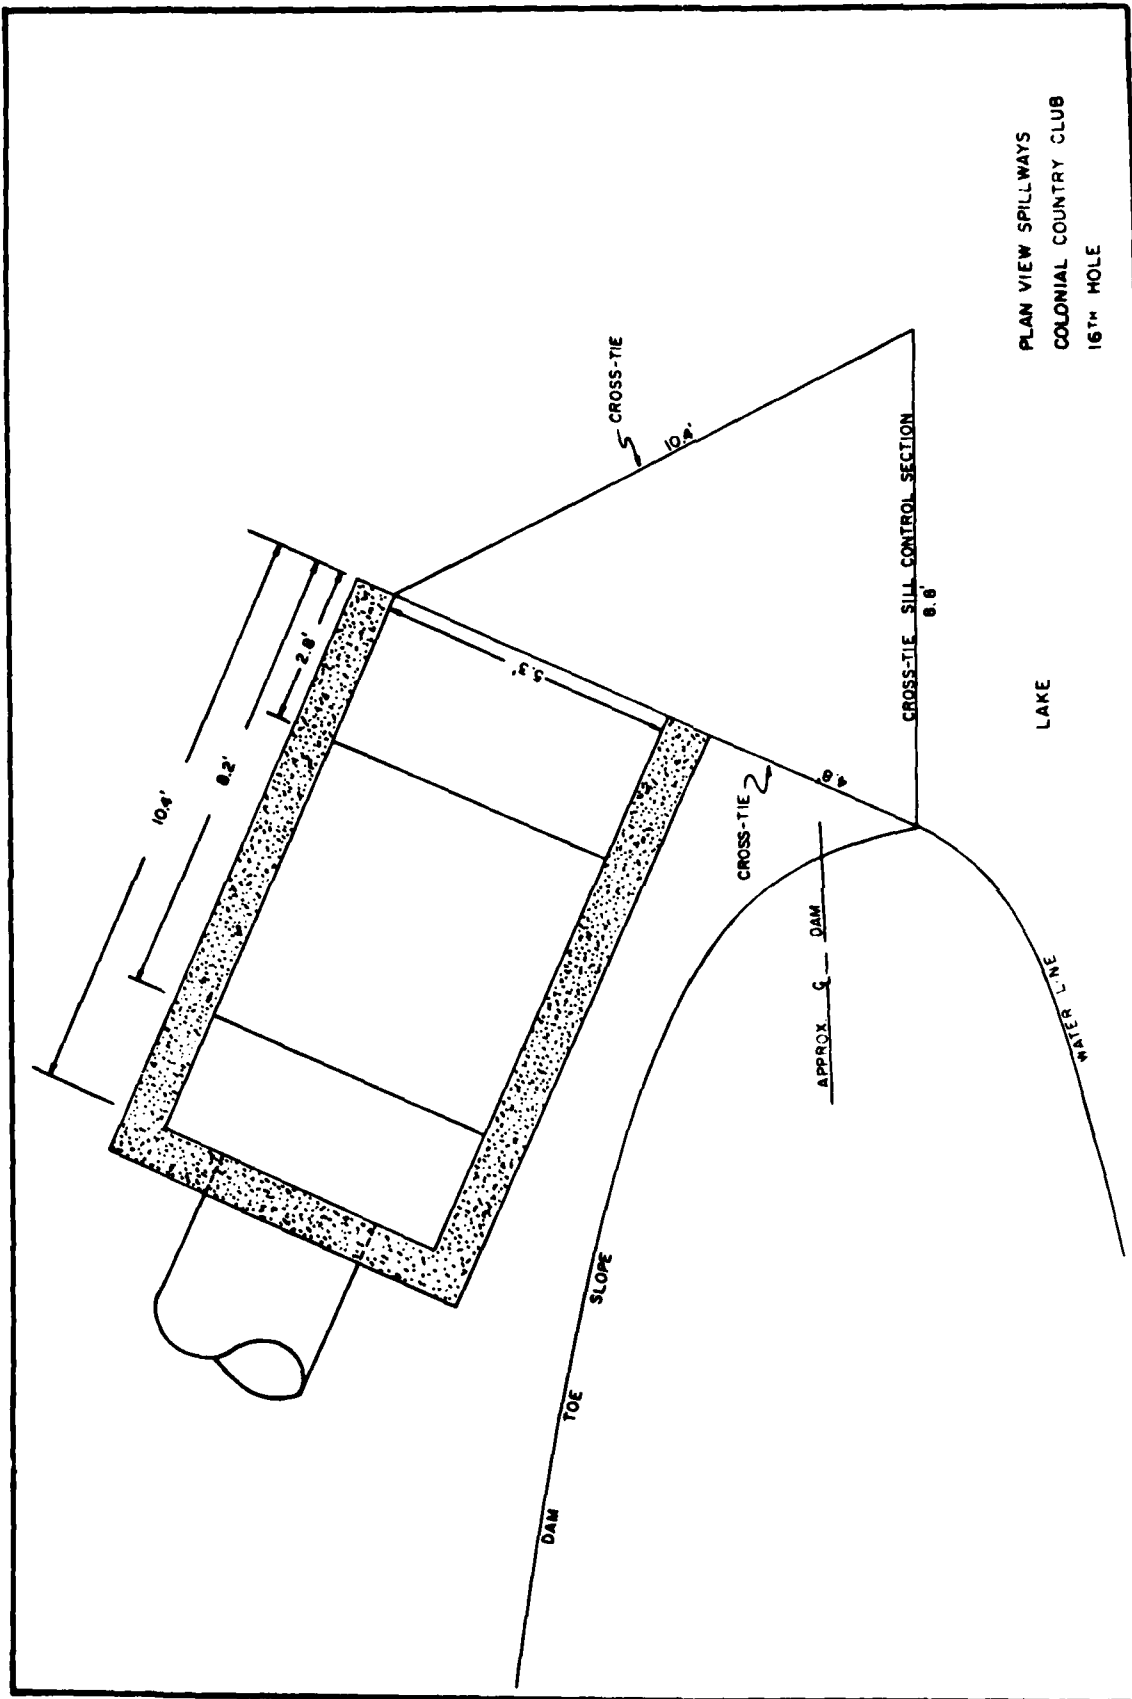
PLAN VIEW SPILLWAYS  
 COLONIAL COUNTRY CLUB  
 16TH HOLE

2.2.3 Emergency Spillway - The emergency spillway is located in the west abutment and has a concrete control section approximately ten feet long with the abutment side slope of 1:6 and the dam side slope of 1:6. The emergency spillway has a flat section approximately 50 feet in length, which includes the service spillway located as noted above. The weir of the service spillway is located approximately 0.2 feet below the control section elevation. It is estimated that the service spillway carries 50% of the maximum flow of the emergency spillway. Excess water is carried in a swale located between the toe of the dam and the foundations of two houses.

At this time, the dam is considered "deficient". It is recommend that a qualified engineer be engaged to: determine the feasibility of relocating the emergency spillway so that the house sites that presently adjoin this facility would be protected; recommend a plan for the removal of undesirable brush and trees from the side slopes; recommend repairs to the telephone cable trench on the downstream slope; and develop an emergency action plan to alert downstream residents in the event a major problem develops with the dam.
