| REPORT DOCUMENTATION PAGE | | READ INSTRUCTIONS<br>BEFORE COMPLETING FORM |
|---|---|---|
| 4. TITLE (and Subtitle)<br>National Program of Inspection of Non-Federal Dams<br>Tennessee. Red Boiling Springs Dam No. 1 (Inventory<br>Number TN11104) near Red Boiling Springs, Tennessee<br>Macon County, TN., Barren River Basin | | 5. TYPE OF REPORT & PERIOD COVERED<br>Phase 1 Investigation Report |

Red Boiling Springs Dam No. 1

Macon County

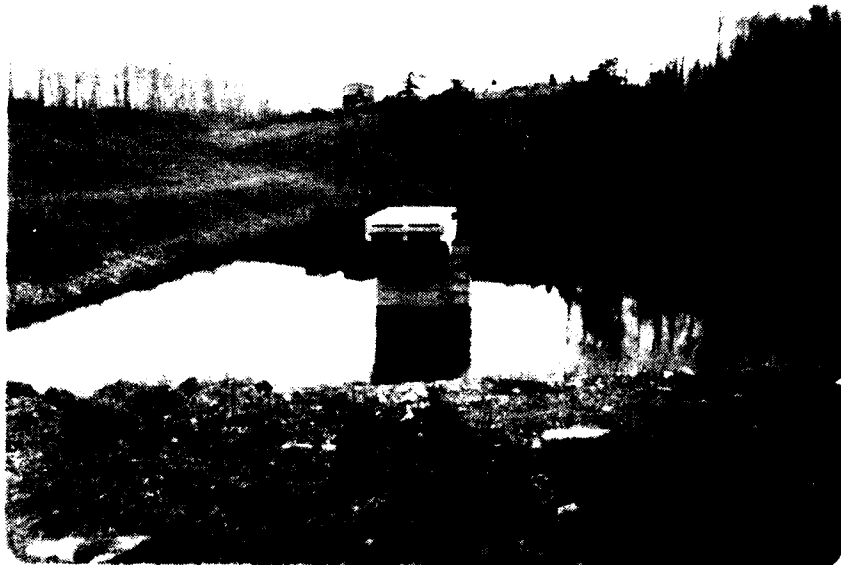
PHOTO NO.7

3.1.2 Service Spillway - The principal spillway appears to be in excellent condition. The riser shows no signs of weathering or cracking. Similarly, the pipe outfall is free of any noticeable weathering. The baffle wall, apron, and end sill of the impact basin are all intact and in good condition. No significant erosion of the underlying and adjacent fill material was observed. There was a nominal flow emanating from the outlet, presumably the result of leakage around the headgate.

- Photo No. 5 - Reservoir.
- Photo No. 6 - Dam crest and spillway entrance channel.
- Photo No. 7 - Riser.
- Photo No. 8 - Riser showing low water release duct.
