REPORT DOCUMENTATION PAGE		READ INSTRUCTIONS BEFORE COMPLETING FORM
1. REPORT NUMBER	2. GOVT ACCESSION NO. HD-A108250	3. RECIPIENT'S CATALOG NUMBER
4. TITLE (and Subtitle) National Program of Inspection of Non-Federal Dams, Tennessee. Chancellor & Son Dam (Inventory Number TN 06939) near Saulsbury, TN., Hardeman County, TN., Hatchie River Basin		5. TYPE OF REPORT & PERIOD COVERED Phase I Investigation Report

PHASE I INSPECTION REPORT
NATIONAL DAM SAFETY PROGRAM
TENNESSEE

Name of Dam Chancellor and Son
County Hardeman
Stream Unnamed trib. of
Spring Creek
Date of Inspection March 10, 1981

PHASE I INSPECTION REPORT
NATIONAL DAM SAFETY PROGRAM
CHANCELLOR AND SON DAM
HARDEMAN COUNTY, TENNESSEE

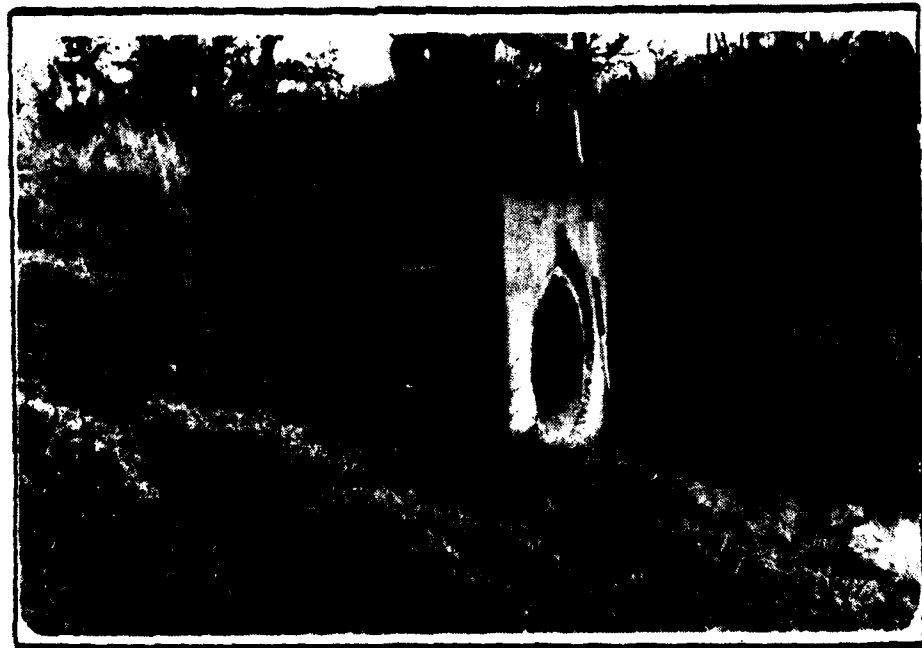
PHOTO NO. 8

Photo No. 8 - The outlet of the service spillway. (Note the lack of fill over the pipe behind the headwall.)

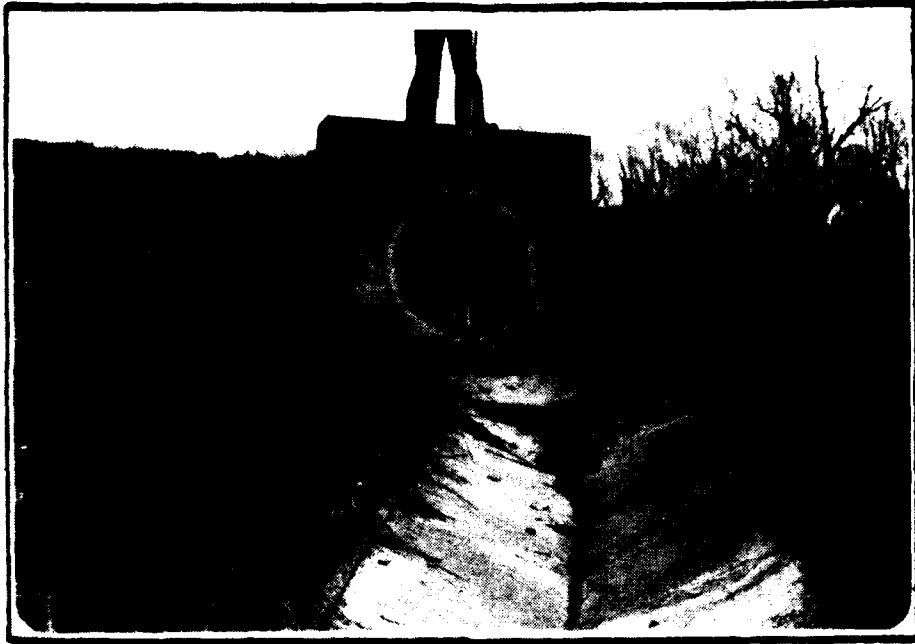
PHOTO NO. 9

Photo No. 9 - The outlet of the service spillway and the chute leading down the slope. (Note concrete plug in invert of pipe.)
