| REPORT DOCUMENTATION PAGE | | READ INSTRUCTIONS<br>BEFORE COMPLETING FORM |
|---|---|---|
| 4. TITLE (and Subtitle)<br>National Program of Inspection of Non-Federal Dams,<br>Tennessee. Lever Lake Dam (Inventory Number TN<br>18708) near Kingston Springs, Tennessee, Williams<br>County, TN., Harpeth River Basin. | | 5. TYPE OF REPORT & PERIOD COVERED<br>Phase 1 Investigation Report |

Lever Lake Dam  
Williamson County  
April 2, 1981

PHASE I INSPECTION REPORT  
NATIONAL DAM SAFETY PROGRAM  
TENNESSEE

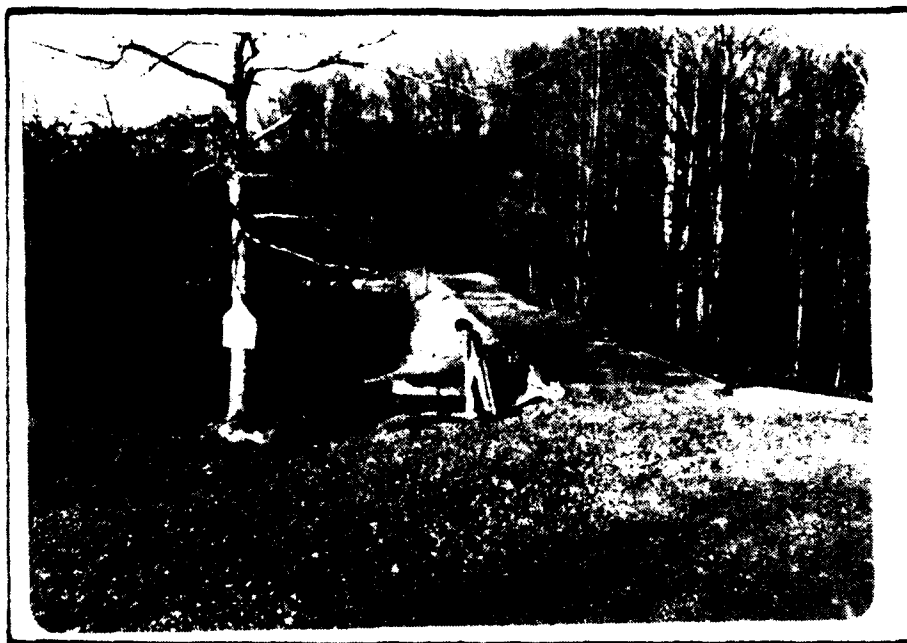
PHOTO NO. 1

- Photo No. 1 - Lake and dam.
- Photo No. 2 - Reservoir from middle of dam.
- Photo No. 3 - Principal spillway from lake side.
- Photo No. 4 - Emergency spillway from upstream dam crest.

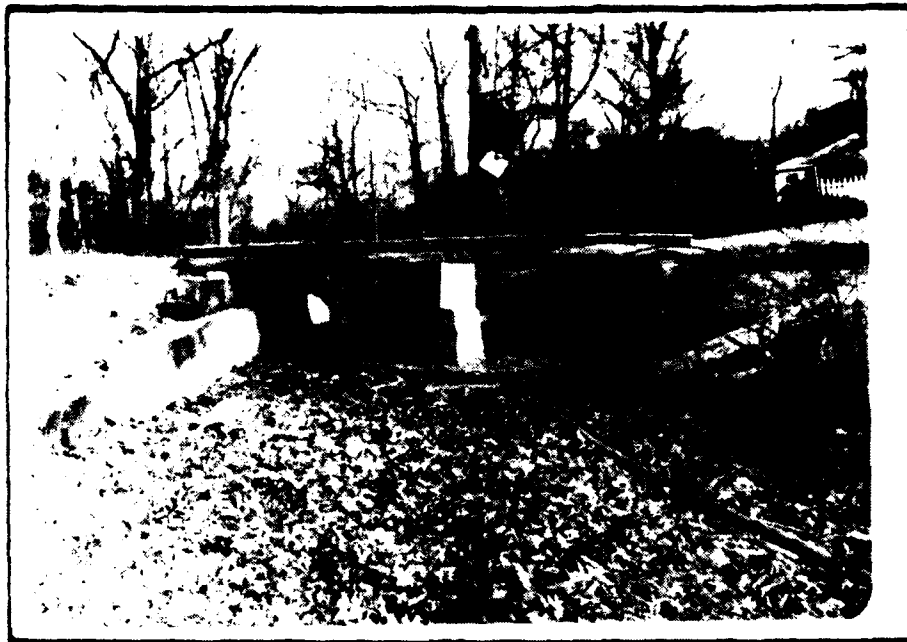
PHOTO NO. 3

- 3.1.2 Service Spillway - The service spillway is in good condition with no appreciable cracking or spalling. The concrete base terminates in an earth and rock channel several feet downstream. The most extensive erosion of the spillway occurs at this transition, but the concrete base is deep enough to have prevented any undermining. The base and side slopes of the channel continue

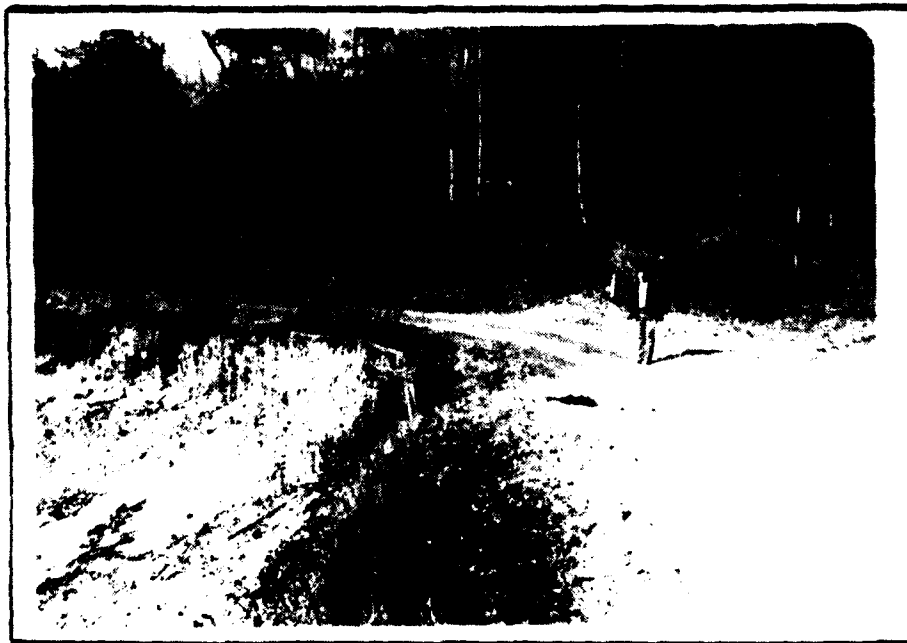
PHOTO NO. 4

3.1.3 Emergency Spillway - The emergency spillway is in good condition and does not appear to have carried flow in recent years. The channel does not have a right sidewall and any flow would impinge on the left abutment tie-in.

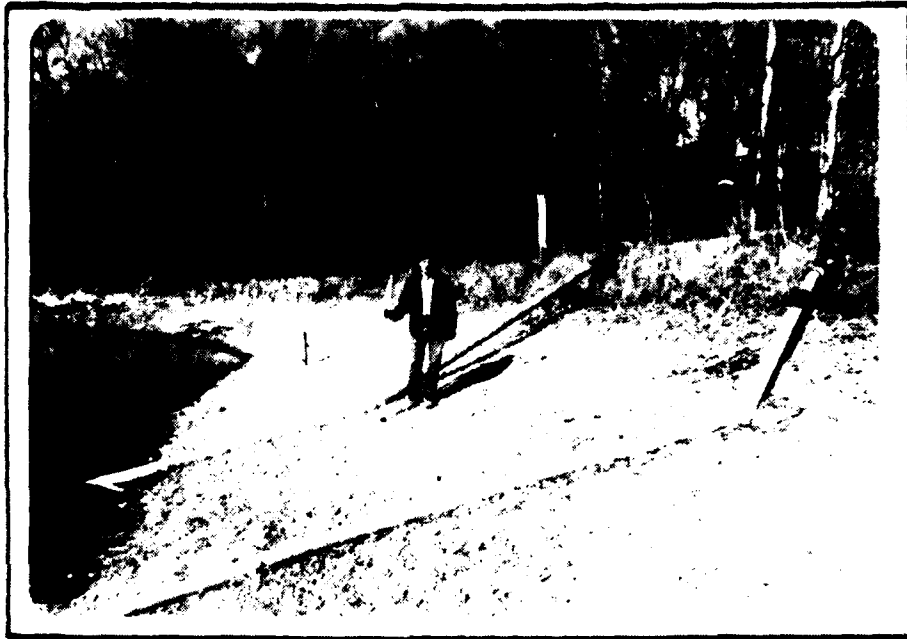
PHOTO NO. 5

3.1.4 Drawdown Facilities - The siphon pipes appear to be operable, but the mode of operation of the 4 inch pipe is of questionable reliability. Since there is apparently no intrinsic mechanism to fill the pipe, any leak of the gate valve would render it inoperable. It would presumably have to be pumped full, via the gate valve. The 6 inch siphon is filled through a capped opening at the top of the horizontal section when the downstream outlet is plugged.

- Photo No. 5 - Upstream slope of dam showing 4" and 6" siphons and drain stem of abandoned concrete drawdown in background.
- Photo No. 6 - 6" PVC siphon pipe and outlet for abandoned drawdown. Center pipe is apparently scrap.

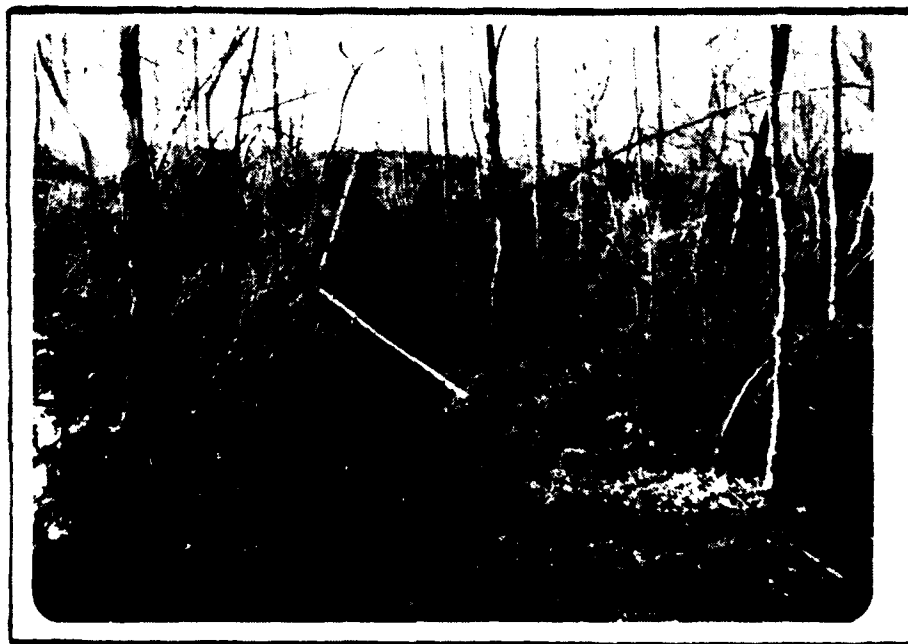
PHOTO NO. 8

- Photo No. 7 - Close-up of drawdown outlet.
- Photo No. 8 - Downstream slope of dam.
- Photo No. 9 - Localized slide at toe just right of concrete drawdown outlet.
