| REPORT DOCUMENTATION PAGE | | READ INSTRUCTIONS<br>BEFORE COMPLETING FORM |
|---|---|---|
| 4. TITLE (and Subtitle)<br><b>National Program of Inspection of Non-Federal Dams<br/>Tennessee. Akers Dam (Inventory Number TN 16503)<br/>near Turners Station, Tennessee, Sumner County, TN<br/>Barren River Basin</b> | | 5. TYPE OF REPORT & PERIOD COVERED<br><b>Phase 1 Investigation Report</b> |

PHASE I INSPECTION REPORT  
NATIONAL DAM SAFETY PROGRAM

Name of Dam ..... Akers  
County ..... Sumner  
Stream ..... Unnamed Trib. of  
Little Trammel Creek  
Date of Inspection ..... April 15, 1981

Akers Dam, Sumner County, Tennessee

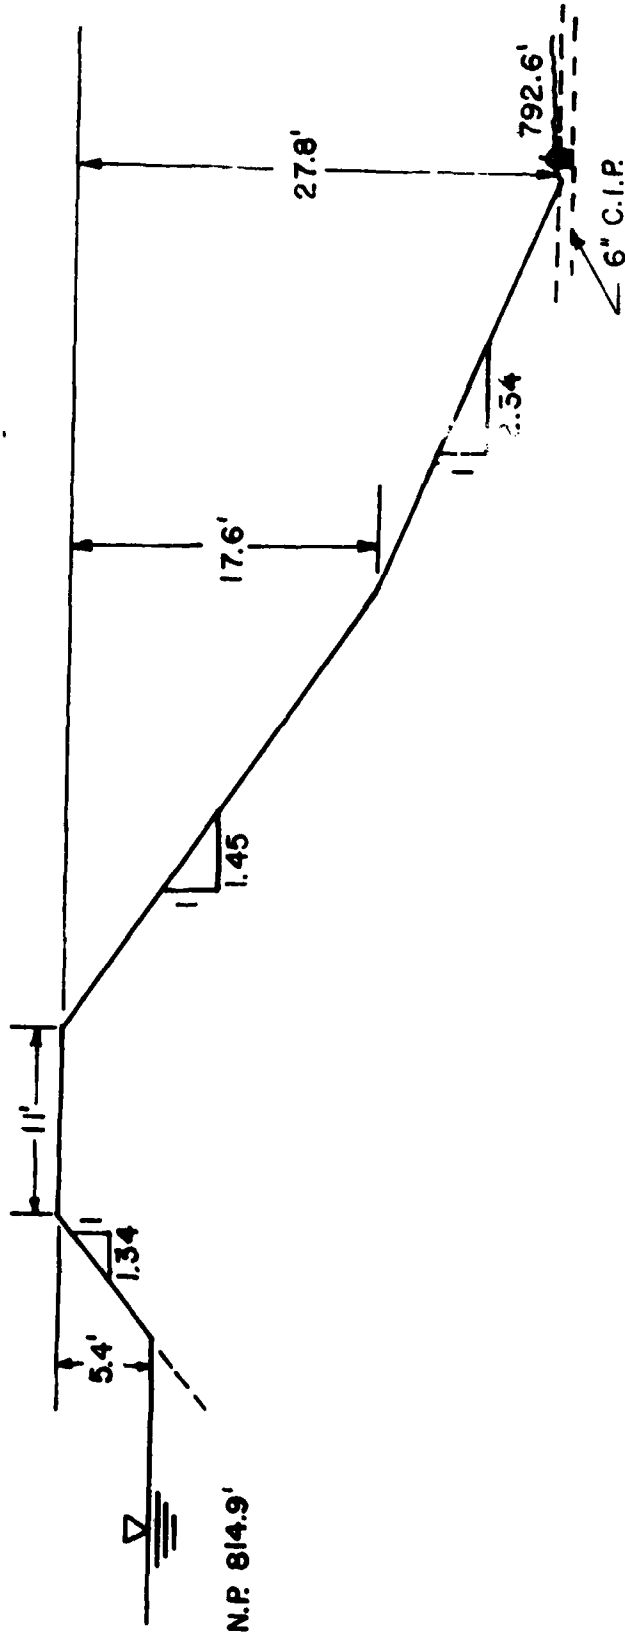
FIGURE 5

2.4.2 Service/Emergency Spillway - The service/emergency spillway founded on dolomite bedrock at the left abutment. The earth and rock side slopes vary down the channel between 1.6 to 2.8H:1V on the left side and between 6.1 to 8H:1V on the right side (Figure 5). Large dolomite slabs were placed on the right slope. The crest elevation at the spillway is approximately 814.9' msl. The spillway channel is roughly 150 feet long and runs perpendicular to the axis of the dam (Figures 3 and 7; photo nos. 5 and 6). Outflow from the channel cascades down the side of a natural draw to the old stream channel.
