PHASE I REPORT
NATIONAL DAM SAFETY PROGRAM
TENNESSEE

Name of Dam Construction Products Dam
County Madison
Stream Tributary - Dyer Creek
Date of Inspection February 5, 1981

This report is based on the findings of a Phase I investigation of Construction Products Dam on February 5, 1981. This study was done in accordance with "Recommended Guidelines for Safety Inspection of Dams", Department of the Army, Office of the Chief of Engineers.

PHASE I INSPECTION REPORT
NATIONAL DAM SAFETY PROGRAM
CONSTRUCTION PRODUCTS DAM
MADISON COUNTY, TENNESSEE

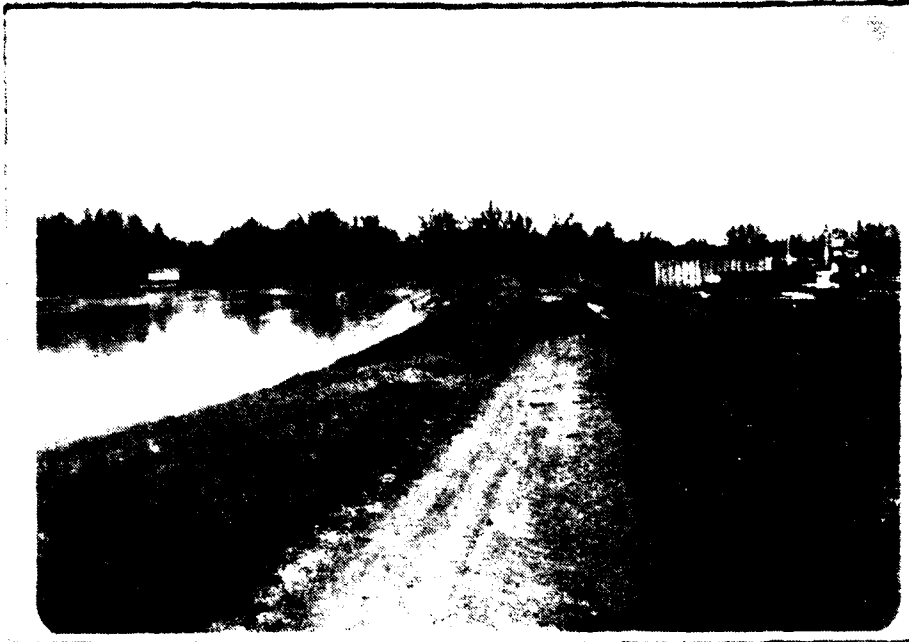
PHOTO NO. 1

- Photo No. 1 - View of the dam and lake.
- Photo No. 2 - View of the downstream slope of the right section of the L-shaped embankment.
- Photo No. 3 - Erosion on the crest of the right portion of the embankment caused by vehicular traffic.

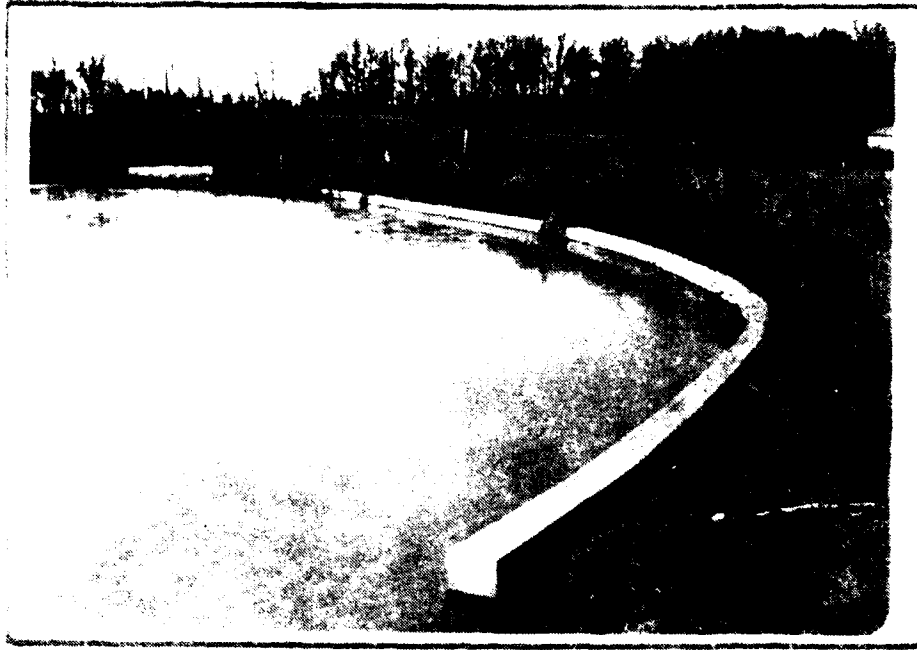
PHOTO NO. 5

3.1.1 Embankment - The slopes of the embankment are uniform and protected with a well established grass cover (photo no. 2). There was no evidence of instability, uncontrolled seepage, serious erosion, or undesirable growth. The upstream slope of the left section is protected against wave action by a 15 inch high concrete wall (photo no. 5). There is minor erosion behind the wall, where several saplings are growing (photo no. 6). The upstream slope of the left section has only grass protection (photo no. 9) where a small bench caused by wave action has formed at normal pool level.

- Photo No. 4 - Erosion of the crest at the left end caused by vehicular traffic.
- Photo No. 5 - View of a concrete wave wall along the upstream slope at the left portion of the embankment.

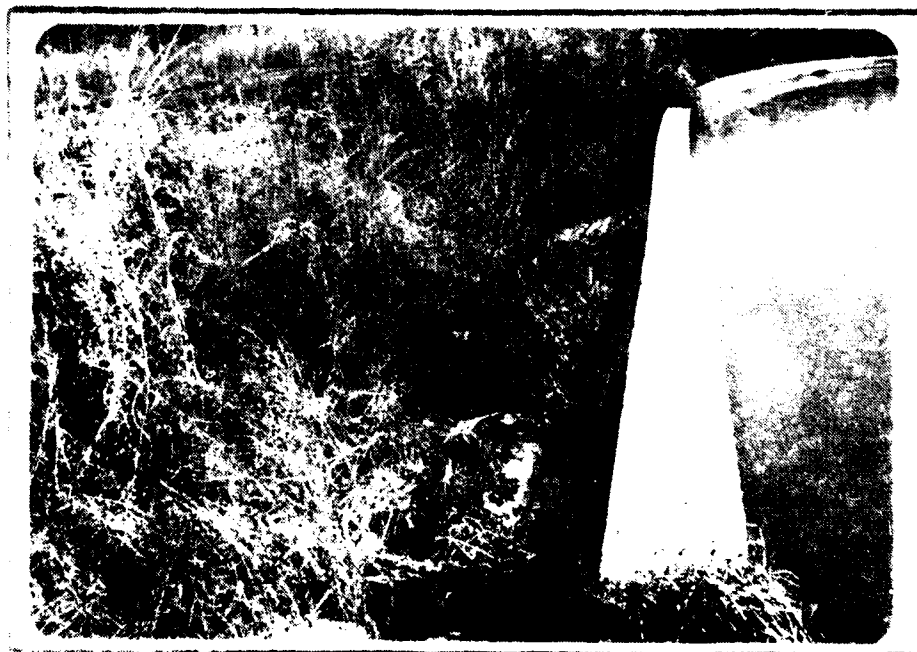
PHOTO NO. 6

- Photo No. 6 - Minor erosion behind the wave wall along the upstream slope.
- Photo No. 7 - View of a collapsed wooden pier on the upstream slope.
- Photo No. 8 - View of the right section of the dam.
