REPORT DOCUMENTATION PAGE		READ INSTRUCTIONS BEFORE COMPLETING FORM
1. REPORT NUMBER	2. GOVT ACCESSION NO. AD-A108465	3. RECIPIENT'S CATALOG NUMBER
4. TITLE (and Subtitle) National Program of Inspection of Non-Federal Dams, Tennessee. Cumberland Springs Lake Dam (Inventory Number TN 12701) near Lynchburg, TN., Moore County, TN., Elk River Basin		5. TYPE OF REPORT & PERIOD COVERED Phase 1 Investigation Report

20. ABSTRACT (Continue on reverse side if necessary and identify by block number) Cumberland Springs Dam has an 8.3 acre lake and is located near the head of Hurricane Creek in Moore County, Tennessee. The concrete gravity structure has a maximum constructed height of 33 feet and a length of 192 feet, including a 36 foot long ogee spillway. The spillway section also includes a drawdown pipe that is gated on the upstream face. The concrete dam is reinforced with six buttresses on the downstream face. The exposed surfaces of the buttresses are badly weathered with horizontal cracks 6 inches deep on the vertical faces. A horizontal crack was observed on the downstream face of the dam approximately

PHASE I INSPECTION
CUMBERLAND SPRINGS DAM
MOORE COUNTY, TENNESSEE

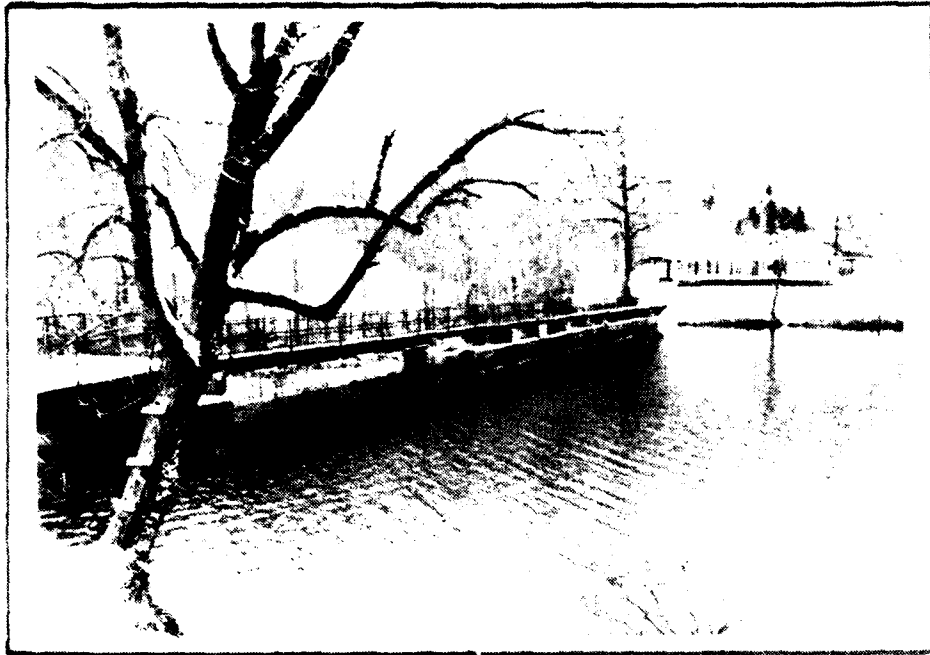
PHOTO NO. 1

- Photo No. 1 - Lake and dam from upstream left.
- Photo No. 2 - Seepage from beneath concrete foundation at right abutment.
- Photo No. 3 - Dam from downstream left.
- Photo No. 4 - Downstream left abutment.
- Photo No. 5 - Seepage at toe just right of center.
- Photo No. 6 - Right abutment rock formation. (Notice leak in dam at top center of picture.)
- Photo No. 7 - Top view of toe, right of center.
- Photo No. 8 - Small dam downstream from main dam crest.
