# BOMB CRATER REPAIR TECHNIQUES FOR PERMANENT AIRFIELDS

Report I

## SERIES I TESTS

David L. Cooksey

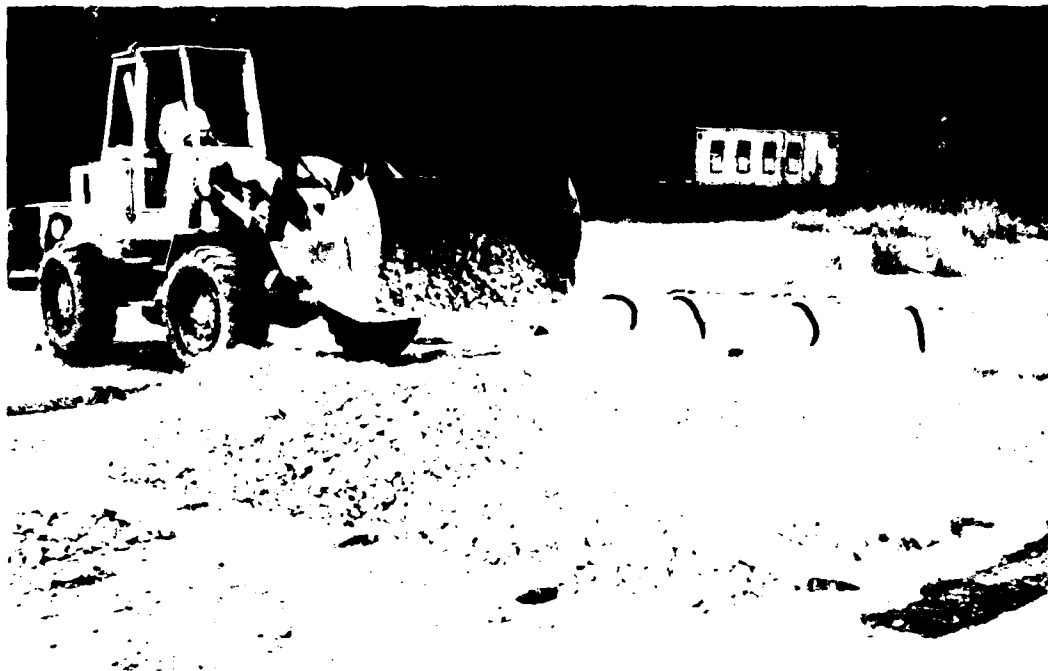
Photo 34. General view of crater 2 showing plastic film and PVC pipes installed prior to grouting. Moment transfer devices are installed along the south half of the crater

of polyvinyl chloride (PVC), 20 ft long, were installed in the crater on top of the plastic film (Photo 34). One end of the pipes was capped and the opposite end contained a 45-deg connector and a 4-ft extension added to reach out of the crater and above the limestone. The pipes contained 1/2-in.-wide longitudinal slots spaced throughout the entire 20-ft pipe length. The pipes were placed on 4-ft centers approximately 2.5 ft from the crater edges. One pipe was placed perpendicular to the others beneath the extensions coming out of the crater. For pumping the grout, 27-ft-long flexible rubber hoses with inside diameters of 3 in. were inserted inside the seven PVC pipes until they were 1 ft from the capped end. Approximately 15 in. of open-graded limestone was placed into the crater over the pipes using a front-end loader and a dump truck (Photos 35 and 36). The limestone was spread by a backhoe and by dragging the bucket of a front-end loader (Photos 37 and 38). The limestone was sprayed lightly with water to prevent the grout mixture water from being absorbed by the dry limestone and to facilitate the passage of the fluid grout around the individual particles of limestone (Photo 39). The grout was prepared and pumped under a contract using commercial equipment (Photo 40). The large commercial equipment was used to facilitate construction and would not be available under combat conditions. Ready-mix transit trucks or other means of delivery could be used. The grout that was used in craters 2 and 3 consisted of PCC (Class A), flake calcium chloride, friction reducer, and water. The grout had a density of 117 pcf and contained the following percentages by weight: cement--68 percent, water--31 percent, calcium chloride--1 percent, and a friction reducer--0.2 percent (approximately). The grout was designed to have an unconfined compressive strength of 800 psi minimum after 8 hr of curing time. The grout was very fluid and level seeking and was pumped at the rate of approximately 42-168 gal/min (1-4 barrels/min (one oil field barrel is 42 gal)). The grout flow was 15-20 sec through a flow cone.\*

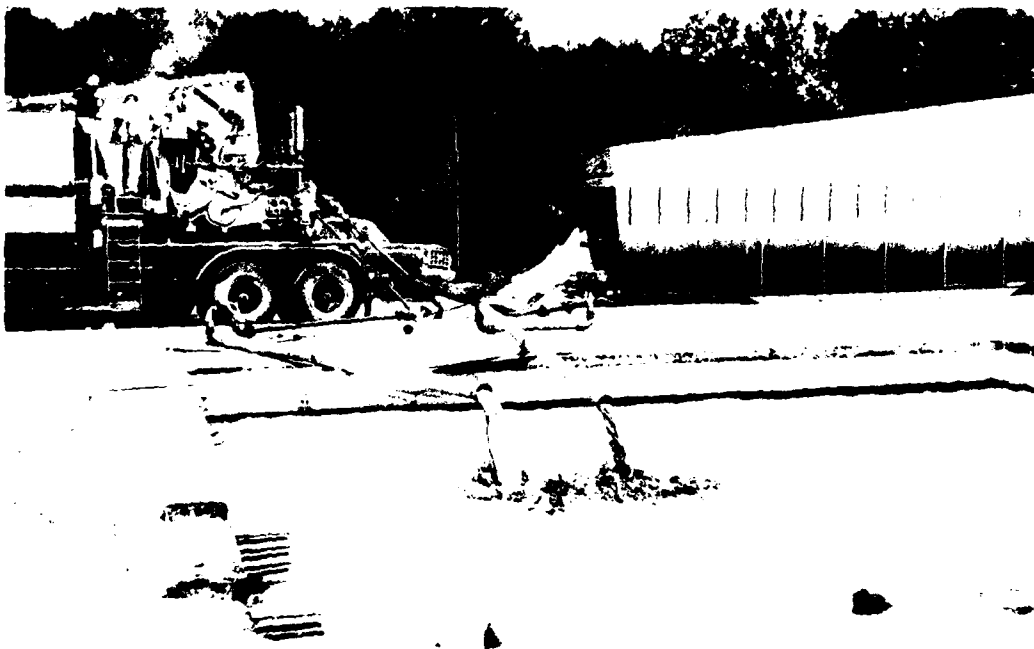
Photo 43. Crater 3 with polyethylene film placed over limestone just prior to grouting. Both the undercut and fabricated moment transfer devices can be observed along the perimeter of the crater

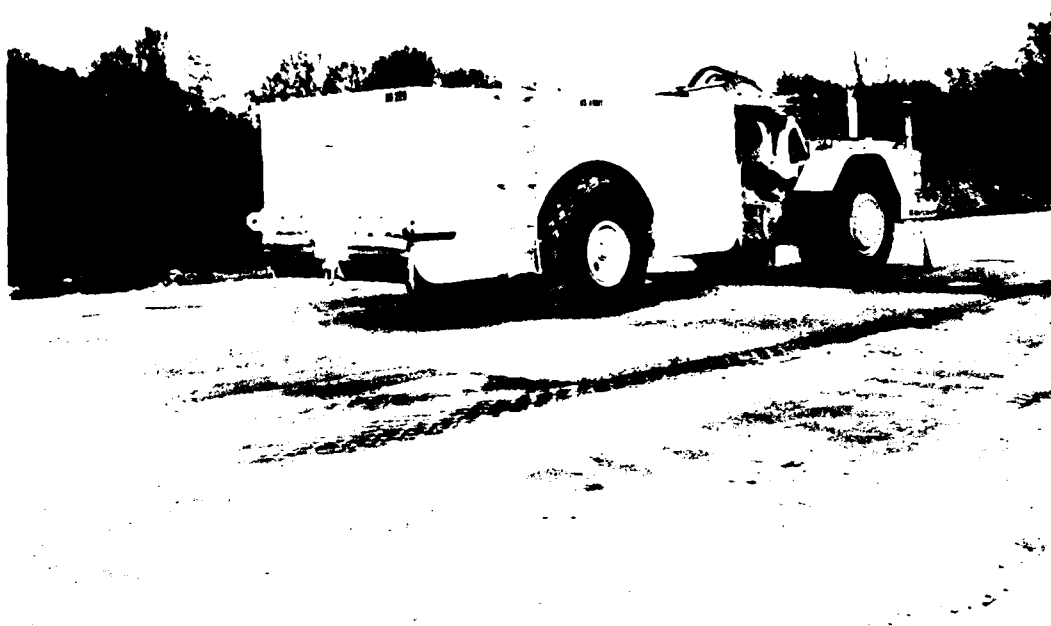
Photo 71. Pneumatic-tired roller compacting limestone which was added to crater 1 as part of normal anticipated maintenance

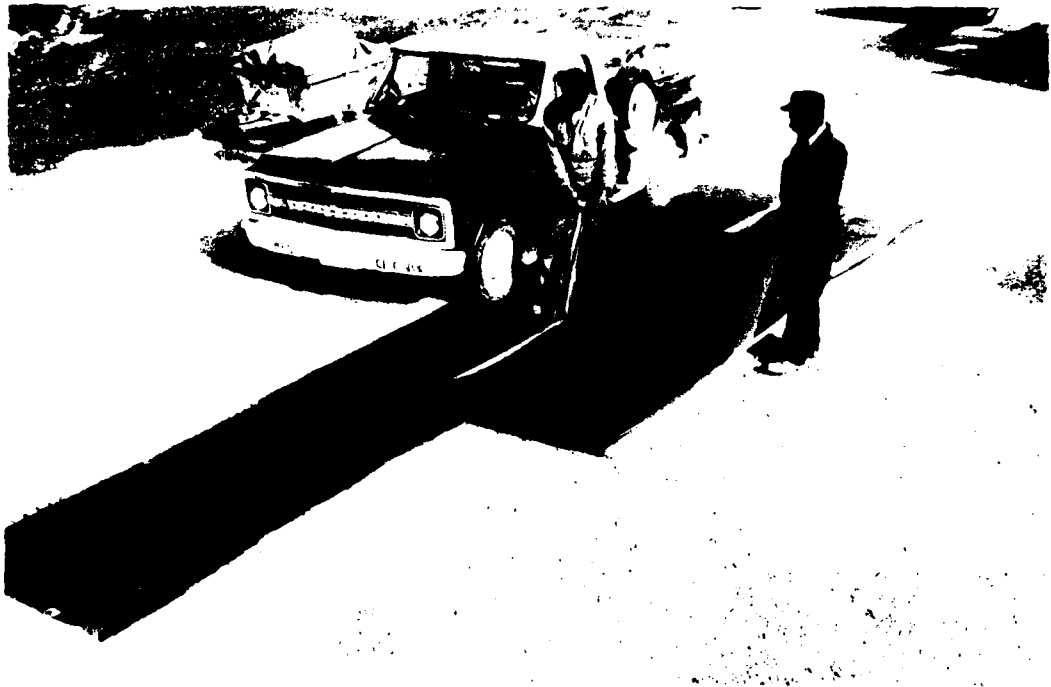
Photo 79. Asphaltic film being placed by hand over surface of limestone to keep individual limestone aggregates intact

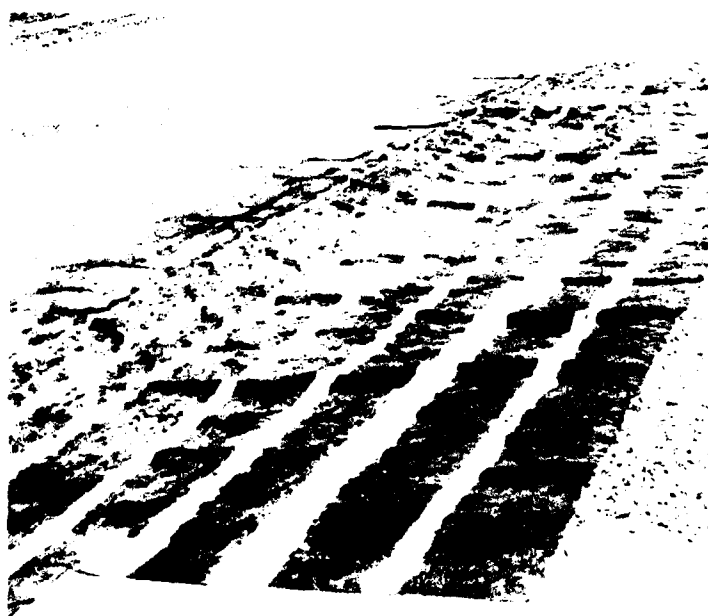
Photo 82. Wrinkles in the asphalt-coated fabric after 10 passes of the C-141 load cart
