BEL-AIR LAKE DAM

NDI I.D. PA-0066

PHASE I INSPECTION REPORT  
NATIONAL DAM INSPECTION PROGRAM

AUGUST 1981

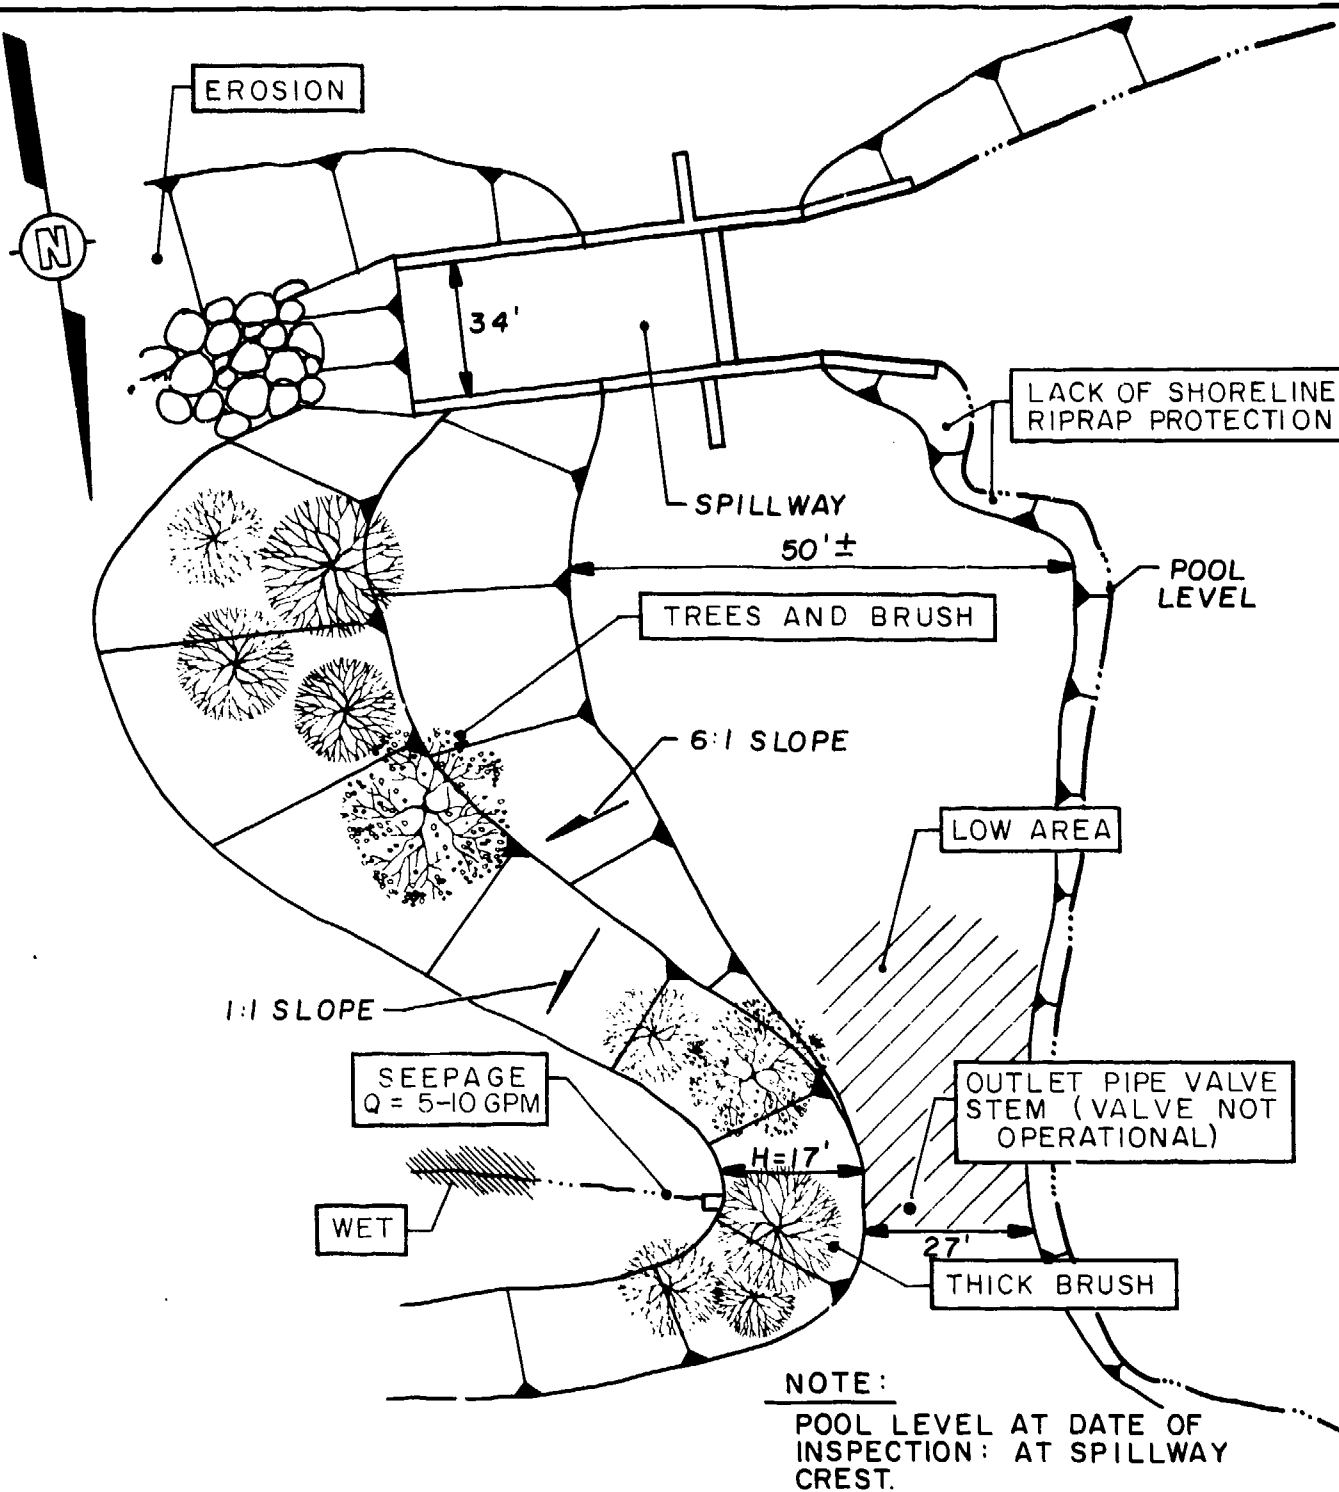
PLATE 5  
 BEL-AIR LAKE DAM  
 GENERAL PLAN  
 FIELD INSPECTION NOTES  
 FIELD INSPECTION DATE: MAR. 24, 1981

The specific observations are illustrated on Plate 5.

In general, the condition of the embankment is considered to be fair. The most significant condition noted was that the center of the dam was significantly lower than the top of the spillway sidewalls, significantly reducing the potential discharge capacity of the spillway. By field survey, the available freeboard measured relative to the low section on the crest of the dam was only about 1.8 feet. Plate 6 shows the existing dam crest profile. The design drawings indicate that the design freeboard was five feet. Therefore, the center of the dam appears to have settled. At this time, no other indications of ongoing settlement were noted. The middle portion of the downstream face is covered with trees and brush.
