*2* BUZZARD SWAMP WATERFOWL AREA

*3* NO. 6 DAM

*8* PHASE I INSPECTION REPORT

*1* NATIONAL DAM INSPECTION PROGRAM

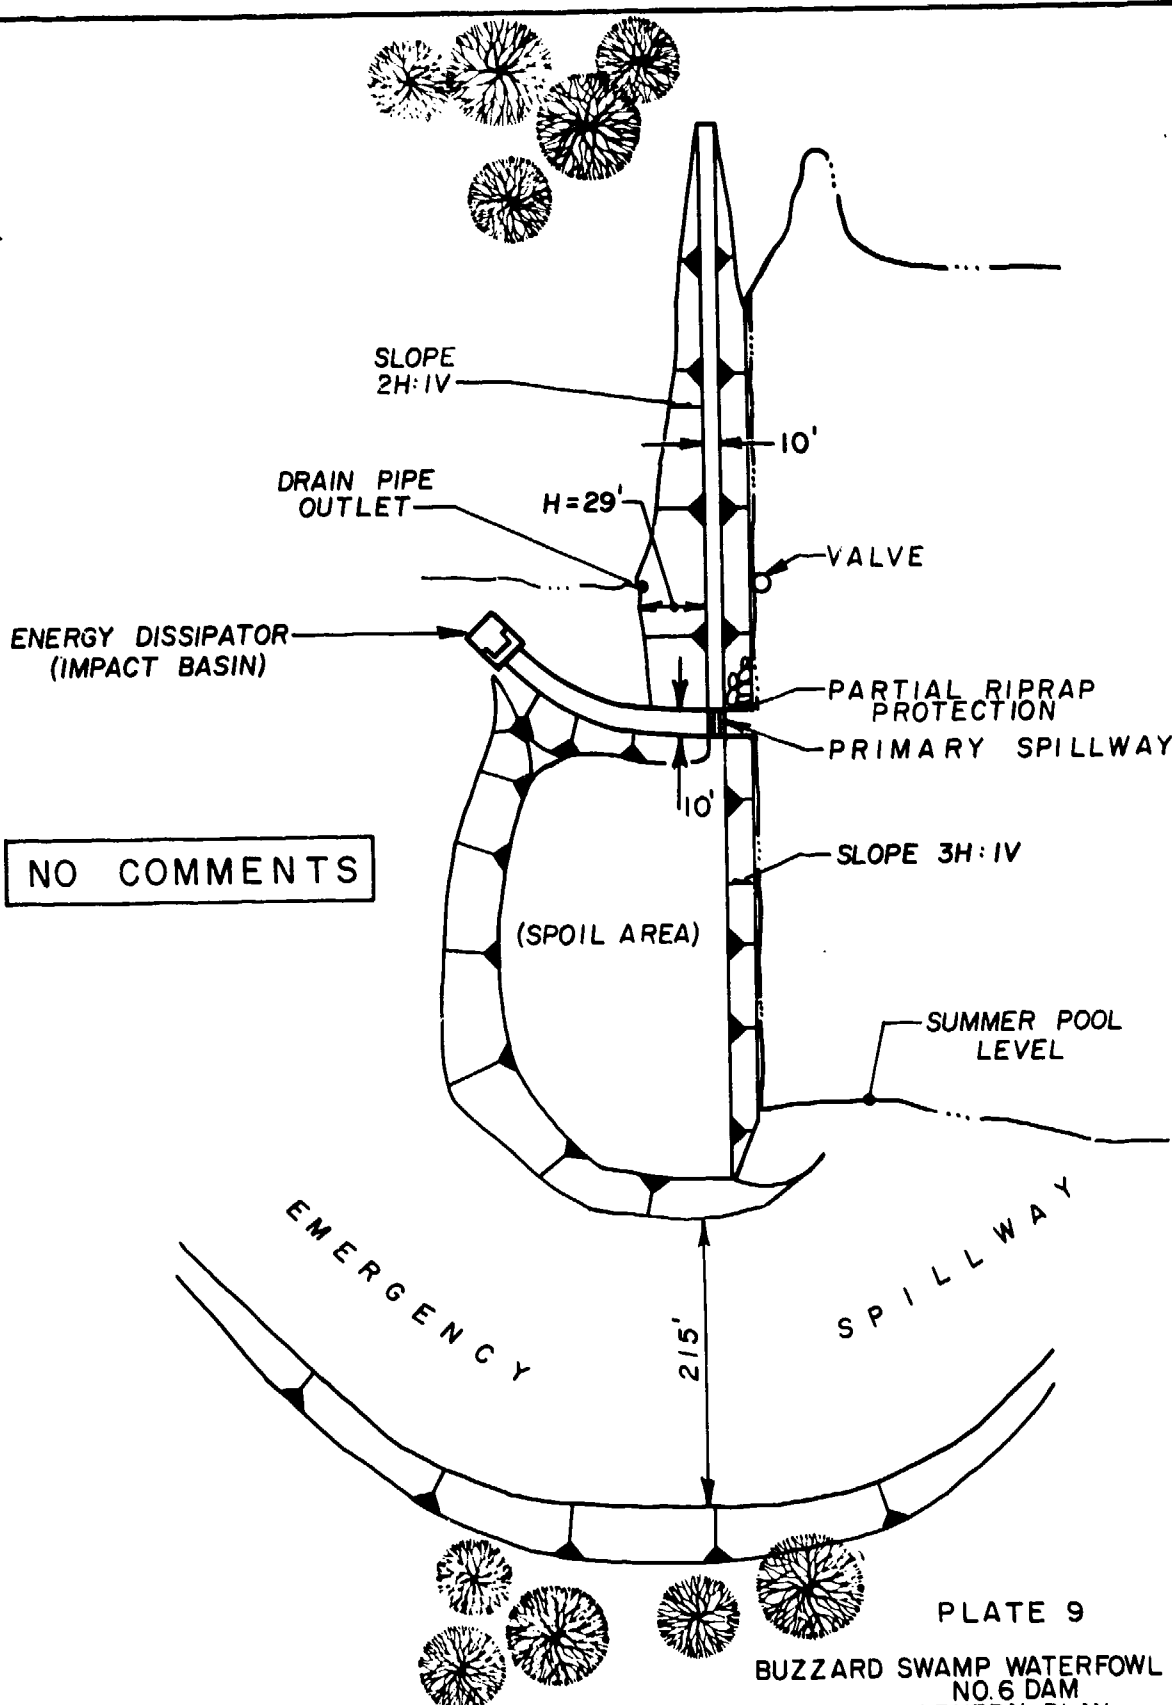
The dam crest was surveyed relative to the emergency spillway crest elevation and was found to be at or above the design level. The lowest embankment area occurred at a section near the right abutment. The dam crest profile, according to field measurements, is illustrated on Plate 10.
